This article aims to reconstruct the geomorphologic and landscape effects of the most catastrophic flood from a man-made dam failure within the territory of today's Czech Republic, namely, the Bílá Desná dam failure, which occurred on 18 September 1916, only one year after the completion of its construction. At the same time, the specific aim of this paper

2. Study area and characteristics of the former Bílá Desná dam

2.1. Characteristics of the former Bílá Desná dam

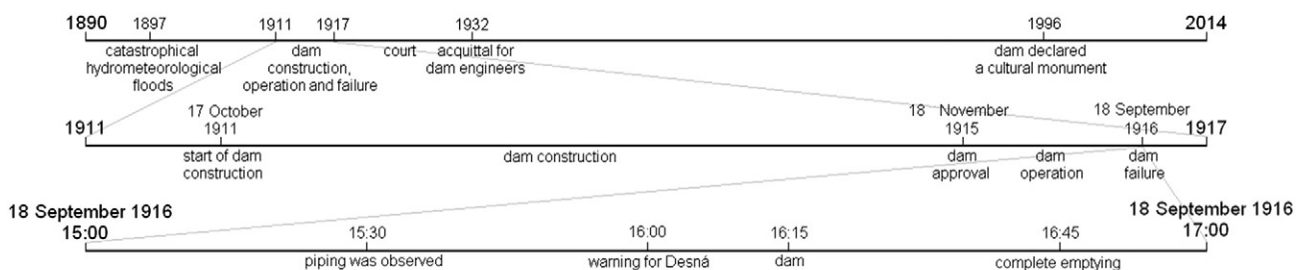
literature (Smrček, 1917; Žák, 1996; Žák et al., 2006) and from archival documentary data. The first evidence of piping through the dam was observed by loggers returning from work along the dam at 15:30 h. At that moment, 290,000 m³ of water was retained in the reservoir. The dam keeper ordered the immediate draining of the reservoir by the full opening of the dam outlet; nevertheless, the piping continued, and the flow rate was exponentially increasing. At 16:00 h, the inhabitants living downstream in the Desné village were warned for the first time by telegraph against the increasing discharge from the dam. Fifteen minutes later, at 16:15 h, the dam failed with an accumulated water volume of 250,000 m³. The village of Desná inhabitants were warned again against a flood following the dam failure at that time. An additional thirty minutes later, at 16:45 h, the dam was completely empty (Fig. 4). The escaped water swept through the valley, leaving behind 62 fatalities and tremendous material damage.

Fig. 3. Chain of events connected to the Desná dam failure (according to Smrček, 1917; Žák et al., 2006).

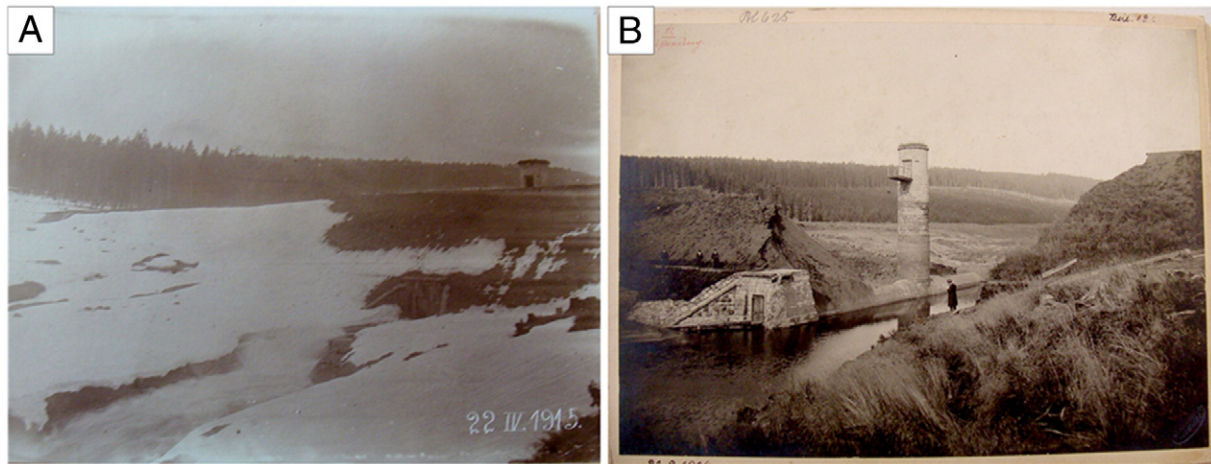
Fig. 4. Upstream view of the Desná dam before (A) and after (B) the dam failure. Source: Archive of the Jablonec nad Nisou, Court reports.

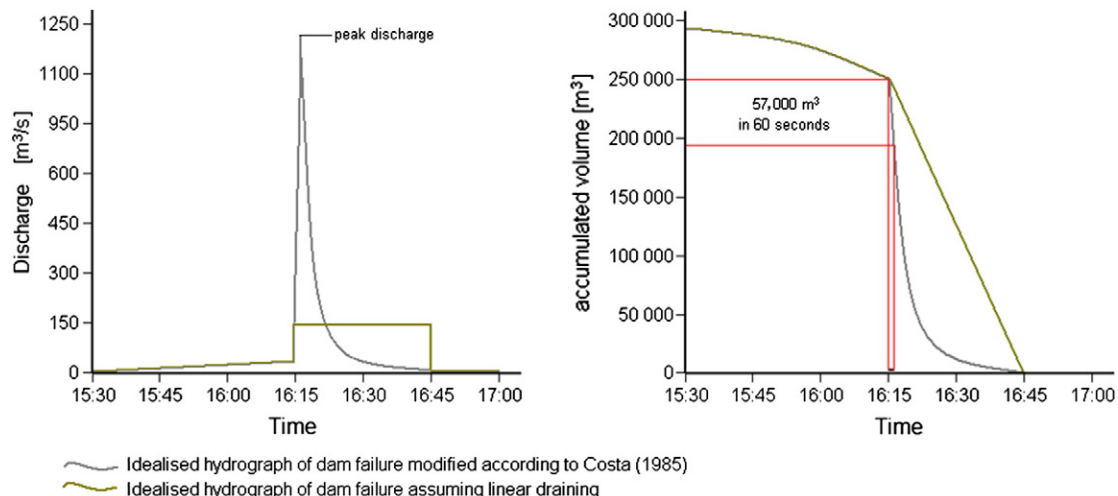
Another point of view concerning the Desná dam failure is represented by a hydrograph describing the change in the flow rate and the decreasing volume of accumulated water between 15:30 h and 16:45 h on 18 September 1916 (Fig. 5). Costa (1985), and later by Tsakiris and Spiliotis (2013), showed that hydrographs describing earthen dam failures are particularly characterised by a steep rising limb and by a steep falling limb, with a peak discharge within minutes to hours, depending on the accumulated water volume, dam characteristics, and failure mechanism.

Fig. 5. Approximate hydrograph of the event (based on the recorded time sequence of the dam failure).

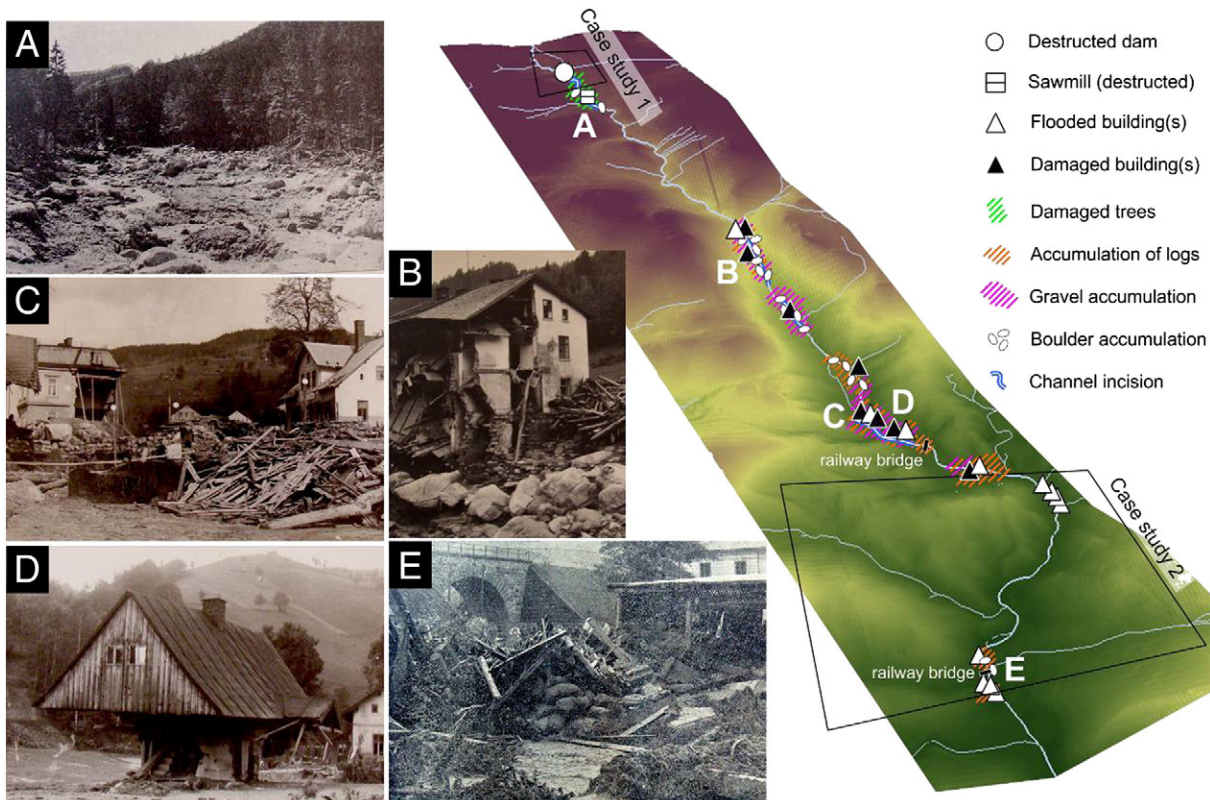
Fig. 6 shows the identified effects of the flood along the river between the failed dam and the town of Tanvald. The detected effects include (i) damage to buildings and to infrastructure and (ii) modifications of the river channel (erosion and accumulation processes), and their intensity can be divided into three segments relative to the longitudinal profile of the Bílá Desná River (Fig. 1D). More than one-third of the studied river length (0–3.2 km) is situated in a narrow intra-mountain valley, with an average slope inclination of ca. 2.80° (806–650 m asl).

Fig. 6. Effects of the flood along the Bílá Desná River based on documentary data. Note: Of the large amount of documentary data, only those data that could be exactly localised were used.

The high gradient of this river segment enabled the stream to transport a large amount of material, which consisted of fractions varying from sand to boulders of up to 2 m in diameter. The flood wave damaged the forest ecosystem in the narrow valley, and the channel underwent a lateral shift (see below in case study 1) and a slight incision in some segments. After reaching the end of the narrow valley, the Bílá Desná River reaches the open space with the settlement of the village of Desná. Between 3.2 and 5 km, the gradient slightly increases to ca. 3.8° as the river channel enters the foothills; however, this gradient gradually decreases from 5 km downstream. The decrease in the gradient, which causes a loss of flow velocity, resulted in the gradual, but massive, deposition of boulders and of timber (approximately between B and D in Fig. 6) that damaged or destroyed tens of buildings, including a few industrial facilities (Gnendiger, 1920) in this river segment. The woody buildings localised near the channel and in the open floodplain (D in Fig. 6) were primarily affected. Owing to the transformation of the flood wave, the last analysed segment of the river (approximately within case study 2) was primarily affected by flooding; however, the destruction of buildings was not frequently documented. This lack of documentation can be ascribed to not only the increasing share of buildings constructed from stones and bricks in this segment but also the decreasing volume of boulders and timber that reached the lower parts of the river. In contrast, the documentary evidence has shown that part of this transported material (both timber and boulders) reached as far as the railway bridge in Tanvald (E in Fig. 6), ca. 8 km below the failed dam.

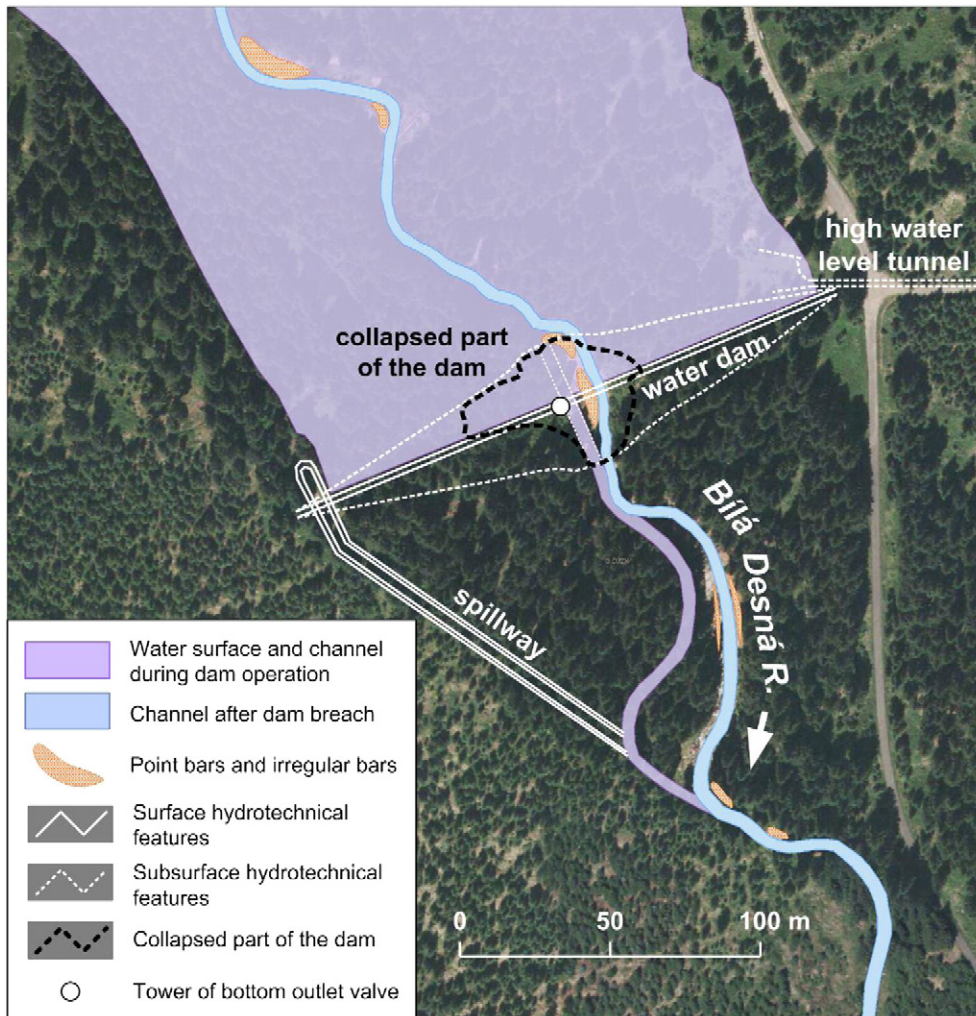
4.1.3.1. Case study 1. The disturbance and modification of the valley and riverbed of the Bílá Desná River following the dam failure has been reconstructed in case study 1, which covers the area of the former reservoir (see Fig. 1). The detailed reconstruction of other river reaches could not be performed because of the limited availability of old maps and photos. Following the dam failure and the rapid discharge of 250,000 m³ of accumulated water during only 30 min, the channel below the dam was significantly modified. The comparison of historical maps from investigation reports of the event and of aerial photos from the early 1950s and from 2010 has shown that the meandering channel below the dam was subject to channel migration and lateral accretion (Fig. 7). The channel width in the reach below the former reservoir varied around 5 m before the dam failure and is currently 8 m in average. The magnitude of channel migration reached up to 30 m in the second meander below the former dam, whereas the lateral accretion only slightly increased the sinuosity of the channel. Instead of channel straightening (cf. Pizzuto, 2002), which could be expected as a result of flood wave flow, the return to the original meandering channel seems to be caused by geometry of a dam-breach and by extreme discharge that disrupted the channel geometry artificially established during the dam construction. This seems to be caused by the disrupting impact of the flood wave caused to channel segments. As documented by cadastral maps from the mid-nineteenth century, the Bílá Desná River channel approximately returned to its original position before the dam construction, with a meandering pattern. The reestablishment of the meandering

Fig. 7. Changes in the channel morphology after the dam failure.

channel pattern and increased sinuosity by lateral accretion enabled the evolution of several gravelly points and irregular bars, which are characteristic of other high-gradient streams in the area. According to Costa and O'Connor (1995), the above-described geomorphic changes are characterised as 'extreme disruptions' of the river channel.

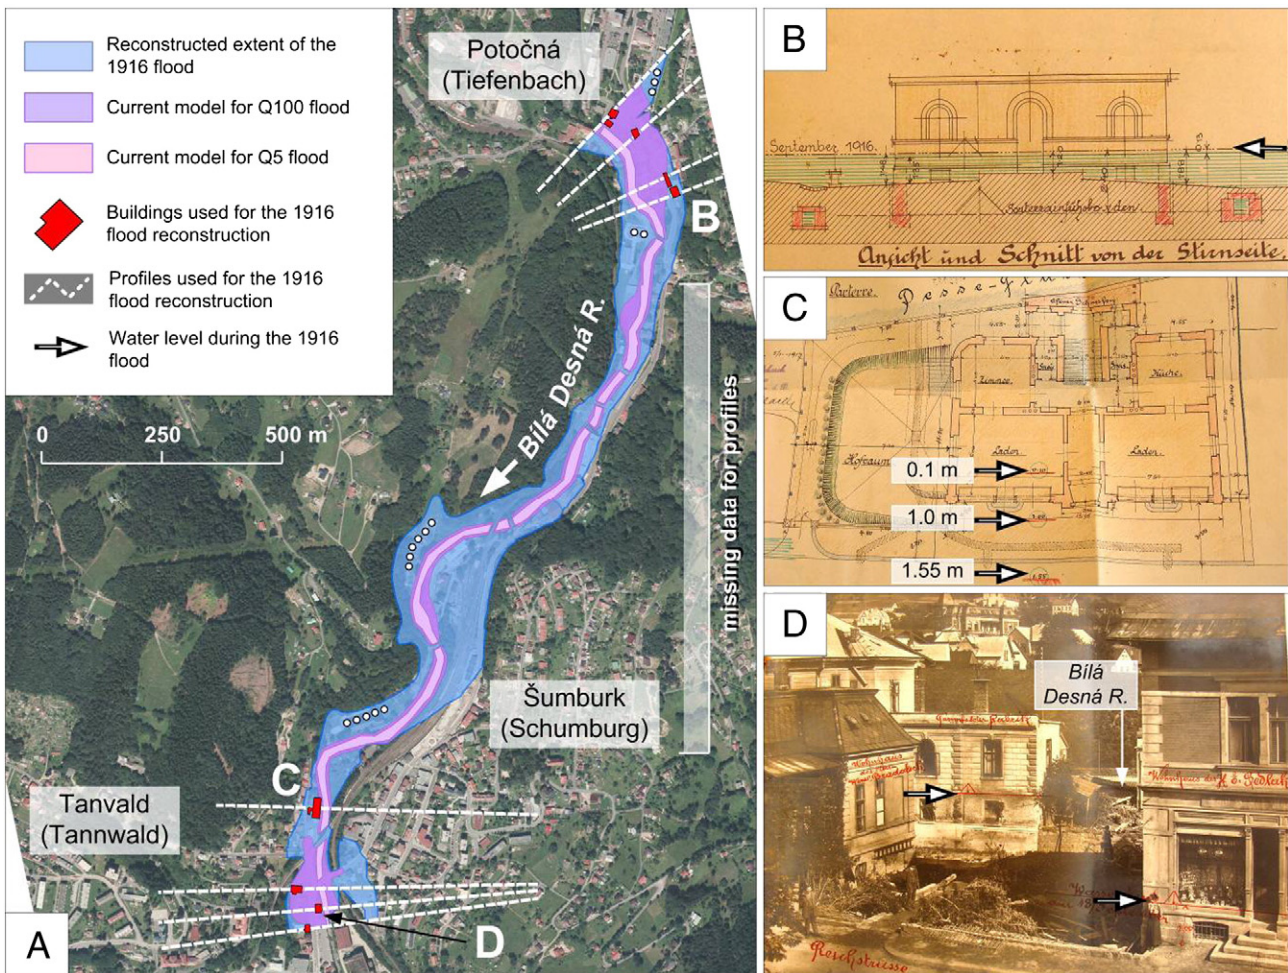
The width of the flooded area ranged between ca. 50 and 250 m, with the highest width reached in built-up areas of the towns and in the meandering channel in the central part of the studied channel reach. In contrast, the minimal width was typical of narrow valley segments, where an increase in the flow velocity can be expected. However, the documentary data did not provide the cross profiles for the central part of the studied river reach. Therefore, the results for this part of the area must be considered only rough estimations. According to the classification presented by Costa and O'Connor (1995), this part of the Bílá Desná River channel was affected by 'small disruptions' from the point of view of geomorphic impacts.

The comparison of the reconstructed flood wave extent with available current flood maps (VÚV, 2014) has shown that the flood wave following the 1916 dam failure exceeded the width of Q_5 and Q_{100} floods 10 times and 5 times, respectively, at some locations. This result can be ascribed to both the extremeness of the peak discharge reached after the dam failure and the subsequent modifications of the Bílá Desná River channel during the last 100 years.

Fig. 8. Estimated flood wave extent. Part (A) illustrates the flood wave extent and the Bílá Desná River valley cross profiles. White dots for major changes in built-up areas after 1916 within the estimated flood wave extent (see Section 4.1.3 for further explanation). Examples of documentary evidence for the flood wave extent and the water level, as preserved in investigation reports for insurance companies. Cross-profile (B), plan (C), and photo (D) with an indicated water level mark.

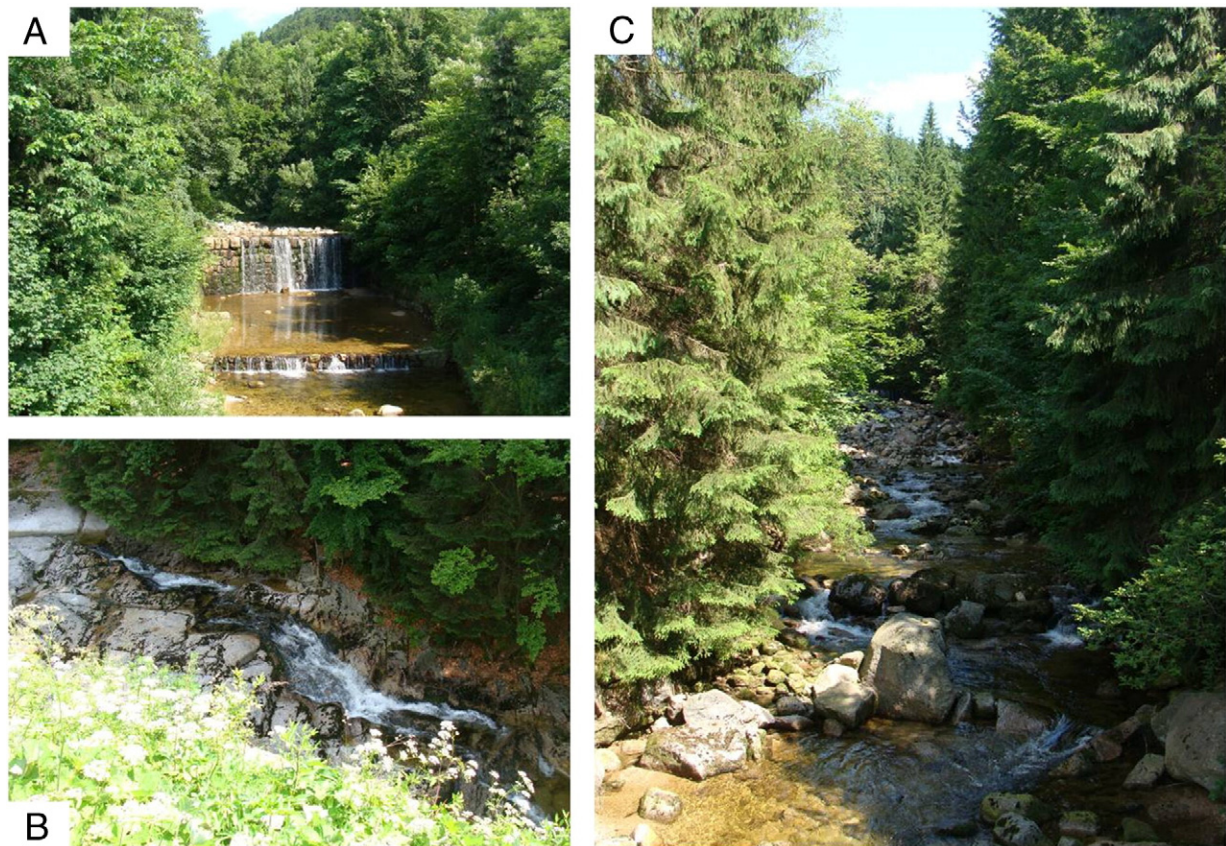
Fig. 9. Part (A) shows an example of stony steps built into the steeper part of the Bílá Desná River channel to protect against floods (debris flows). Part (B) shows a natural bedrock-based part of the river channel bottom. Part (C) shows a natural (unremediated) part of the Bílá Desná River channel.

modified between 1923 and 1936. These technically demanding and expensive remedial works included the complete pavement of the river bottom along the 1.5-km-long lower part and the construction of 34 stony steps in the steeper 2-km-long upper part (Fig. 9A); bedrock-based parts of the river bottom were left without modifications (Fig. 9B). The stony steps are between 1.0 and 4.2 m high and 11.0 to 18.0 m long and serve as a sediment trap (prevention against the initialisation of debris-flow movement). All of these artificial elements are designed for a maximal flow rate of $60 \text{ m}^3 \text{ s}^{-1}$ (Žák, 1996). The section from the upper part of the village of Desná to the former Desná dam position has a natural character, with no artificial channel modifications (Fig. 9C).
