# The drainage of the Lake Ha!Ha! reservoir and downstream geomorphic impacts along Ha!Ha! River, Saguenay area, Quebec, Canada

G.R. Brooks<sup>\*</sup>, D.E. Lawrence<sup>1</sup>

*Geological Survey of Canada, 601 Booth Street, Ottawa, ON, Canada K1A 0E8*

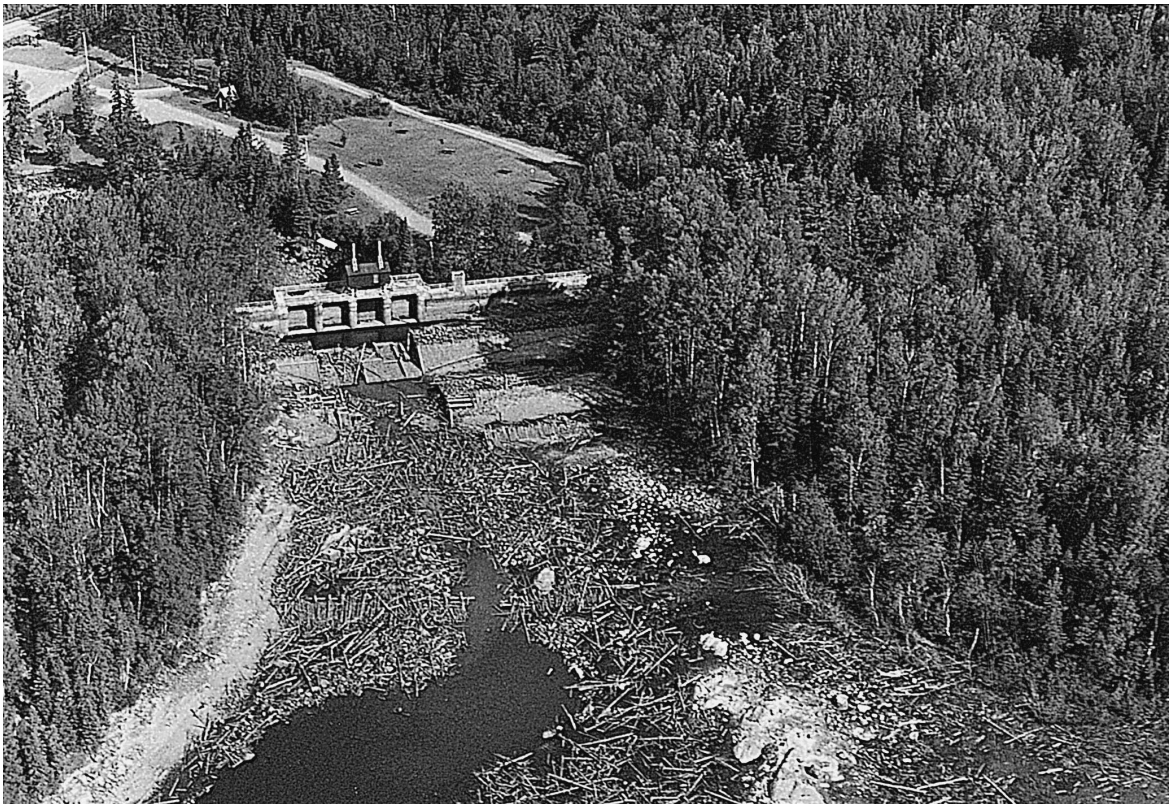
Fig. 5. Post-flood view of the concrete gravity dam that controlled the level of Lake Ha!Ha!. Lake basin is in the foreground. For scale, the four stoplog sluices within the dam are 4.56 m high.

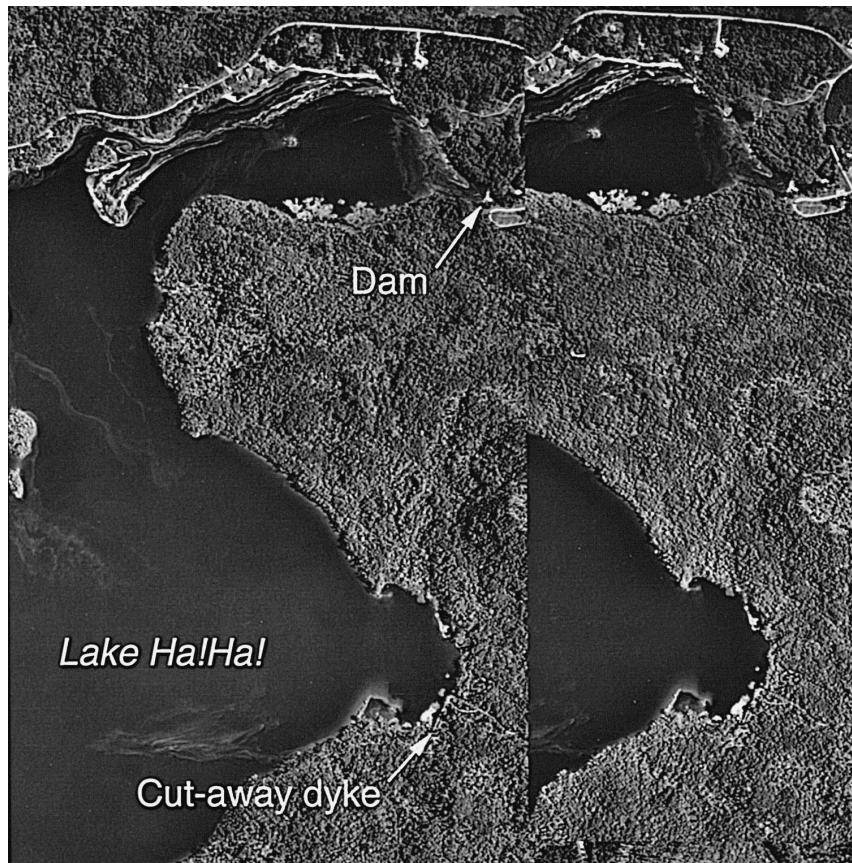
Fig. 6. Photostereogram of the pre-flood morphology of the dyke and saddle where the new channel was eroded causing the drainage of the Lake Ha!Ha! reservoir (aerial photographs 22D3-92; -93, June 15, 1994; reproduced with permission Photocartotheque Québécoise, Ministère des ressources naturelles, Québec).

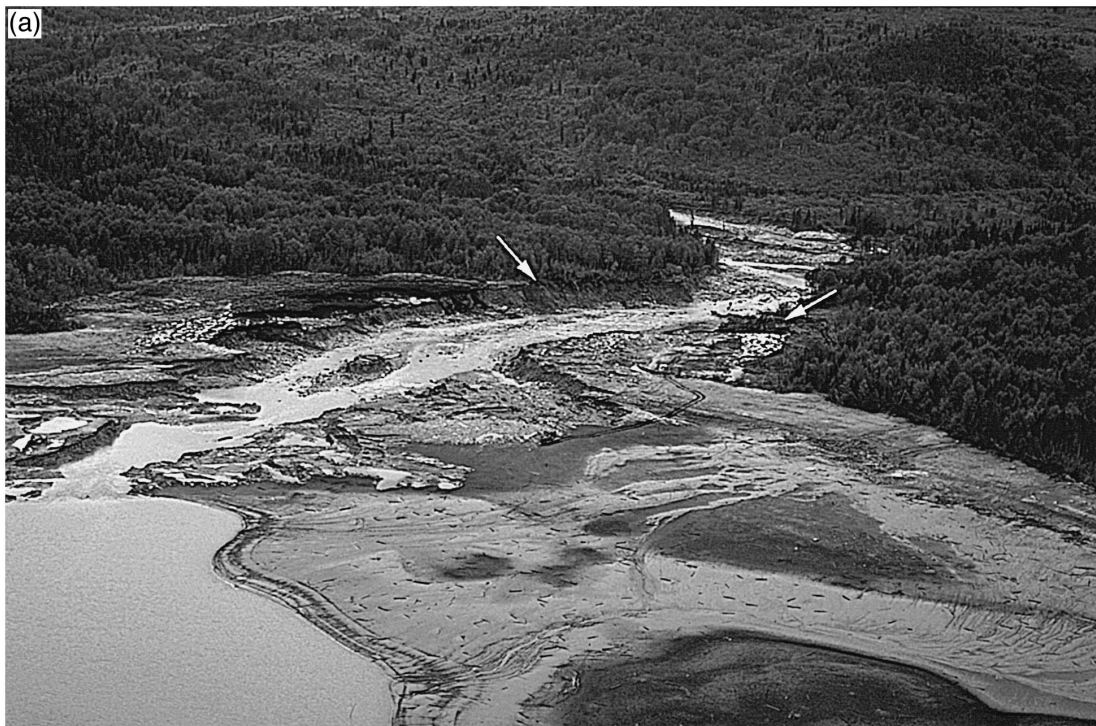
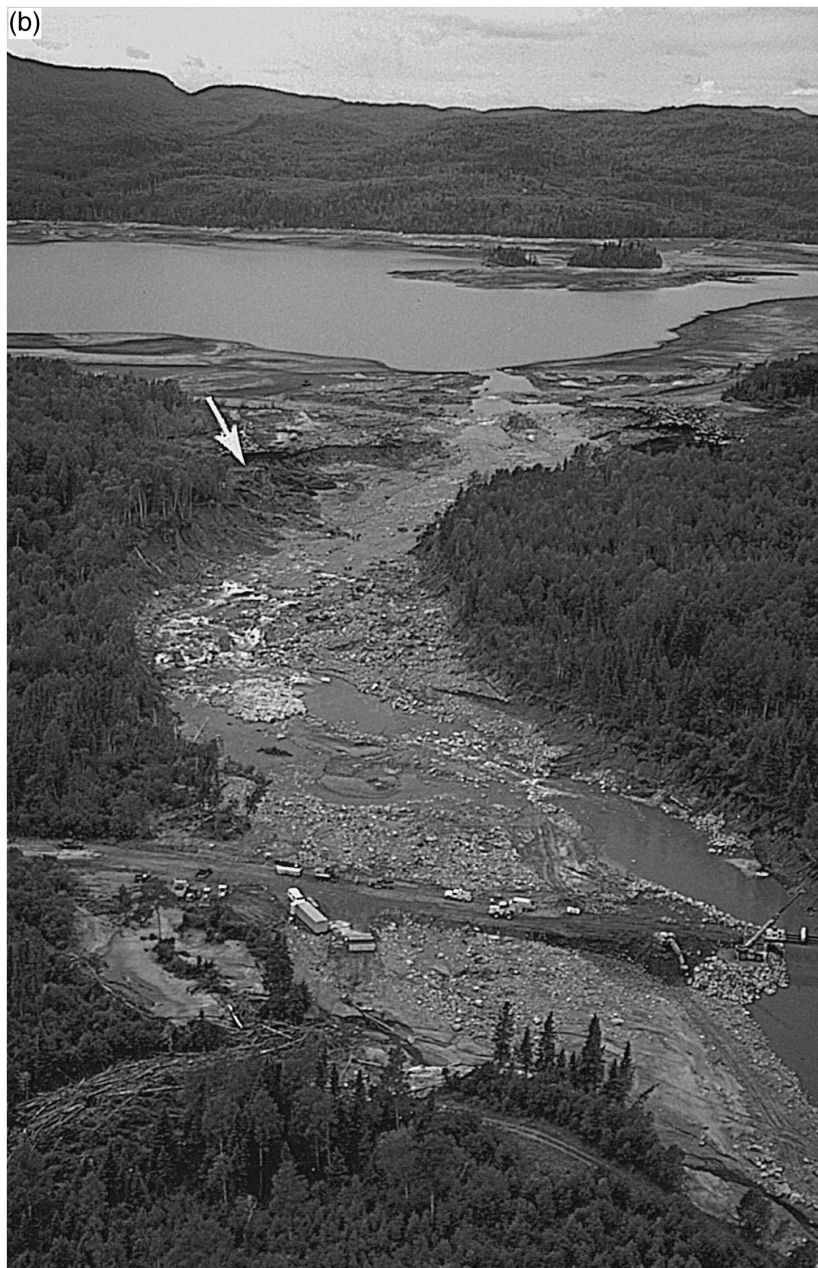
reflects that roughly three quarters of the 14 m incision at the site of the Cut-away dyke eroded into surficial material of the saddle (compact, massive, matrix-supported (silty-sand), glaciogenic diamicton) rather than entirely of earthfill dyke material. Also significant is the high ratio of pre-flood height to width of the topography across the saddle into which the escaping waters incised (see Fig. 7a).

Fig. 7. The new outlet at the Lake Ha!Ha! reservoir that was eroded through the Cut-away dyke, (a) looking downstream from above the lake basin and (b) looking upstream into the drained lake basin. The outlet is about 130 m wide at the site of the dyke. In both pictures, visible locations of the remnant dyke are marked with arrows.

Preliminary work to reconstruct a replacement earthfill dyke across the new outlet channel of Lake Ha!Ha! began within days of the waning of the flood. Work on the dyke was underway in mid-November, 1996 and scheduled to be completed by the end of December, 1996 (Emile Soucie, pers. comm., November 13, 1996). The new dyke is located several hundred metres west of the remnants of the Cut-away dyke, on ground that was originally part of the reservoir bed. The dam that again controls the reservoir level has been rebuilt and now incorporates a wide concrete overflow spillway.

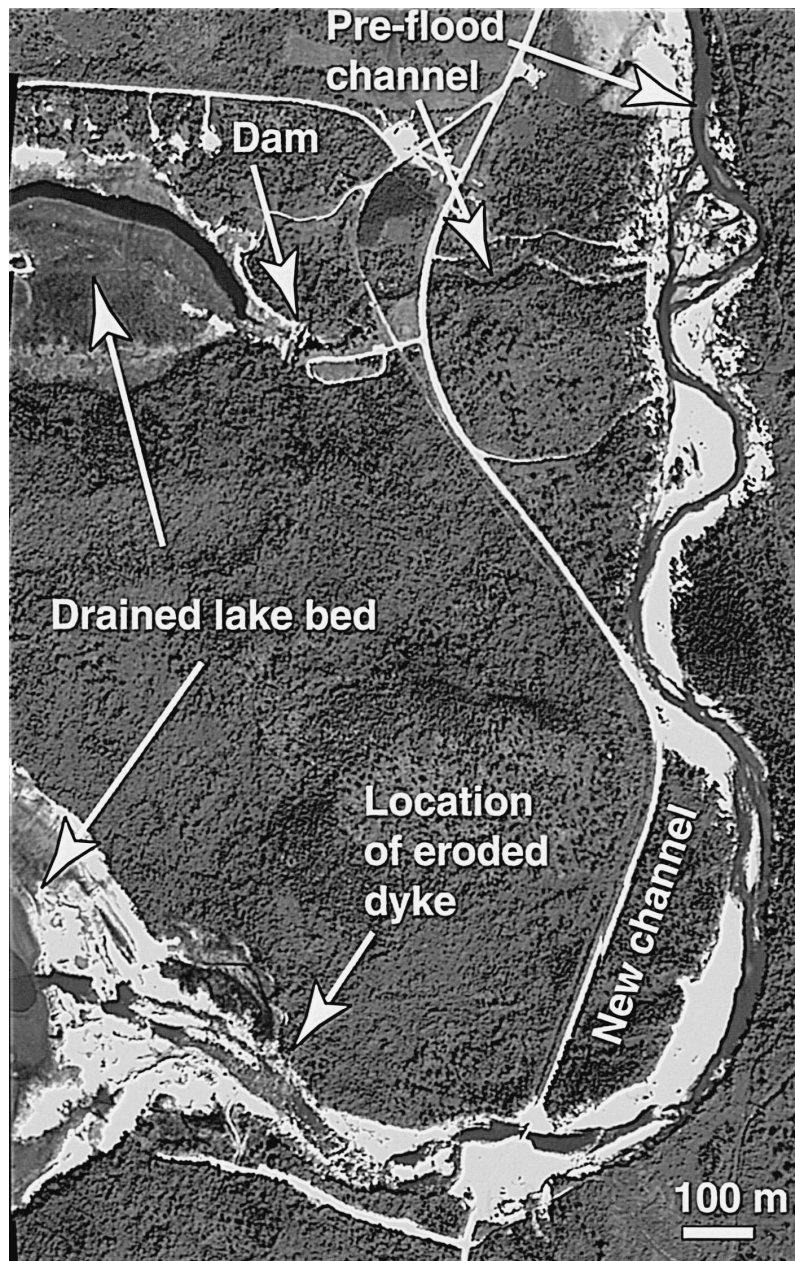
Fig. 8. Vertical multi-spectral video image of the northern portion of the Lake Ha!Ha! reservoir showing the new outlet and a portion of the drained lake bed, taken August 6, 1996 (courtesy of Canada Centre of Remote Sensing).

Immediately below the overtopped dyke, a completely new channel, 2 km long, was eroded into the saddle and valley bottom and joined the pre-flood channel at km 33.5 (Fig. 8). The new channel ranges

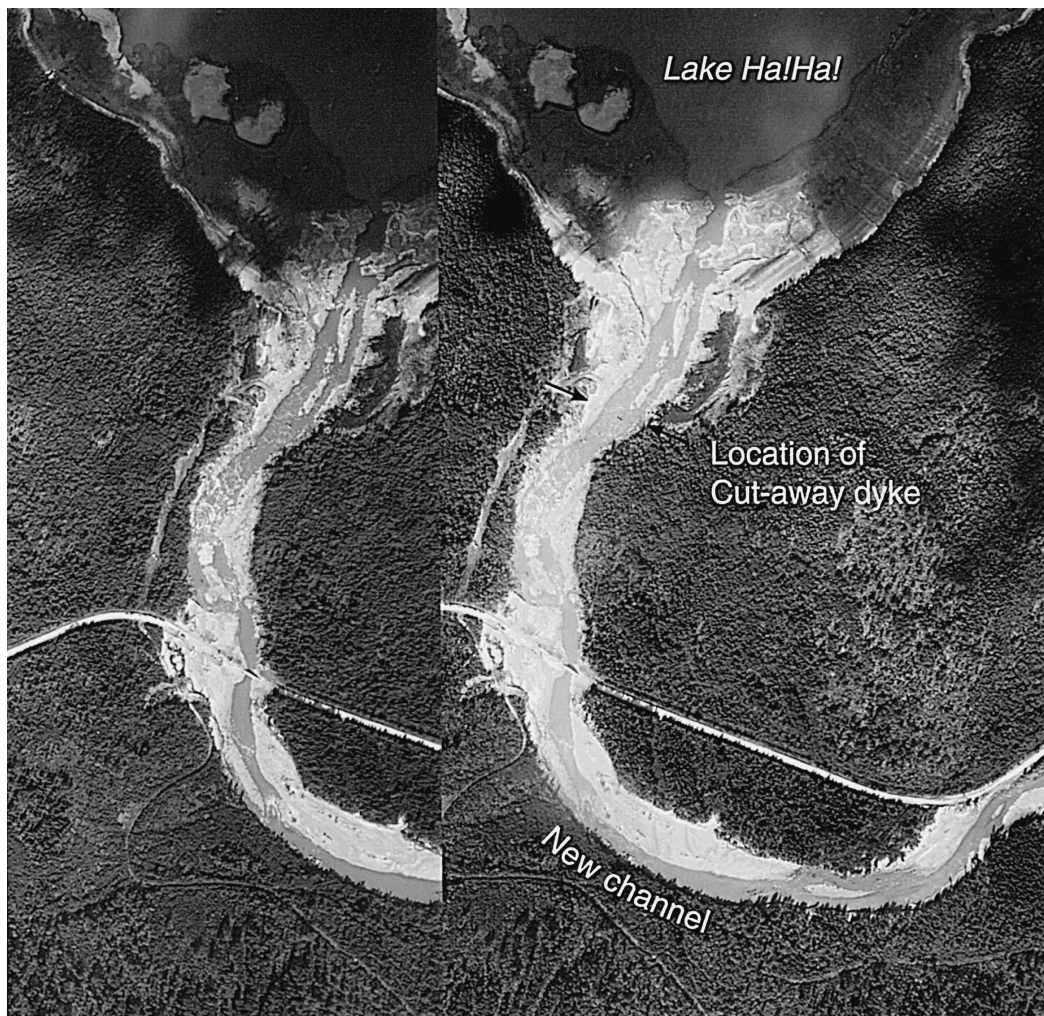
Fig. 9. Photostereogram of the post-flood outlet of the Lake Ha!Ha! reservoir eroded through the Cut-away dyke (aerial photographs Q96304-90, -91; reproduced with permission Photocartotheque Québécoise, Ministère des ressources naturelles, Québec). The outlet channel extending downvalley was created by the escaping water. Note the dry knickpoints branching from the channel incised into the subaerial lake bed.

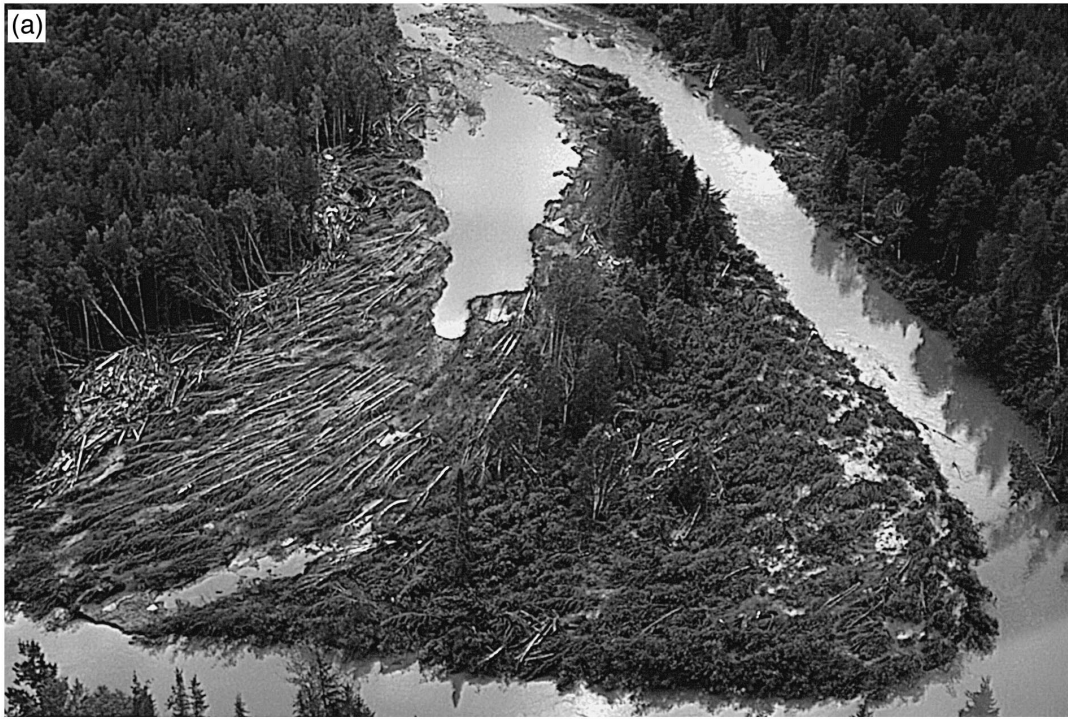
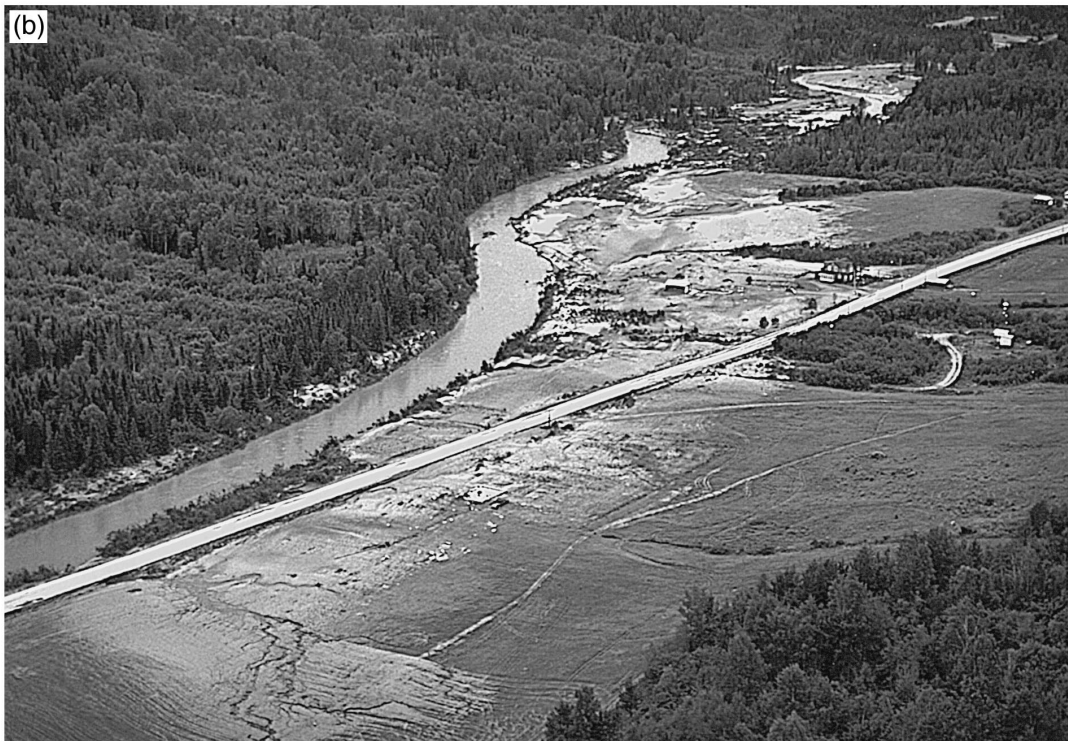
Fig. 11. Geomorphic effects along Ha!Ha! River between km 33.5 and 27.5: (a) trees on the floodplain knocked over by flood water and an elongated scour hole, view looking upvalley from about km 29.5 (GSC photograph 1997-42HH), and (b) overbank deposition on the valley bottom (light-shaded areas), looking upvalley of km 32.5 (GSC photograph 1997-42II). Photographs taken on July 28, 1996.

between km 33.5 to 32.5 and 31 to 29.5 where up to 2 m of sediment was deposited (Fig. 11b). The sediments, derived from erosion of the new channel immediately upstream, form broad fine sand sheets that aggraded wide, low-lying areas of the valley bottom. Deposition also occurred along the narrower parts of the valley bottom and within the forested areas of the floodplain where the vegetation trapped the sediment.

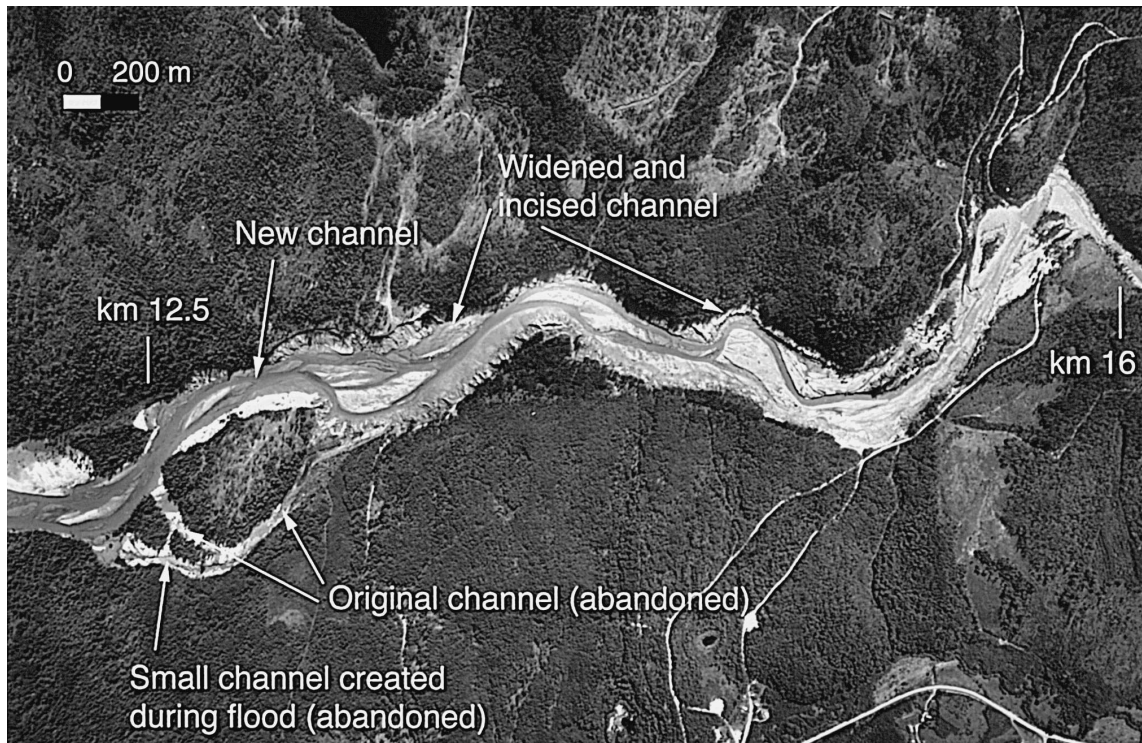
Fig. 12. Post-flood aerial photograph of the reach from km 16 to 12.5 reach which was severely altered by the flood, as mentioned in the text (aerial photograph Q96304-74, taken July 30, 1996; reproduced with permission Photocartotheque Québécoise, Ministère des Ressources naturelles, Québec). Flow of the river is from right to left.

the Chute-à-Perron rapids is preserved, albeit somewhat widened and with a new branch extending downstream from it (Fig. 12). The combination of major incision and widening of the channel along this reach resulted in the reworking of a considerable volume of unconsolidated sand, silt and clay, estimated by INRS-Eau (1997, Table 2) to be  $6.3 \times 10^6$  m<sup>3</sup>.

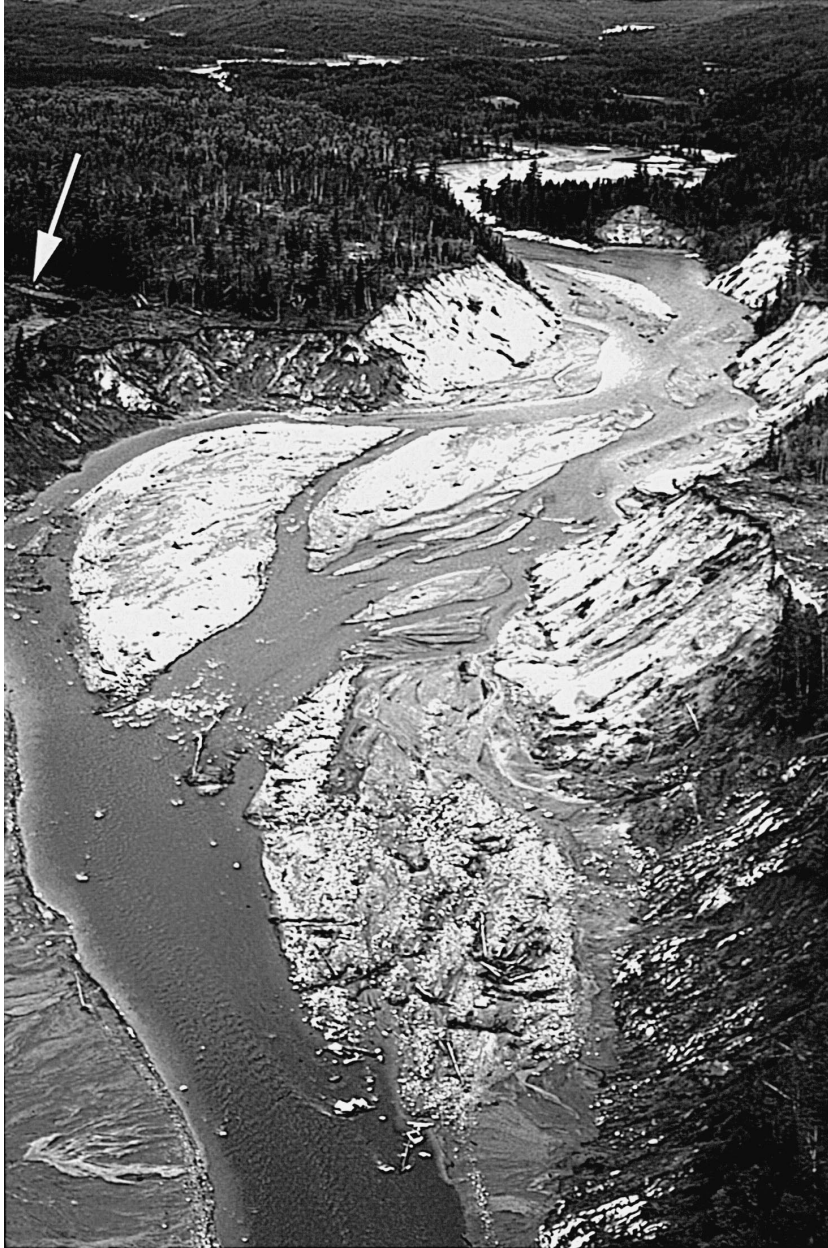
Fig. 13. View looking downstream from about km 13 along the new channel course that follows the route of a pre-flood ravine. The original channel (marked by a white arrow) which leads to the now-abandoned Chute-à-Perron rapids, 'hangs' about 20 m above the valley bottom. Up to 20 m of incision occurred locally along this portion of the river. Photograph taken on July 28, 1996.

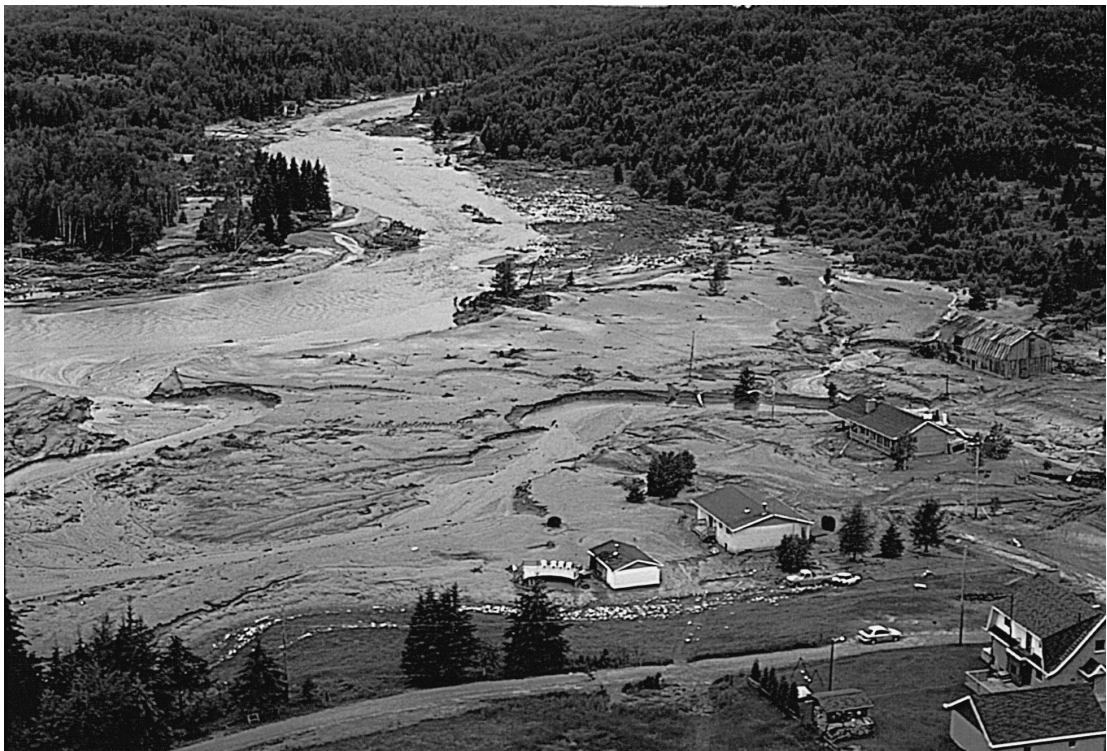
Fig. 14. Extensive sand aggradation along the right side of the valley at km 10.5 to 10. The post-flood channel flows on fresh alluvium that covers the valley bottom. Photograph taken on July 28, 1996 (GSC photograph 1997-42KK).

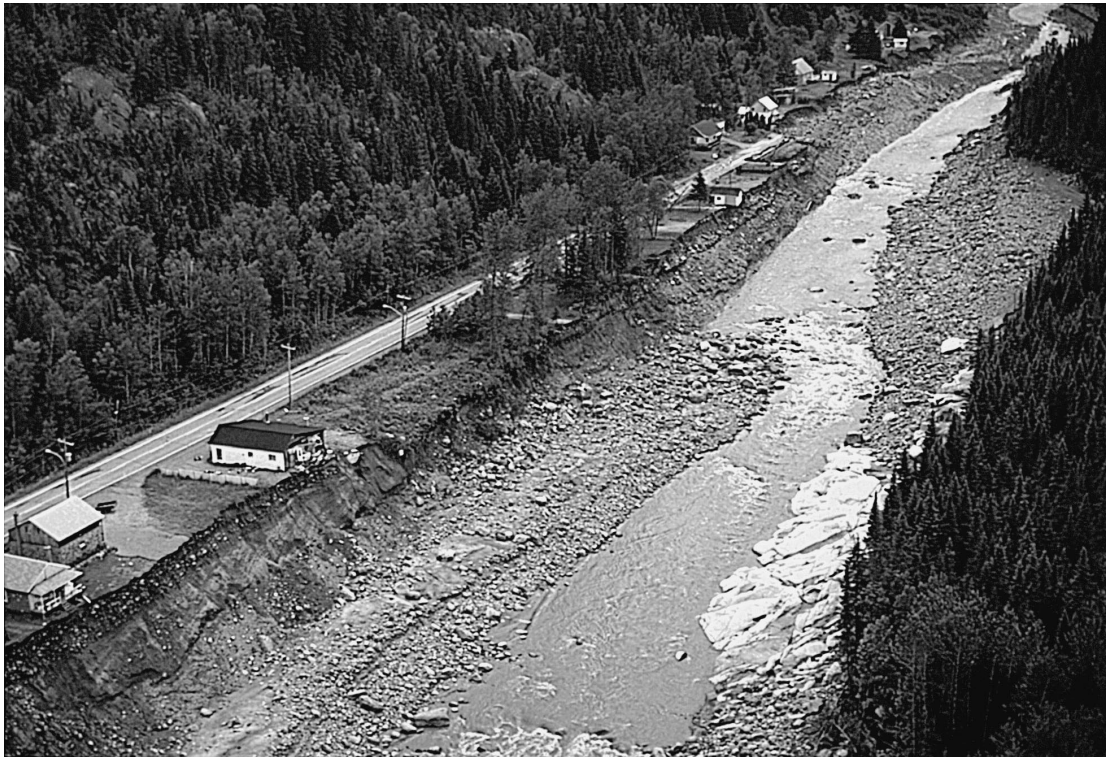
Fig. 15. The incised and widened channel, about 15 m deep, looking upstream from km 6. Exposed alluvium, diamicton and bedrock, and bouldery lag form the perimeter of the channel. Note the homes damaged by undermining along the right bank. Photograph taken on July 28, 1996 (GSC photograph 1997-42NN).

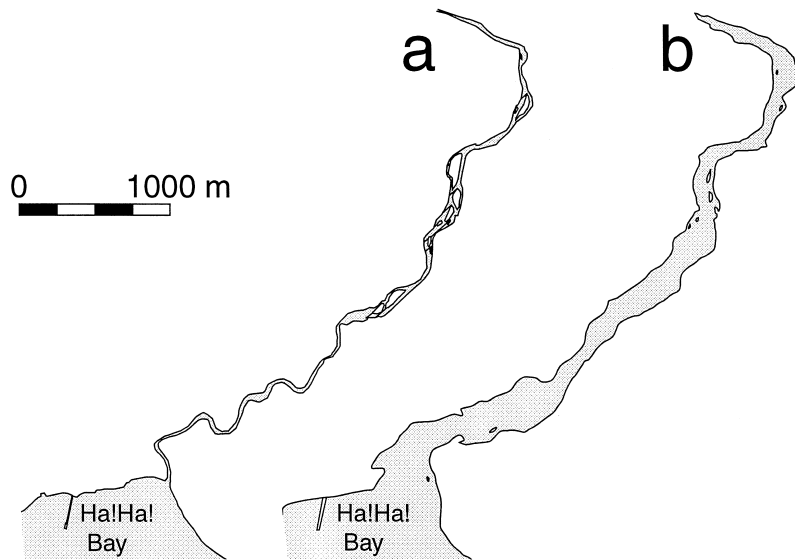
Fig. 16. Maps showing (a) the pre-flood and (b) post-flood channel width along the lower 4 km of Ha!Ha! River (see Fig. 3). The pre-flood map is based on Quebec Ministère de L'Énergie et des Ressources map 'La Baie' (22D02-200-0101), 1:20,000 scale while the post-flood map was obtained from a rectified mosaic of multi-spectral video images acquired on August 6, 1996 (courtesy of Canada Centre for Remote Sensing).

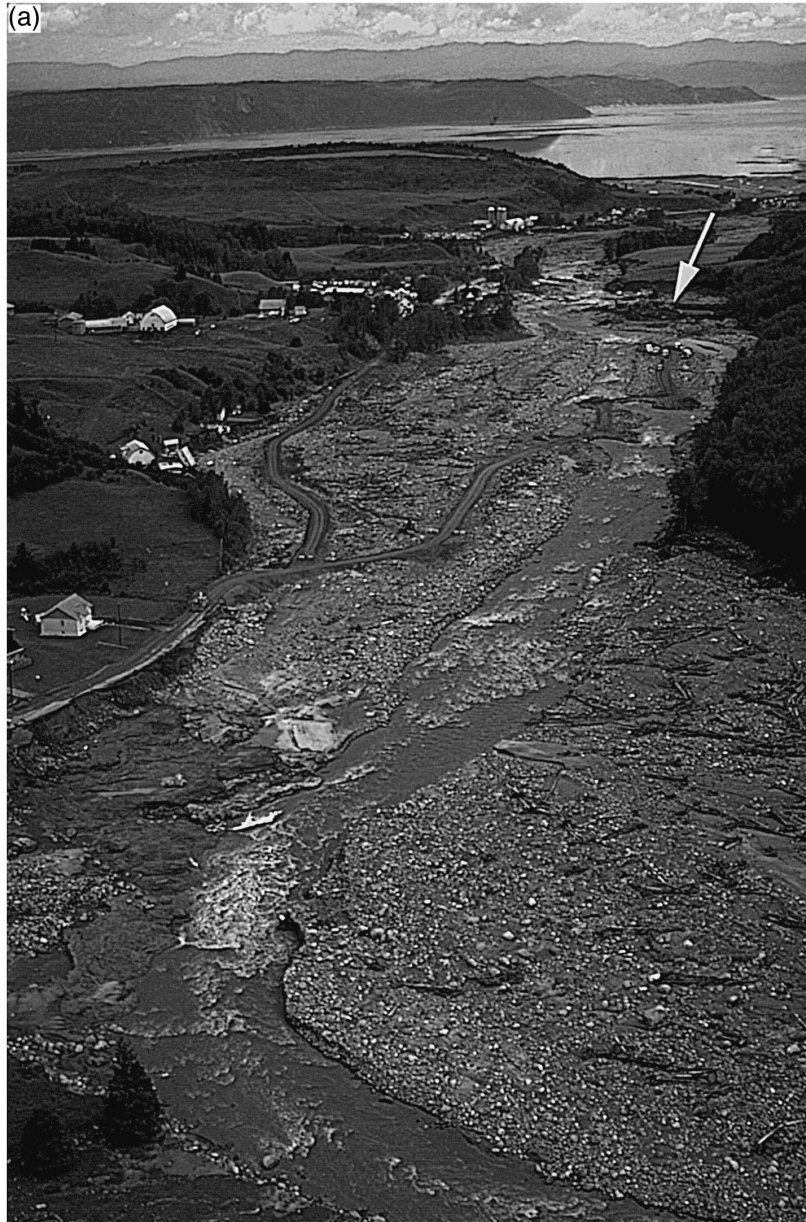
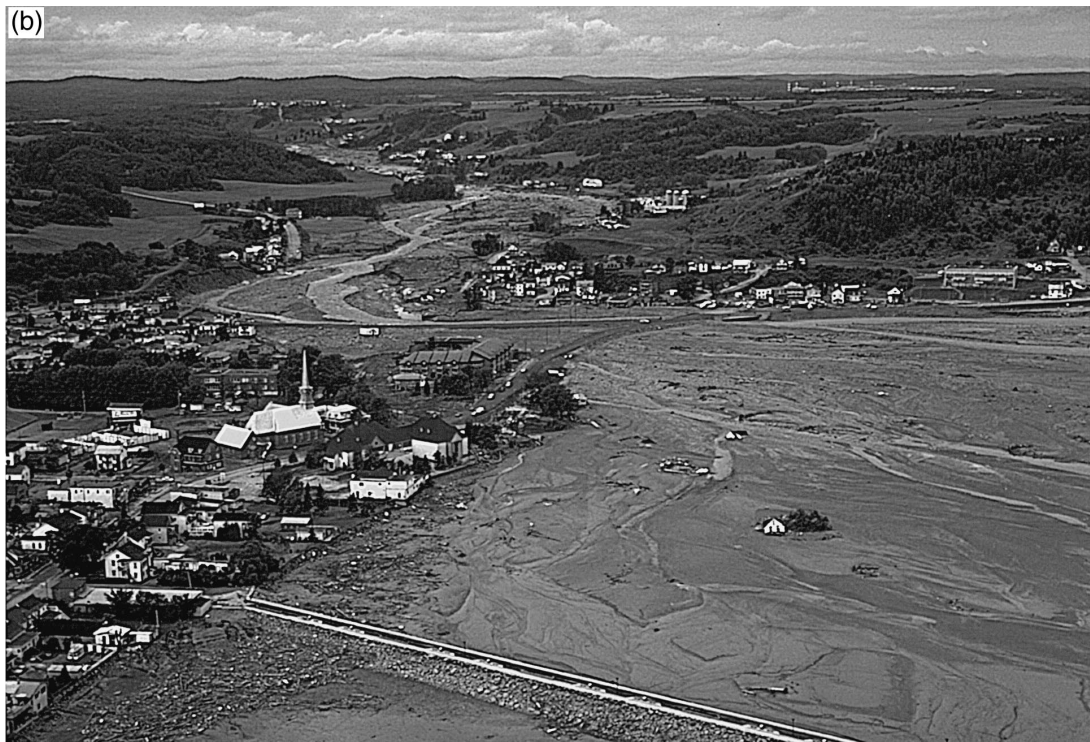
widening occurred adjacent to the small dam (km 1.8) where overflow of the left abutment resulted in major lateral erosion and incision of the floodplain formed a new channel adjacent to, and lower than, the dam (Fig. 17a). This erosion drained the small reservoir, damaged the dam, severed the penstocks, and destroyed the powerhouse.

Fig. 17. The broad post-flood channel of Ha!Ha! River (picture 'a'), viewed downstream from km 3 (GSC photograph 1997-42RR). The pre-flood valley bottom (floodplain and terraces) has been extensively reworked; an arrow marks the remains of a dam severely damaged during the flood. Tidal flat at the river mouth looking upstream into the Ha!Ha! River valley (picture 'b'; GSC photograph 1997-42TT). Note the debris from destroyed buildings on the tidal flats and the considerable damage to residential and commercial areas within the City of La Baie at the river mouth. Photographs taken on July 28, 1996.
