Chapter 1

Examples of Tsunamis and Tsunami Disasters

1.1 Case Studies of Actual Tsunami Disasters

1.2 Indian Ocean Tsunami Disaster

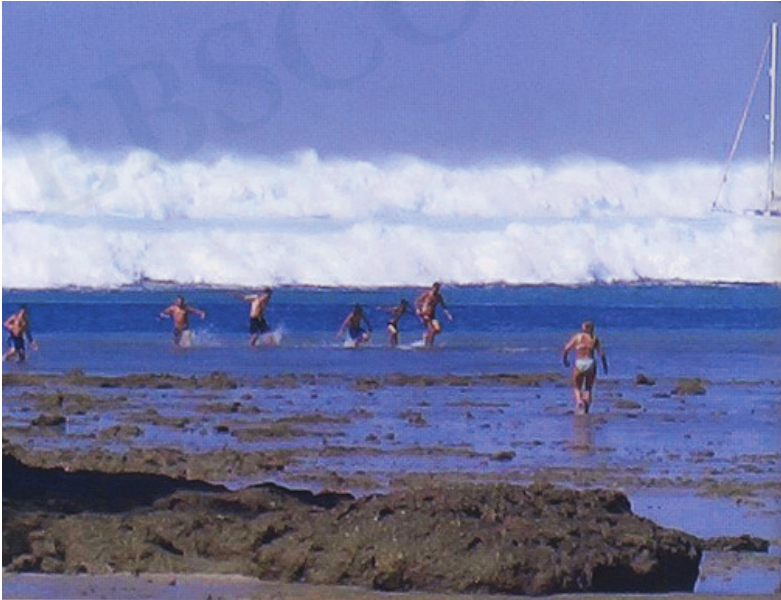
Figure 1.1 shows the tsunami approaching the coast of Thailand and people trying to escape from the tsunami during the Great Indian Ocean Tsunami, which occurred in December 2004. The people in the photograph are trying to escape from it, realizing that the danger is serious. Fortunately, all of these people survived, but did they really understand what was happening at the time, what would follow this scene, and what they should do?

Fig. 1.1 Swimmers fleeing an attacking tsunami (Thailand, 2004).

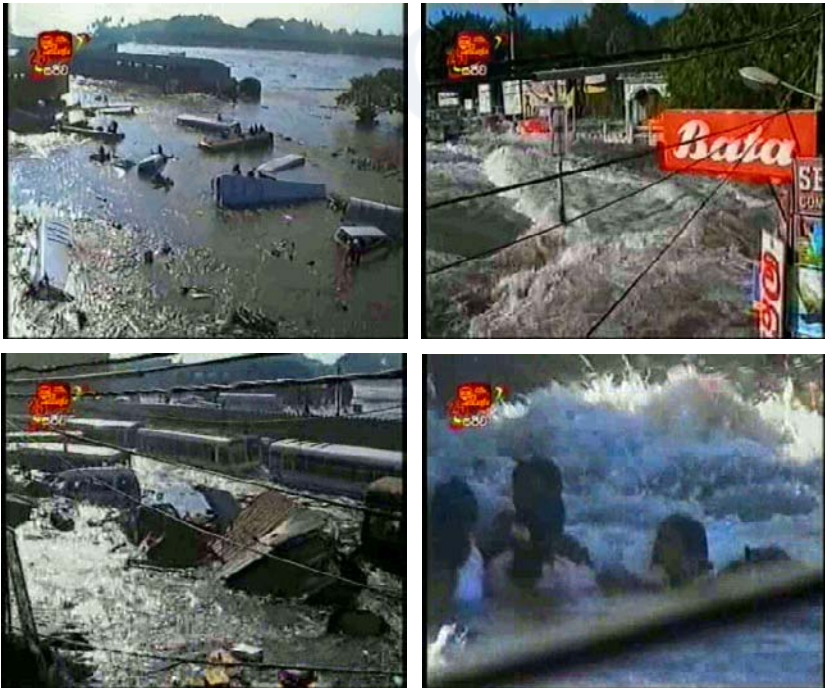
Figure 1.2 shows video images taken in Sri Lanka during the same Great Indian Ocean Tsunami. These images were taken at the bus terminal in the center of Galle, Sri Lanka. The tsunami caused an extremely violent flow in the bus terminal from the left rear. The video shows cars and the remains of houses being carried along by the tsunami and people caught in the current. Images like these were broadcast around the world, and many people saw the terror of tsunamis with their own eyes. In other words, seeing video images of a tsunami is a valuable experience for disaster prevention, even for people far from the actual scene.

Fig. 1.2 Violent flow caused by an attacking tsunami (Sri Lanka, TV).

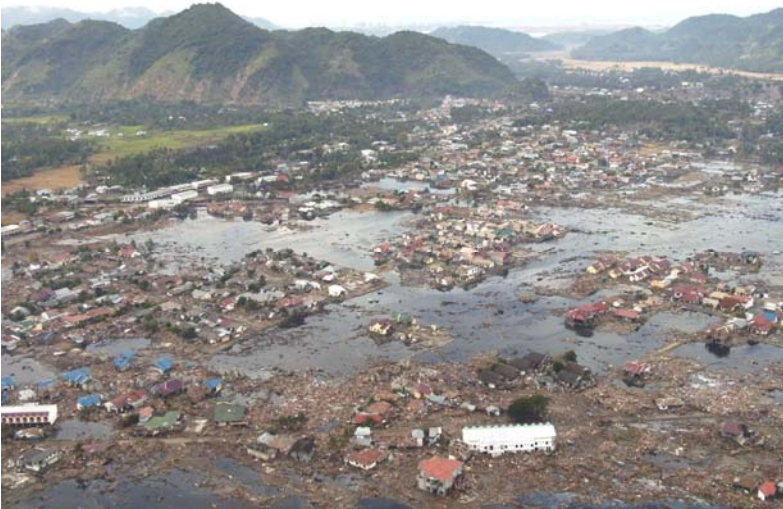
Fig. 1.8 View of the damage in Banda Aceh (US Navy, Reconnaissance Team of the Japan Society of Civil Engineers, 2005).

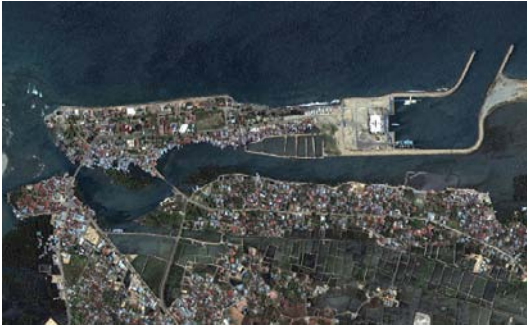
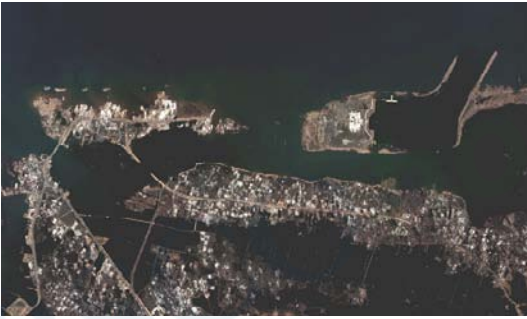
The residential area of Banda Aceh near the coast received devastating damage. Figure 1.9 shows satellite photographs before and after the tsunami. Although these are difficult to see in the photo, erosion countermeasures had been constructed on the shore of the sandbar facing the sea in order to protect the coast from storm surge. However, these countermeasure works were damaged by the tsunami. As a result, the land behind the works was eroded and the coastline was moved back. The land in the center of the sandbar was completely submerged as a result of erosion. As these photographs show, a tsunami has the power to change the shape of the land.

(a) Before the tsunami

(b) After the tsunami

Fig. 1.9 Sandbar eroded by the tsunami (© Digital Globe).

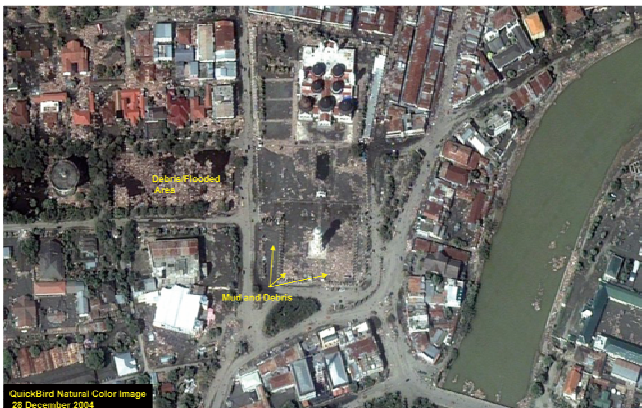
Figure 1.10 shows the remains of a residential area on the sandbar in Fig. 1.9(a) after the tsunami. Attacked by a tsunami as high as 10 m, houses were easily swept away, and even the pavement of roads was ripped up and carried away. There is a high possibility of damage to reinforced concrete (RC) buildings when the height of a tsunami exceeds

Fig. 1.10 Remains of destruction caused by the tsunami.

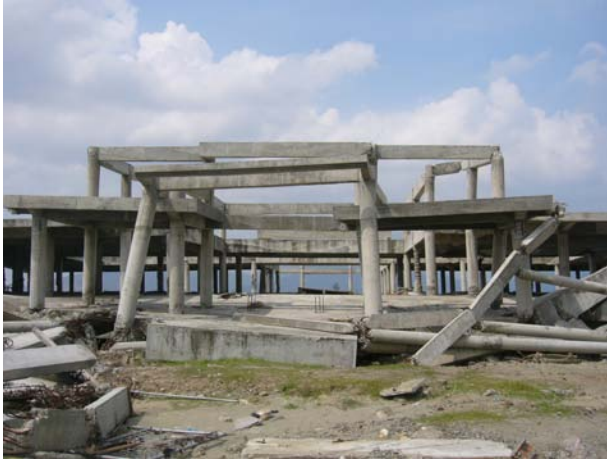
Fig. 1.11 Ferry terminal building under construction, which survived the tsunami.

5 m. However, one RC building on this sandbar withstood the tsunami. This was the ferry terminal building (Fig. 1.11). The first floor collapsed, but the second and higher floors remained. It may be noted that the first floor was destroyed by the earthquake, and not by the tsunami. This terminal building was under construction at the time. The framework of RC columns had been completed, but the walls had not been constructed. The 10-m tsunami attacked the building at this stage of construction and it passed cleanly through the building because it happened to have a wall-less “piloti” structure. As a result, the building escaped destruction by the tsunami. (“Pilotis” are piers. In a piloti structure, the building is raised above the ground on piers. In other words, the first floor consists of piers and open space without walls.) This example shows that a piloti structure can be effective as tsunami countermeasures, provided the structure is strong enough to withstand the earthquake ground motion.

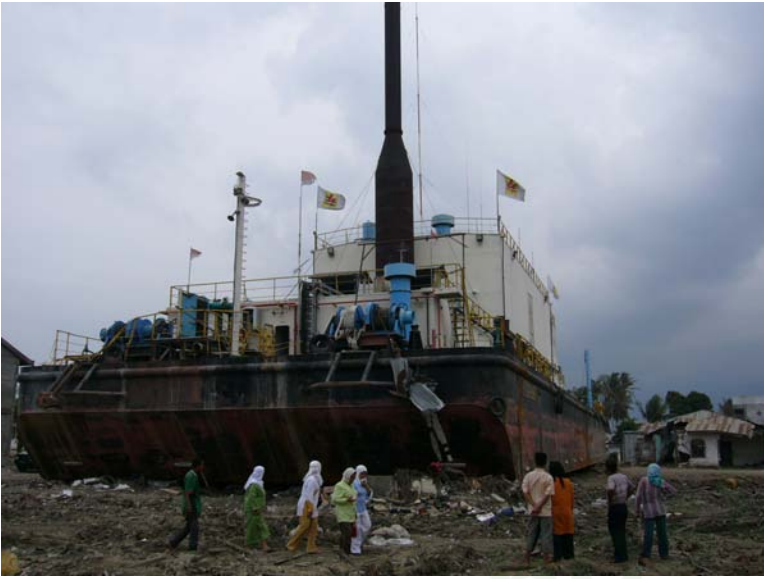
The high tsunami also pushed and moved gigantic objects which would normally seem impossible. Figure 1.12 shows a power generating barge that was carried about 3 km inland from the coast by the tsunami. The barge is approximately 60 m long and 20 m wide. This barge was moored in the port before the tsunami. The water marks left by the

Fig. 1.12 Power generating barge carried onshore by the tsunami.

tsunami on buildings near where the barge was moved were about 3 m above the ground. This is roughly the same as the draft of the barge. It seems that the barge finally stopped when its bottom stuck on the ground. Large ships were carried inland in other areas as well, and these were also flat-bottomed boats. This shows that flat-bottomed boats are easily run up on land by tsunamis.

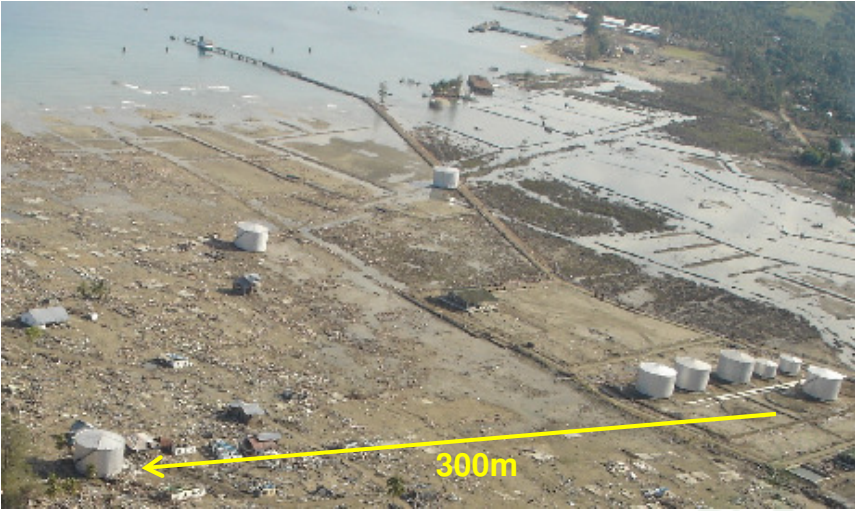
In Kreung Raya Port to the east of Banda Aceh, the tsunami reached 5 m above ground level. Here, three empty oil tanks (out of a total of nine tanks) were carried by the tsunami. These tanks, which were 17 m in diameter and 11 m in height, were carried about 300 m along the coastline (Fig. 1.13).

Fig. 1.13 Oil tank carried by the tsunami.

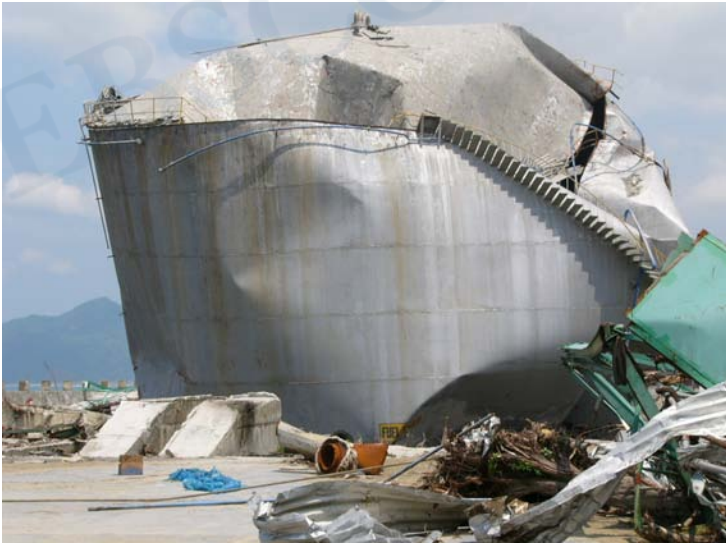
At a cement works on the west coast of Sumatra, an oil tank was heavily deformed by the force of the tsunami (Fig. 1.14). The height of the tsunami was estimated at more than 20 m. The destructive force of the tsunami can be imagined from this picture.

Fig. 1.14 Oil tank heavily deformed by the tsunami.

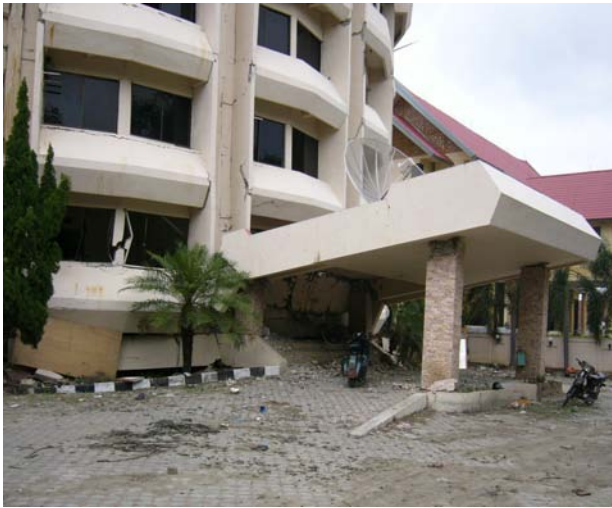
Fig. 1.15 Building after the first floor collapsed in the earthquake.

Before the tsunami attack, the city of Banda Aceh was also hit by large tremors (earthquake ground motion). On the Japanese scale, the earthquake intensity was a little less than 5 to a less more than 6. This intensity indicates that the tremors were so large as to make it difficult for a person to keep standing on the ground. Many RC structures were destroyed by this shaking. As shown in Fig. 1.15, several of these were destroyed when the first floor (ground floor) collapsed. As mentioned previously, Banda Aceh is on flat land with no high ground where people can escape from a tsunami. In flat areas like this, high buildings are essential as places of refuge from tsunamis. Thus, buildings which can withstand earthquakes (that is, earthquake resistant buildings) are important.

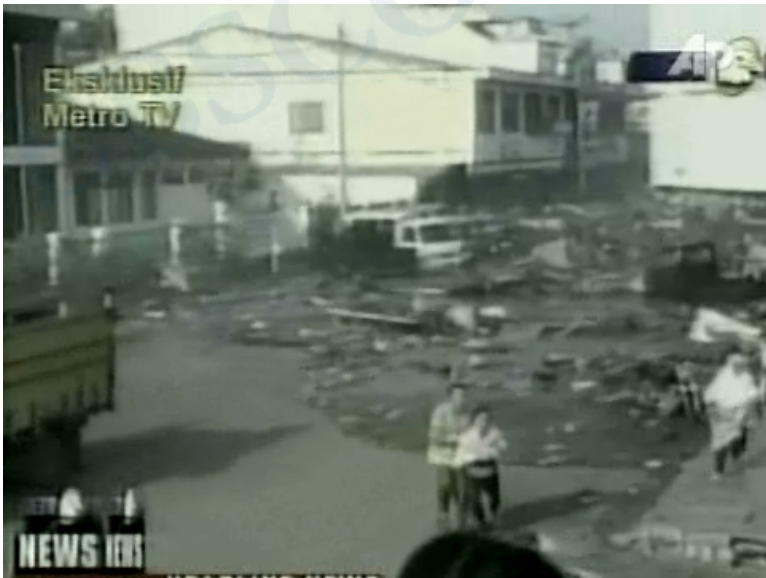
Fig. 1.16 People fleeing the leading edge of the tsunami in Banda Aceh.

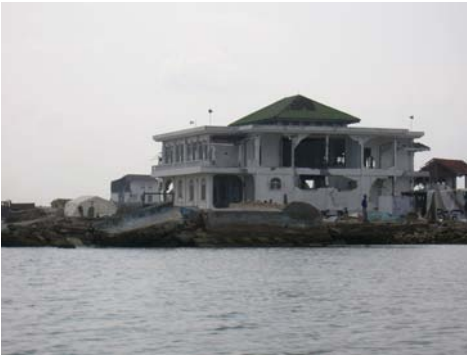
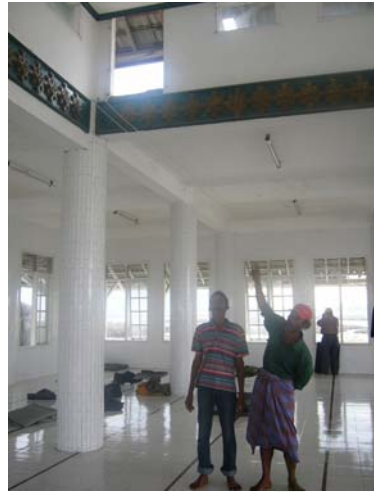
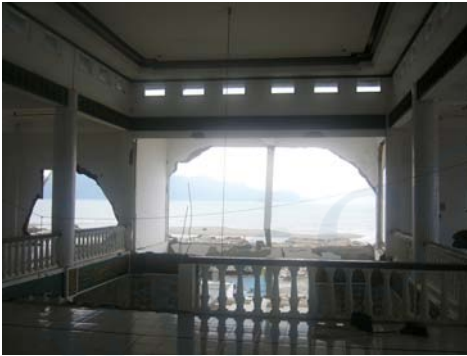
(a) Mosque, as seen from the sea

(c) Hole used to escape onto the roof

(b) View from inside the mosque

Fig. 1.17 Mosque by the sea, which was attacked by a 12-m tsunami.

Figure 1.17 shows a mosque near the coast (Baiturrahim Mosque; “Mosque by the Sea”), which was attacked by a tsunami of 12 m in height. Many mosques are constructed more strongly than ordinary houses, and survived both the earthquake and the tsunami. People also survived by fleeing to this mosque. However, because the 12-m tsunami reached just below the roof of the mosque, people broke through a wall leading to the roof and climbed onto the roof in order to escape.

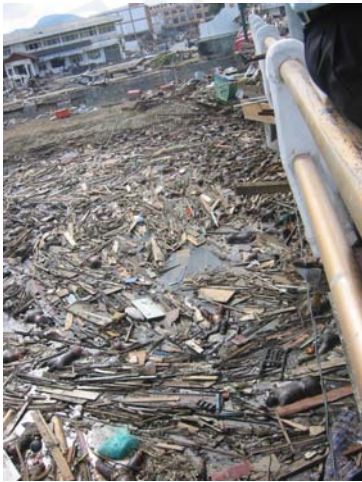
As the tsunami moved through the town of Banda Aceh, it destroyed many houses and other buildings. The flow of the tsunami included debris from these destroyed buildings, mud, floating automobiles, and other objects (Fig. 1.18). The color of the water was dirty and muddy. The flow also carried large ships, fishing boats, etc. (Fig. 1.19). In addition to drowning, there are following many other dangers if you are caught in this kind of tsunami. You may be thrown against a building or rock, you may not be able to keep your head above water, or you may be injured by floating objects. There are also several examples of lucky people who held onto a floating object and were rescued offshore. However, this is generally very difficult. Even if you are confident about your swimming ability, it is important to flee before you are caught in a tsunami.

Fig. 1.18 Debris carried by the tsunami.

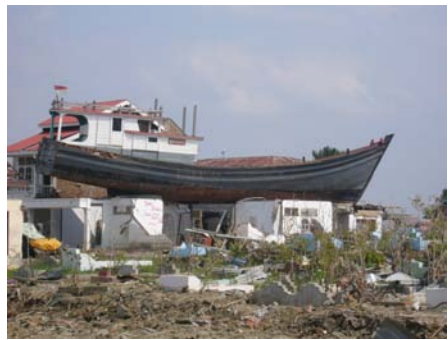
Fig. 1.19 Fishing boat carried onshore by the tsunami.
