Kvarterní struktura proteinů

Analytická ultracentrifuga, DLS – exkurze

Aplikovaná bioinformatika, Jaro 2016

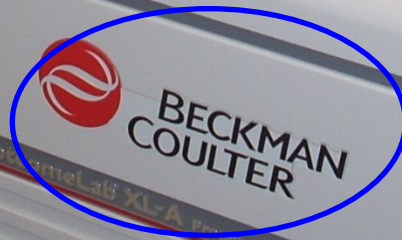
ProteinLab XL-A Protein Characterization System

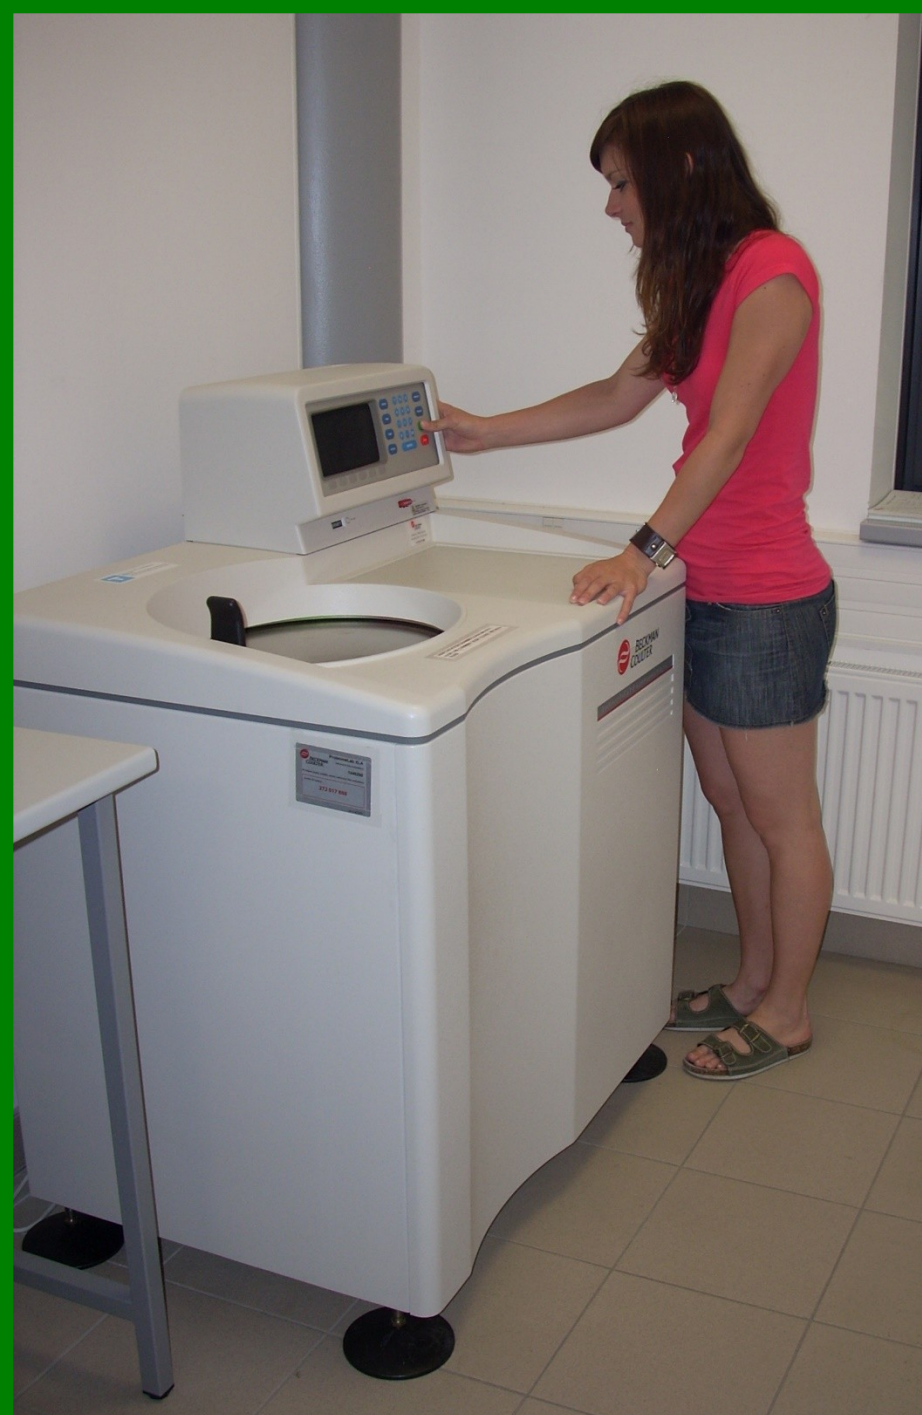
60 000 rpm (otáčky/minuta)

Přetížení 500 000 g

Titanový rotor

Vakuum – minimalizace tření

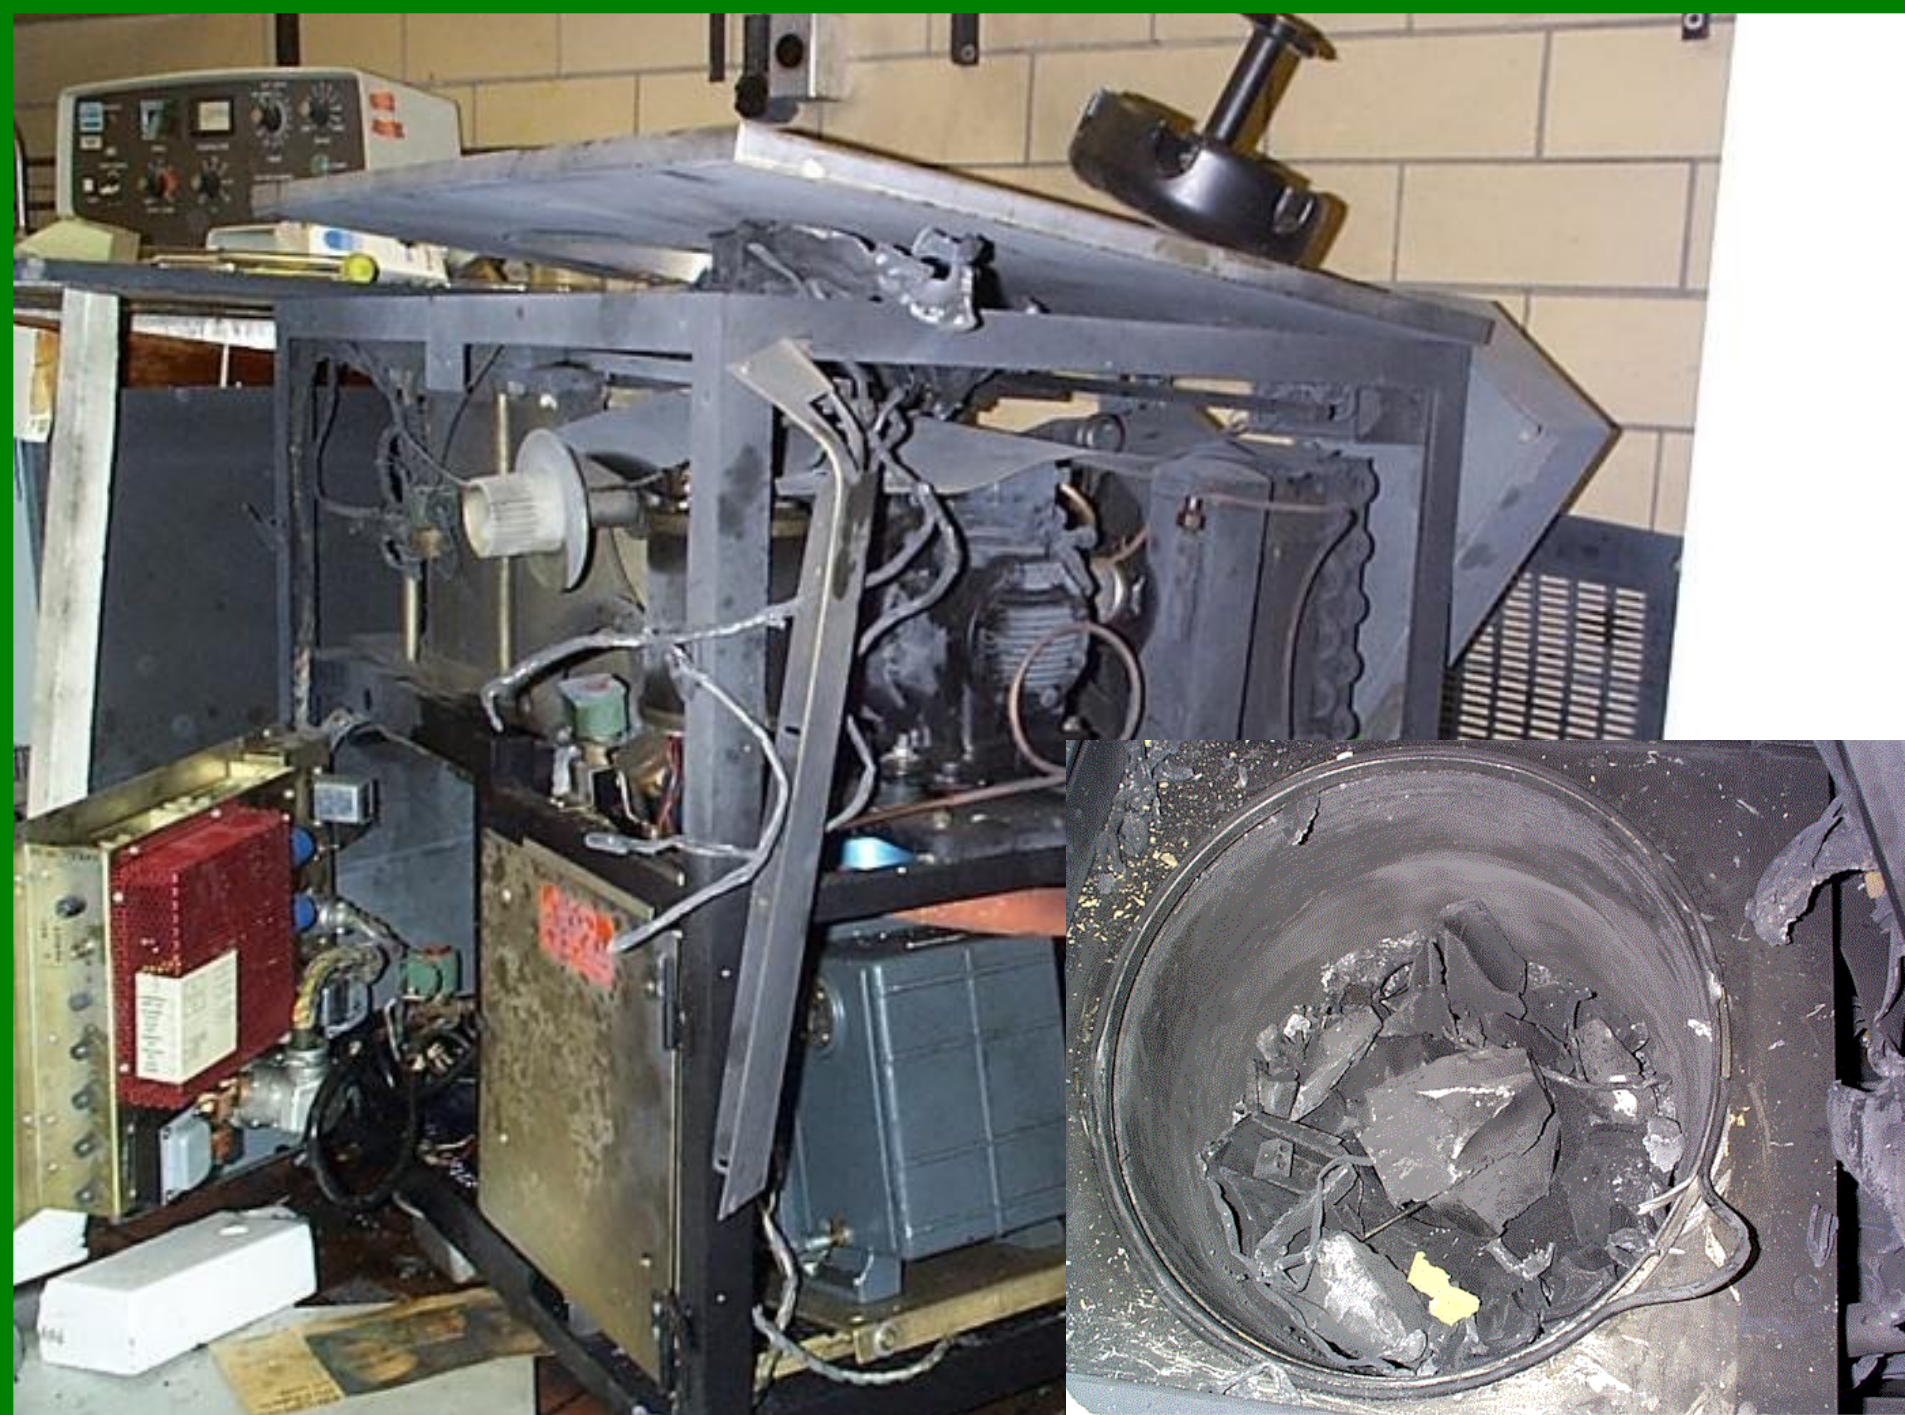
Centrifuge Explosion Damages Cornell

On December 16, 1998, milk samples were running in a Beckman L2-65B ultracentrifuge using a large aluminum rotor (a rotor is a large metal object that holds the individual sample tubes and is connected to the spin drive of the centrifuge). The rotor had been used for this procedure many times before. Approximately one hour into the operation, the rotor failed due to excessive mechanical stress caused by the "G" forces of the high rotation speed. The subsequent explosion completely destroyed the centrifuge ([picture 1](#))([picture 2](#)).

The safety shielding in the unit did not contain all the metal fragments. The half-inch thick sliding steel door on top of the unit buckled allowing fragments, including the steel rotor top, to escape ([picture](#)). Fragments ruined a nearby refrigerator and an ultra-cold freezer in addition to making holes in the walls and ceiling. The unit itself was propelled sideways and damaged cabinets and shelving that contained over a hundred containers of chemicals ([picture](#)). Fortunately, sliding cabinet doors prevented the containers from falling to the floor and breaking. A shock wave from the accident shattered all four windows in the room. The shock wave also destroyed the control system for an incubator and shook an interior wall causing shelving on the wall to collapse ([picture](#)). Fortunately the room was not occupied at the time and there were no personal injuries.

The cause of the accident is believed to be the use of a model of rotor that was not approved by Beckman for use in a model L2-65B ultracentrifuge.

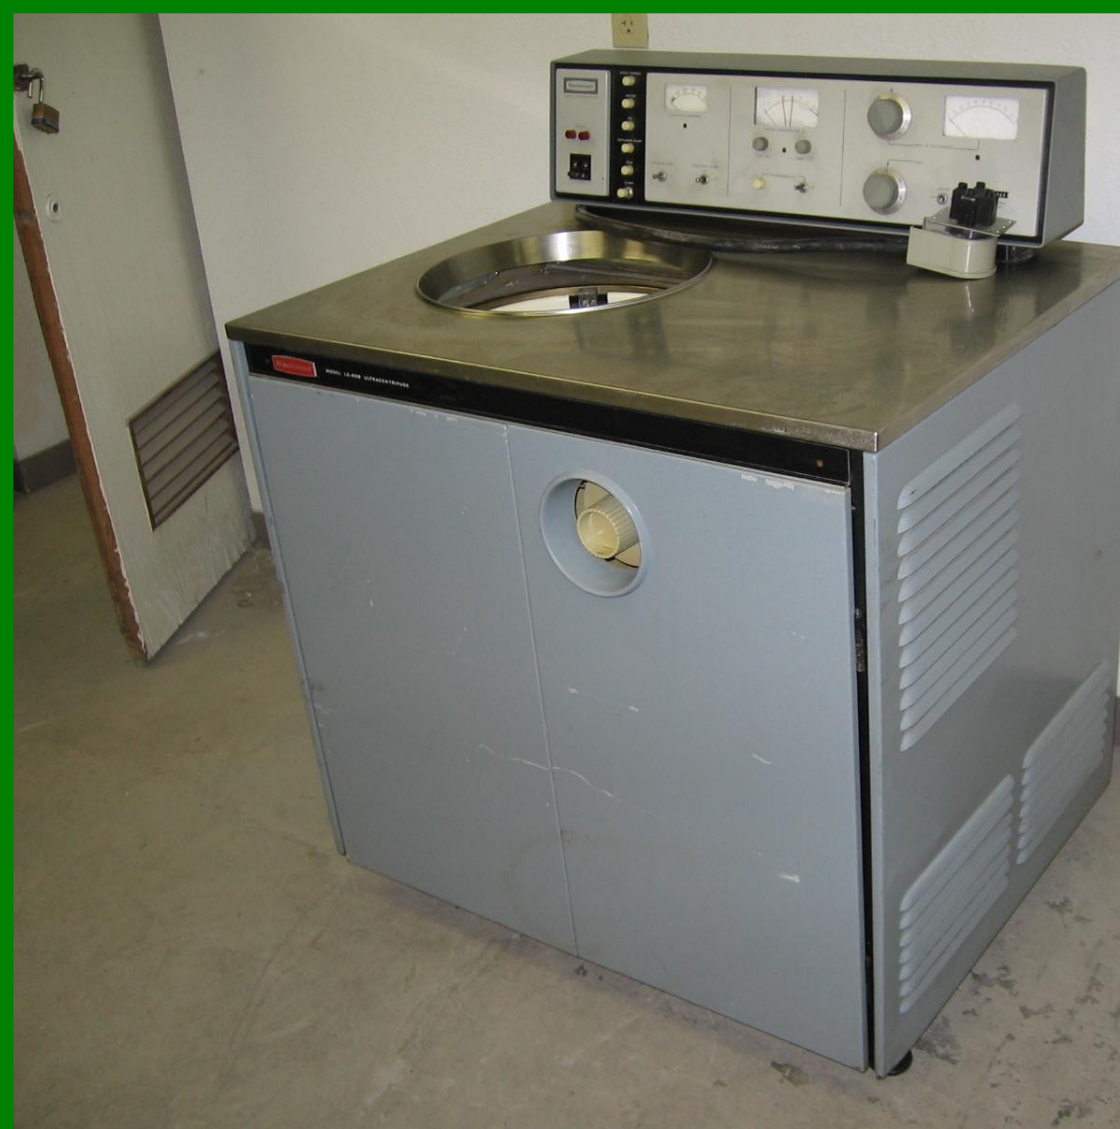
Beckman L2-65B

Takhle nějak vypadala předtím...

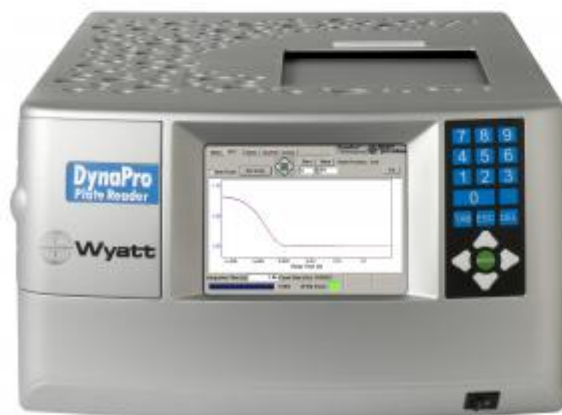
DynaPro™ Plate Reader II

Automated, high-throughput, temperature-controlled Dynamic Light Scattering
