Říční systémy - současné směry výzkumu a vybrané případové studie

Lateral Erosion of the Sacramento River, California: Human influences and consequences for floodplain lake habitats

Feedbacks on Restored Floodplain Lakes Sedimentation of Upper Rhône River

Morphodynamics of the Exit of a Cut-off Meander: Experimental Findings from Field and Laboratory Studies

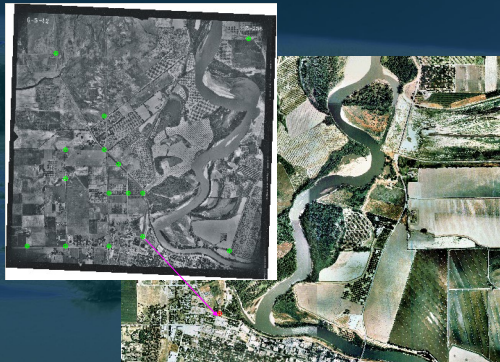
Active channel by segments

1) Channel boundaries from map or photo
Transsects
Channel centreline
Average of transect endpoints

To study the longitudinal organisation and character of the different features, we created a coverage of elementary segments of 250 m in length from which we extracted the active channel area, the low flow channel length and the area and eroded floodplain area.

Using channel centrelines mapped for a total of 19 dates from historical maps and aerial photographs dates 1896 to 1997, we dated historical cutoffs to within 5 years (within 3 years for more recent years).

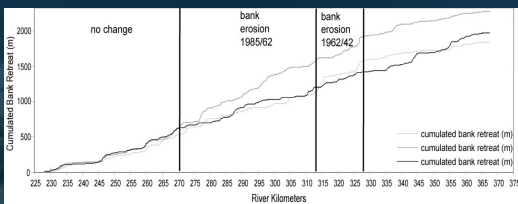
Evolution of bank erosion by 250m length segments of active channel

- Four distinct reaches were then distinguished statistically:
- the first one downstream of km 272 did not undergo any change in tendency of cumulative bank retreat whatever the period,
- the second one between km 272 and km 315 is characterised by an important increase in bank erosion during the period 1962-1985),
- the third section between km 315 and 330 with significant bank erosion period 1942-1962 (average bank retreat respectively 7.01, 5.41 and 3.63 m/yr).
- the fourth section presents showed two local peaks km 346 and km 358 during the most recent period and underwent from 1942 to 1999 a constant

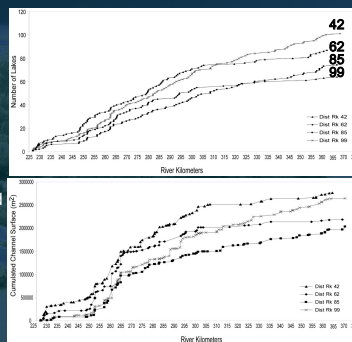
Longitudinal Evolutions of Floodplain Lakes

- many lakes downstream disappeared from 1942 to 1962, but were partly compensated for by creation of new lakes over the entire period through 1999
- In upstream reaches (km 300 to 360), many new lakes appeared from 1962-1985 and from 1985-1999. The longitudinal distribution of lakes did not change (regardless of lake type), but the cumulative values differed from one photo set to another.

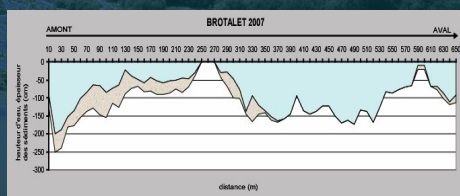
Sedimentation rates in floodplain lakes T-1 (before), T (rest year), T+1 (after)

Water depth and sedimentation

Catchment	Annual mean sedimentation rate (cm/year)			Mean water level (cm)		
	T	T+1	T+2	T	T+1	T+2
MAL	29.93	14.62	11.47	7.7	74.4	106.02
BRO	13.47	5.57	6.06	6.56	104.6	181.28
Belley	T+1	T	T+2	T+1	T	T+2
LUI	0	0	0	110	102.5	98
MCH	1.22	1.1	1.12	6.27	67.2	116.46
FOU	0	0	0.83	0	61.67	125.2
BEA	0.7	1.75	1.87	0.12	7.3	76.02
LUC	0	0	0.95	0.42	98.8	112.4
YEN	0	0	0	3.75	119.25	101.88
CHA	ND	2	ND	ND	151.6	ND
Bregnier-Cordon						
GRA	0	2.32	0	in 2008	0	129.2
VAC	0	0	0	in 2008	96.7	96.4
CER	0.27	9.16	7.08	in 2008	65.4	76.48
MAT	0.76	8.4	in 2007	in 2008	22.4	95.8
MDL	2.26	27.7	17.34	in 2008	54.8	145.2
PLA	5.05	33.9	18.77	in 2008	55.1	165.2
				in 2008		182.15
