Review

Geomorphological and sedimentological analysis of flash-flood deposits The case of the 1997 Rivillas flood (Spain)

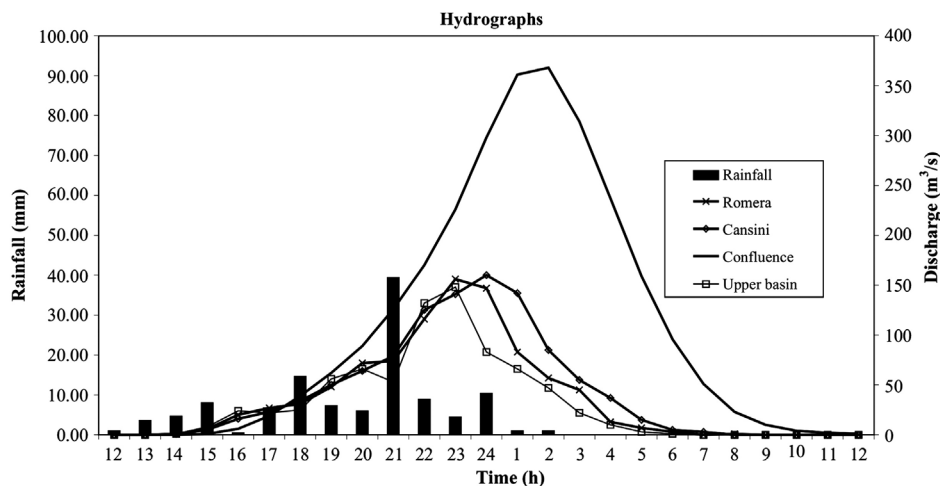
Fig. 2. Rainfall distribution and hydrograph of the 1997 flood event for different sites at the Rivillas basin.

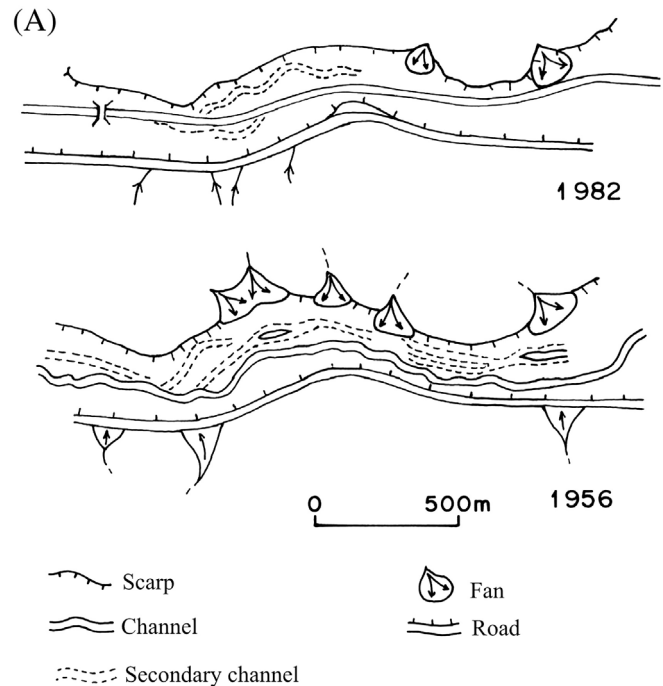
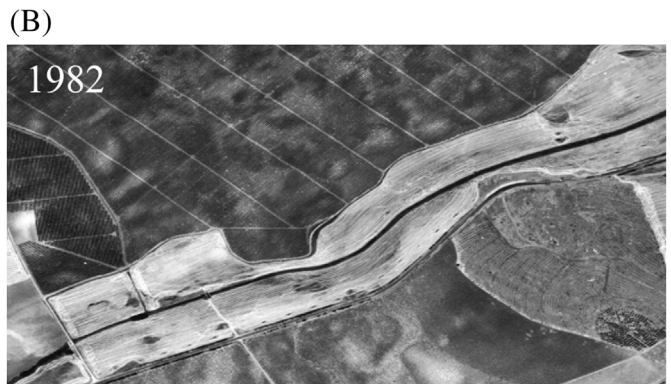
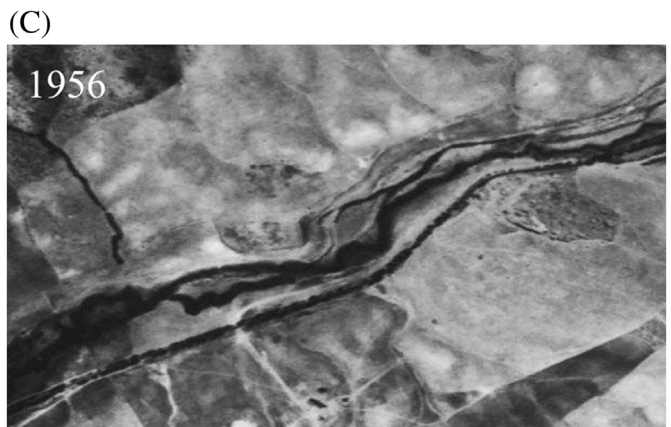
Fig. 3. Changes occurred at the Cansini reach between 1956 (A) and (C) when the channel was sinuous and 1982 (A) and (B) after channel straightening and intensive farming.

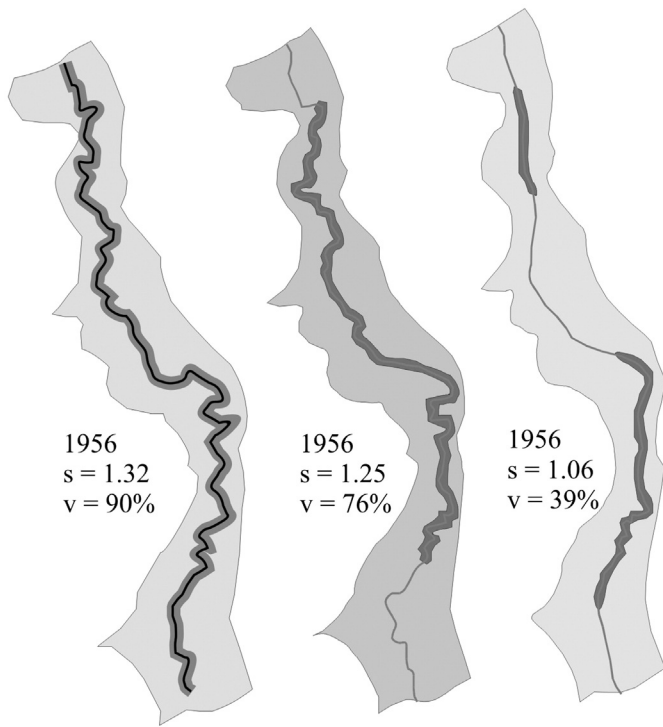
Fig. 4. Anthropogenic changes in stream sinuosity index (*s*) and riparian vegetation cover (*v*) in Romera reach between 1956 and 1997.

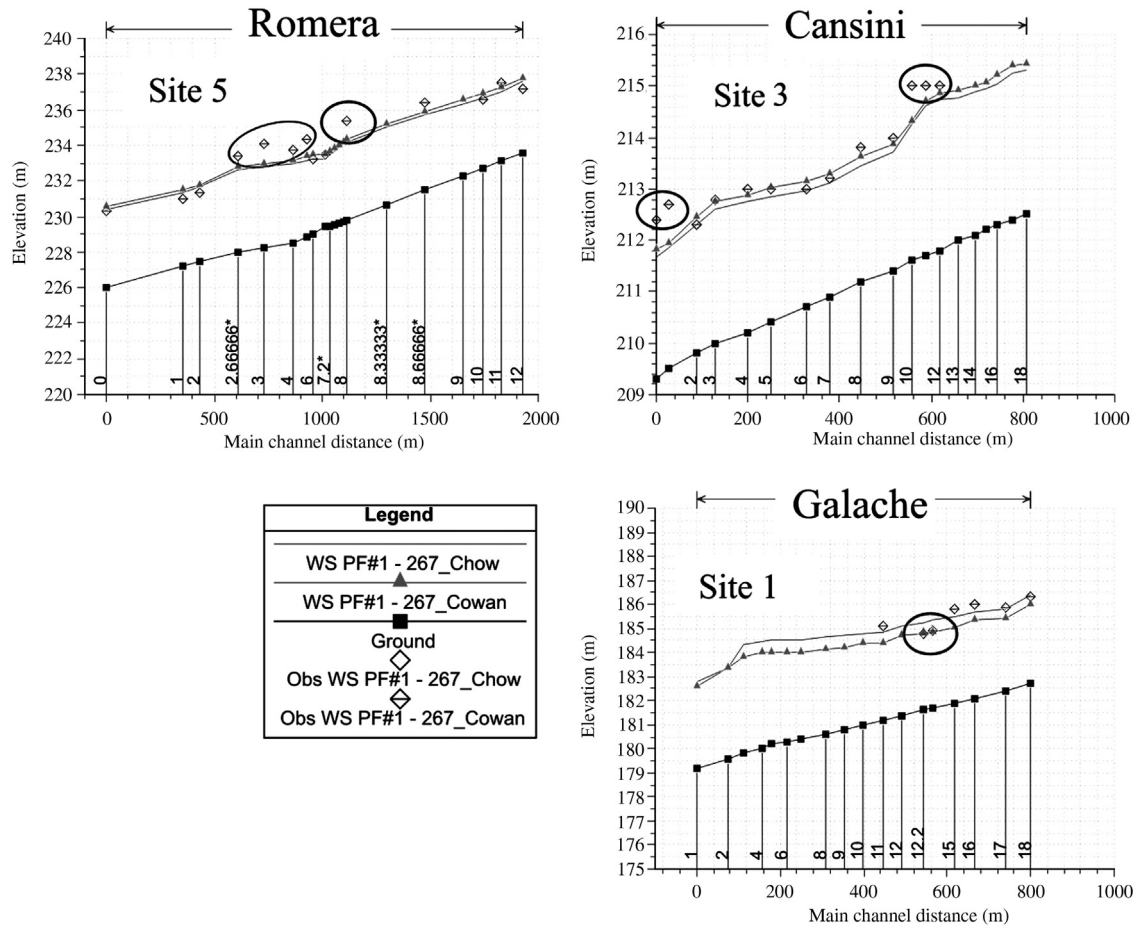
Fig. 10. Adjustment of roughness values in relation to flotsam data. Values that consider offering possible flow perturbation are marked with a circle.

Site	Average difference (m)		Discharge (m ³ s ⁻¹)
	Cowan	Chow	
Site 5	0.58	0.53 (0.43*)	156
Site 3	0.33	0.23 (0.21*)	180
Site 1	0.42	0.26 (0.15*)	300
Rivillas (average)	0.44	0.34 (0.26*)	–

Results marked with an asterisk (*) are considered reliable.

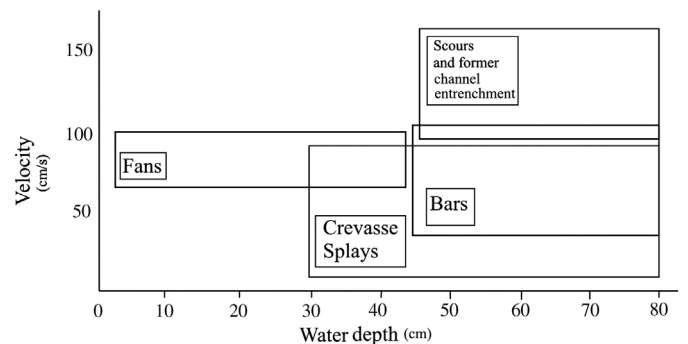
Fig. 11. Stability fields for velocity and water depth obtained for some features by modeling with HEC-RAS.

Feature	Reach	Water depth (cm)	Velocity (m s ⁻¹)	Shear stress (N m ⁻²)	Stream power (W m ⁻²)		
Bars and splays	Longitudinal sand bars	Site 5	50–100	0.4–0.9	9–40	4–33	
		Site 3	100–140	0.8–1	21–33	18–34	
	Crevasse splays	Site 1	60–140	0.7–1.1	19–47	15–55	
		Range	60–140	0.4–1.1	9–47	4–55	
Alluvial fans	Site 5	<150	0.6	16.5	11		
		Site 3	30–100	0.2–0.9	4–31	0.8–29	
	Range	30–150	0.2–0.9	4–31	0.8–29		
		Site 5	<100	0.7–1.01	14.9–37.3	10–38	
	Erosional features	Longitudinal scour fields	Site 3	<30	0.9	39.2	37
			Site 1	<30	0.95	29.1	28
Former channel entrenchment		Range	<100	0.7–1.01	15–39	10–38	
		Site 5	150	1.37–1.67	81–93	120–152	
Former channel entrenchment	Site 3	100–145	1–1.42	31–76	32–108		
		Site 1	130	0.68–1.2	17–57	22–71	
	Range	100–150	0.68–1.67	17–93	22–152		
		Site 5	170	1.1	58.7	69	
Former channel entrenchment	Site 3	120	1	35.4	36		
		Range	120–170	1–1.1	35–58	36–69
