Technological Studies

Kunsthistorisches Museum Vienna

Special volume: Storage
Vienna, 2015

Technologische Studien Kunsthistorisches Museum.
Konservierung – Restaurierung – Forschung – Technologie,
Sonderband Depot, Band 9/10, Wien 2012/13

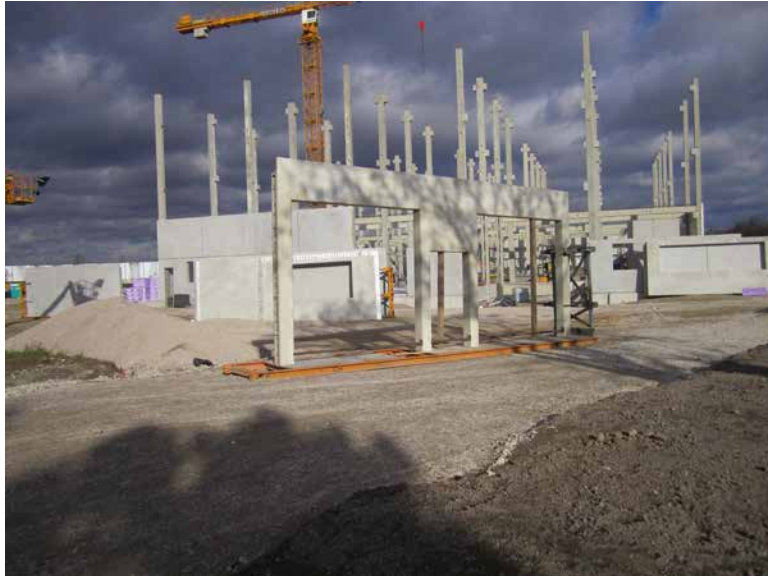
Fig. 2: Prefabricated industrial construction units contributed substantially to the short construction time.

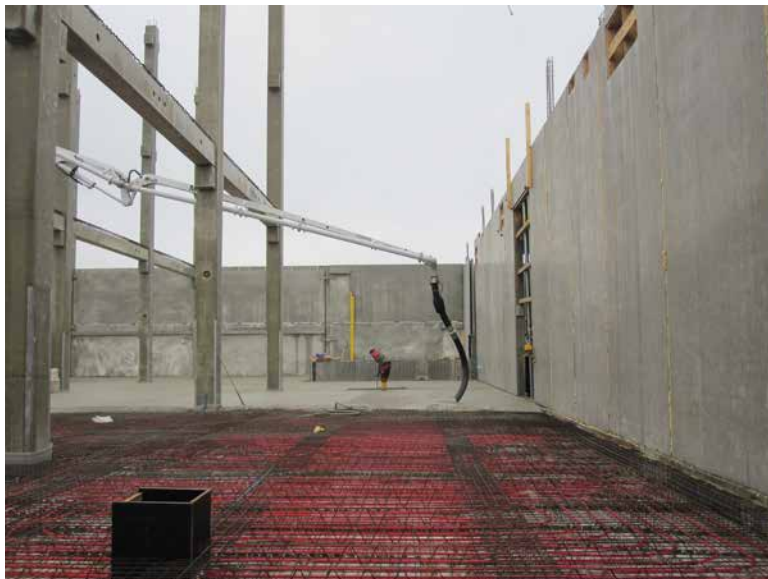
Fig. 4: Addition of concrete to the ceilings with concrete core activation and reinforcement already in place.

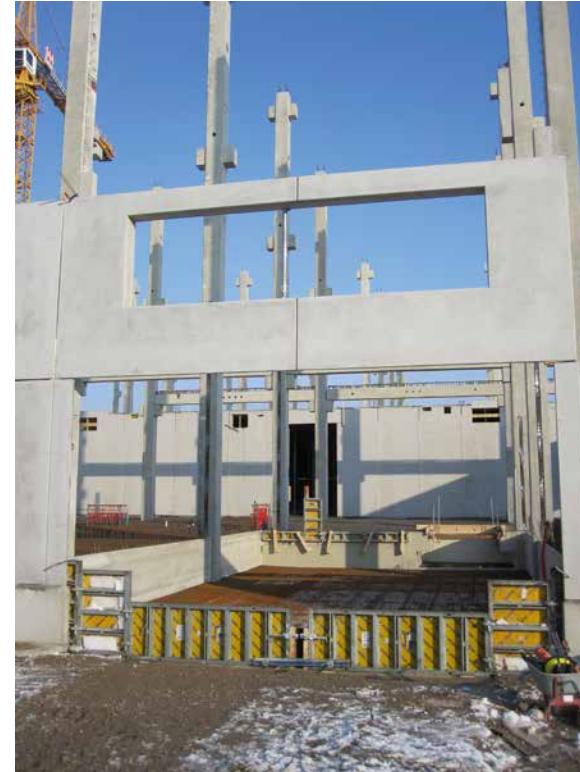
Fig. 3: Facade construction units with gaps for the windows.

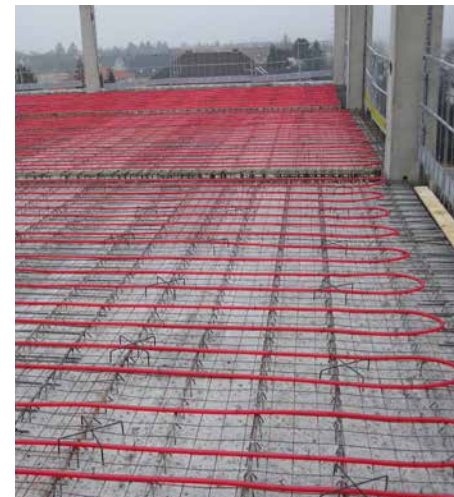
Fig. 5: The activated floors provide a stable climate. The photograph shows the installation of the tubing for the concrete core activation before the concrete has been poured.

The heating and cooling is carried out by heat pumps in combination with 32 geothermal probes that extend up to 100 m into the earth. During the winter, heat is withdrawn from the earth, while in the summer, the ground absorbs the heat drained from the building. The required rH of 50 % is maintained by commercially available, individual dehumidifiers placed throughout the building. The dehumidification of 500 m² storage space at the height of summer requires only one machine. In areas where a lower rH is necessary, for example, for bronze objects, so-called “climate boxes” were installed. The ventilation for these areas is closed-off from that of the rest of the storage facility; separately controlled dehumidifiers maintain rH of 30–40 % in these rooms.

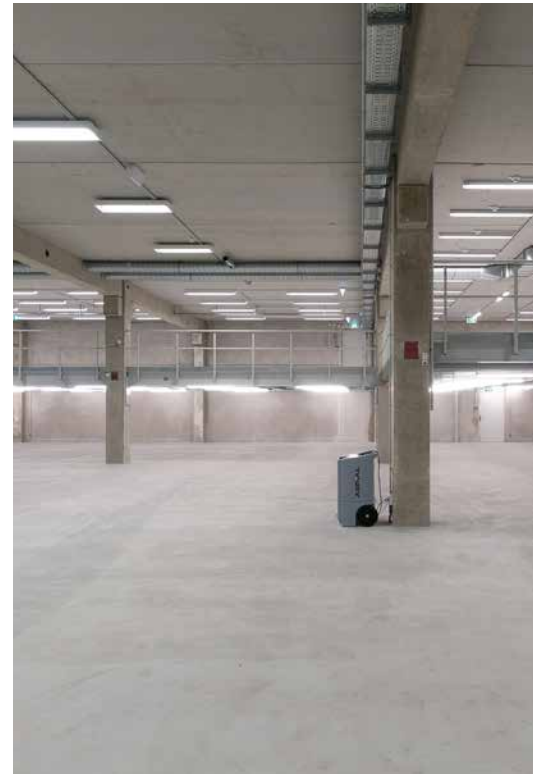
Fig. 7: The installation of intermediary steel platforms made it possible to optimise the use of the ceiling height.

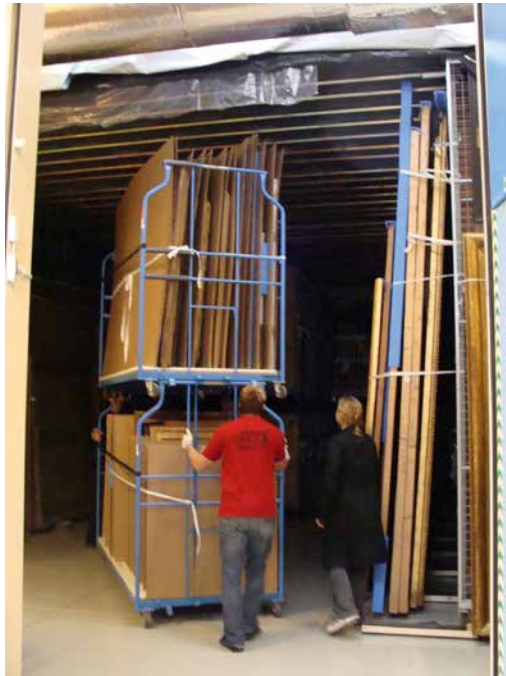
Fig. 4: The conservator Eva Götz and an employee of the company Füreder bringing objects into the nitrogen tent in the storage facility in Inzersdorf.

As a result, the paintings and decorative frames from the Picture Gallery were treated with nitrogen by the company Singer in a plastic tent in the old storage area (fig. 4); affected objects from the Imperial Carriage Museum were also treated on-site in two nitrogen tents (fig. 5).

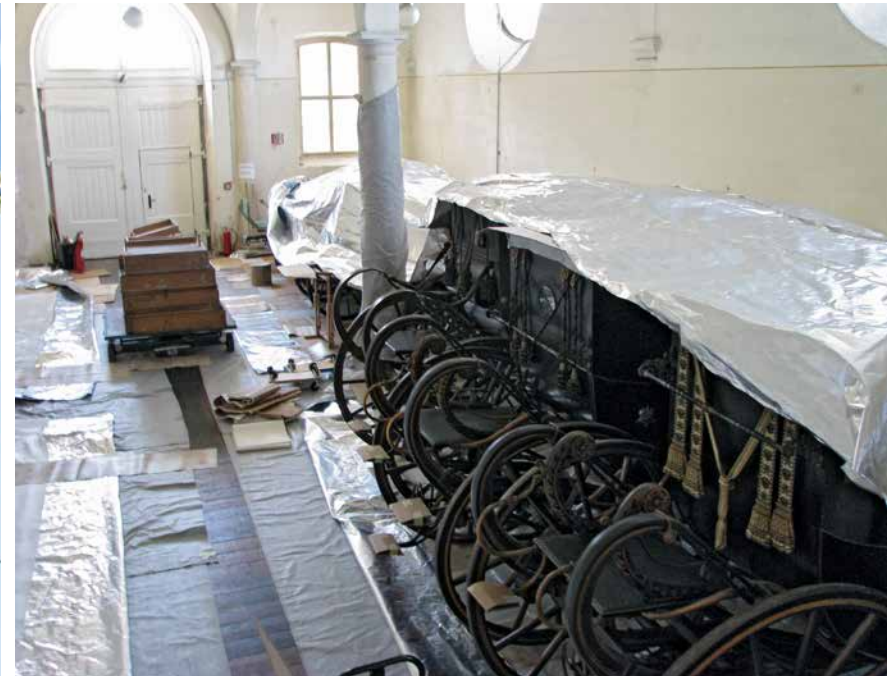
Fig. 5: Nitrogen tent for anoxic nitrogen treatment of the carriages from the Imperial Carriage Museum.

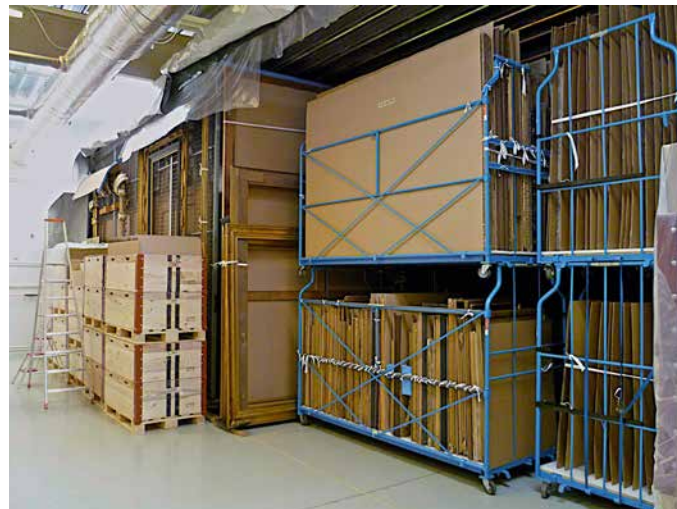
Fig. 15: Loading the anoxic nitrogen tent in the old storage facility with packed Corlette storage racks and ÖBB stackable crates on Euro-pallets. (©: www.prevalt.ch.)

Medium format paintings, furniture, theatre models, and marionettes were moved with the help of so-called furniture Corlettes® (mobile storage racks for heavy weights). They come in four sizes and can be stacked up to three times upon one another (fig. 30; see fig. 15). They were also adapted for the move of artworks with the addition of cardboard or Ethafoam, covered with bubble wrap, or secured with shrink wrap. After use, the furniture Corlettes can be folded up and stored – a great advantage when space is limited. Various accessories are available for the Corlettes, such as insertable shelves or poles (figs. 31 and 32). The Corlettes can be purchased or rented. The latter is preferable when they are needed only for a limited time.

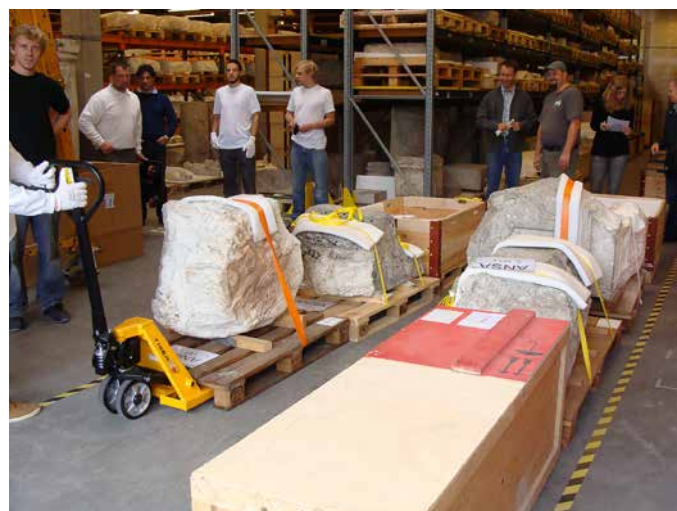
Fig. 25: Employees from the company Kunsttrans moving objects from the Collection of Greek and Roman Antiquities with pallet trucks.

Strategy 1: Employ the use of transport containers and prepare the objects to be moved well in advance so that they can be transported with a pallet truck or forklift (see fig. 25). Manoeuvring individual objects by hand, as shown in fig. 26, is not expedient.

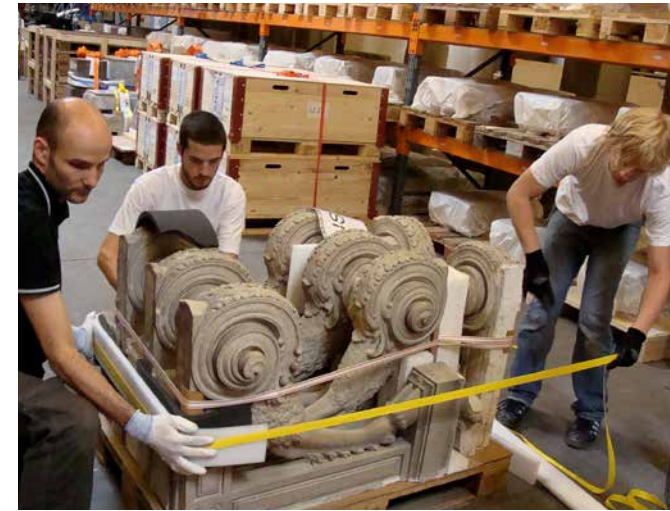
Fig. 27: Wooden Euro-pallet for the transport of stone reliefs from the Collection of Greek and Roman Antiquities.

Commercially available packing materials were used and adapted to the transport of artworks, like wooden Euro-pallets (120 × 80 cm) and polyethylene Euro-boxes (60 × 40 cm) (figs. 27 and 28). Only newly constructed pallets that had undergone a requested heat treatment by the manufacturer were used for the move in order to prevent the introduction of wood pests. Stacking frames of the Austrian Railways (ÖBB) are commercially available for the Euro-pallets (fig. 29; see fig. 17). These were used individually or stacked for the transport of large stone and ceramic fragments, small-format paintings, costume accessories and mannequins.

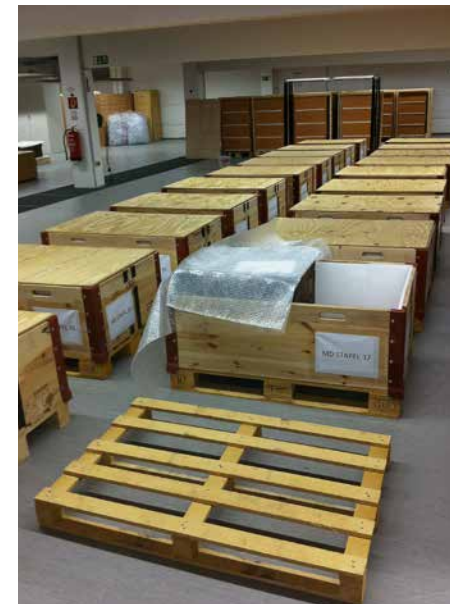
Fig. 29: Individual ÖBB stackable crates with pallet lids for the transport of costume accessories from the Court Wardrobe.

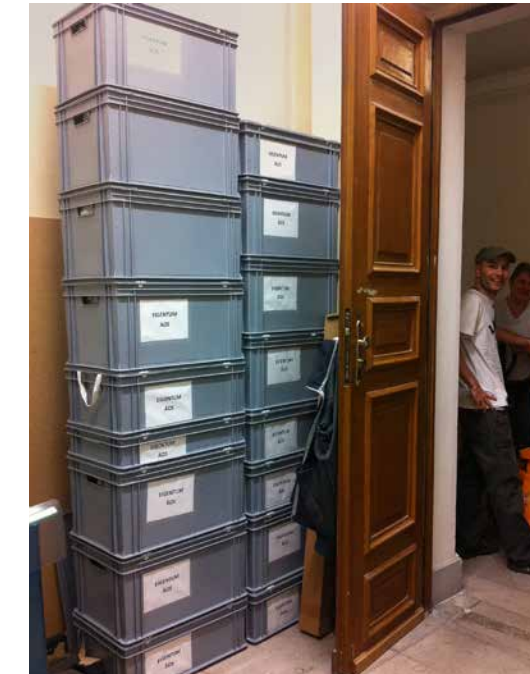
Fig. 28: Polyethylene Euro-boxes for the transport of ceramic fragments from the Collection of Greek and Roman Antiquities.

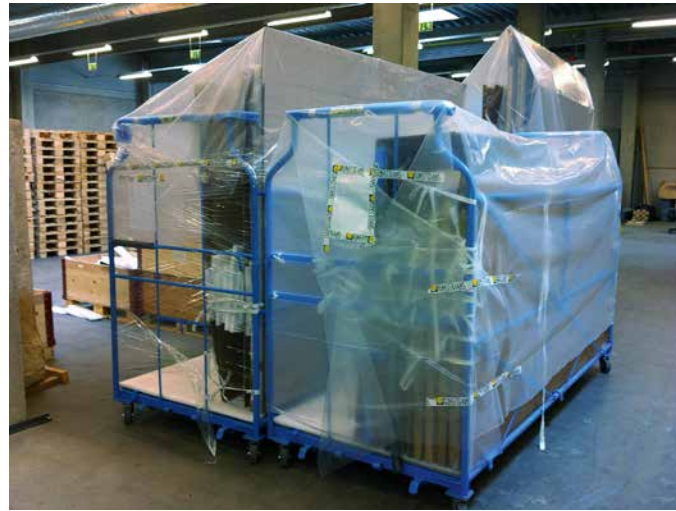
Fig. 30: Corlette storage racks for the transport of medium-format paintings from the Picture Gallery.

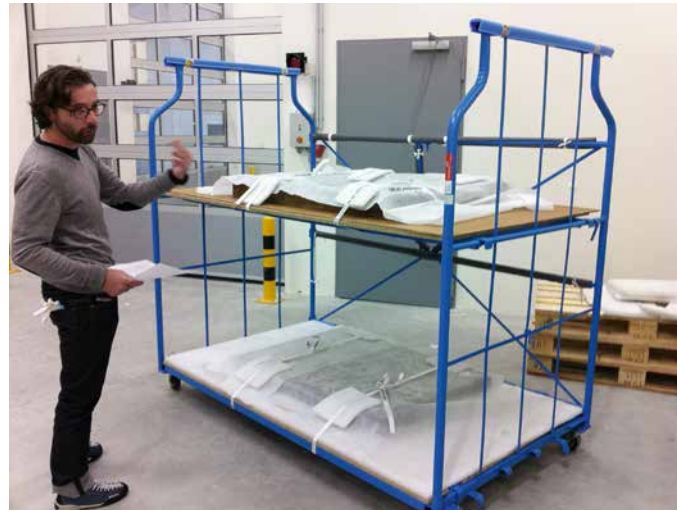
Fig. 31: Corlette storage rack with insertable shelves for the transport of stone panels from the Kunstkammer.

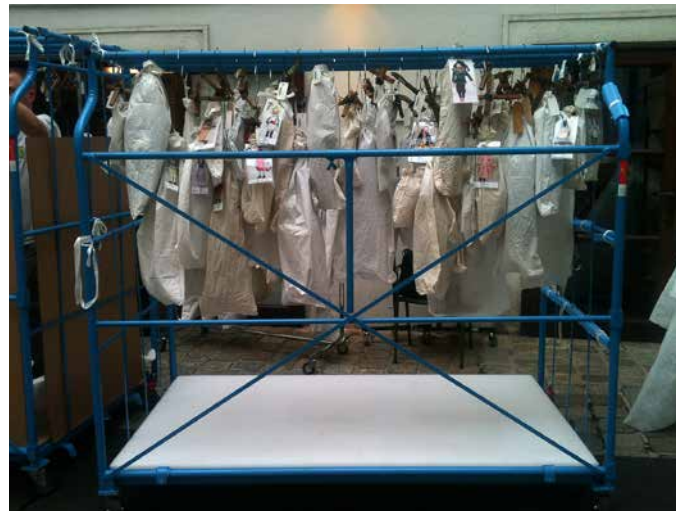
Fig. 32: Corlette storage rack outfitted with poles for the transport of marionettes from the collection of the Theatre Museum.

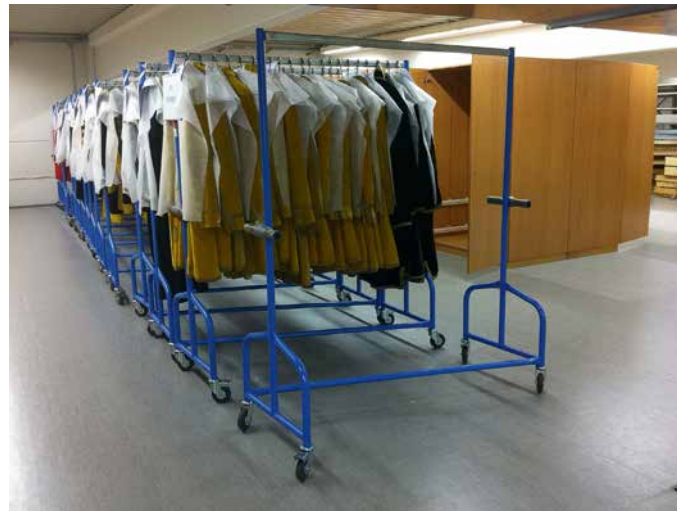
Fig. 33: Mobile clothes racks (rented) for the transport of court uniforms from the Court Wardrobe, which can be nested together when stored by Z-shaped frames in order to save space.

Mobile clothes racks assisted with the efficient transfer of the costumes and marionettes to their new location. Fig. 33 shows rented mobile clothes racks that can be stored nested together by Z-shaped based frames in order to save space. For the move, however, mobile clothes racks already in the museum's possession were also used (fig. 34). In order to keep the amount of material used to a minimum, a large part of the objects were moved in boxes, old drawers, or original storage chests already on hand. They could be fitted together, stacked on top of one another on customised or Euro-pallets, and then stabilised for transport (figs. 35 and 36).

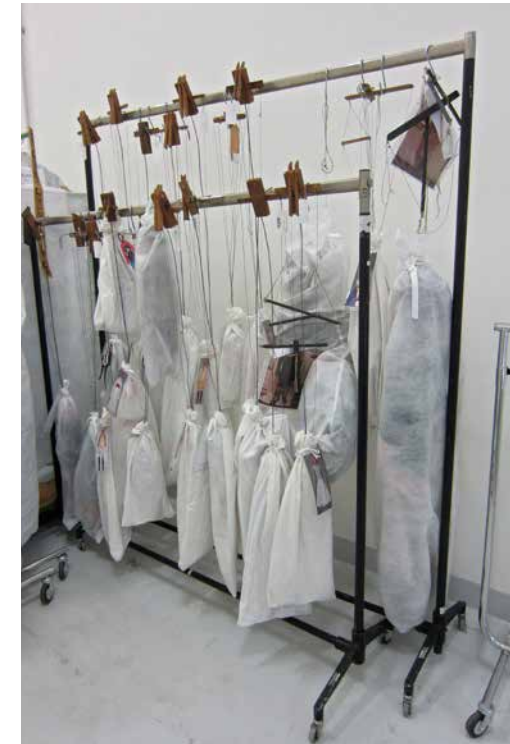
Fig. 34: Mobile clothes racks from the museum's holdings for the transport of the marionettes from the collection of the Theatre Museum. (©: Nina Zangerl.)

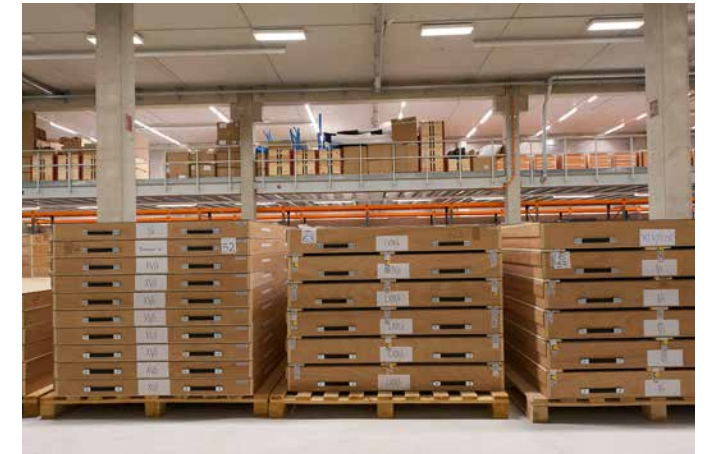
Fig. 35: Boxes with folded tapestries from the Kunstkammer, stacked on customised pallets for transport.

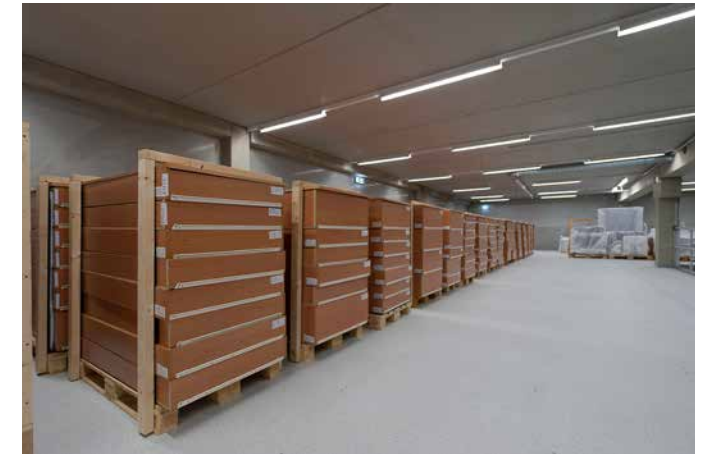
Fig. 36: Drawers containing costume accessories from the Court Wardrobe stacked on Euro-pallets for transport.

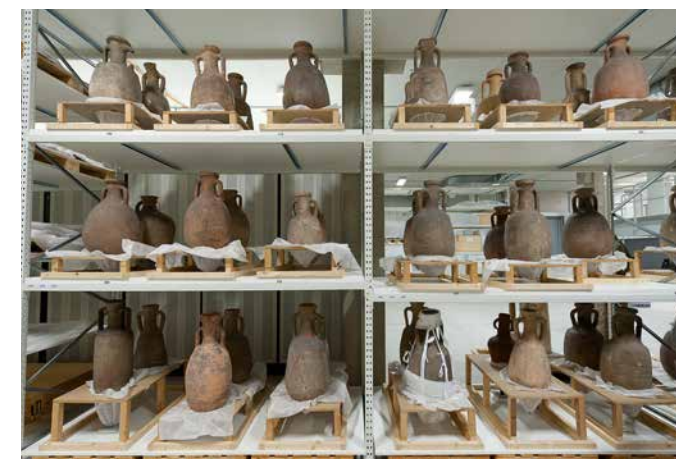
Fig. 37: Wooden mounts for the transport and storage of amphorae from the Collection of Greek and Roman Antiquities.

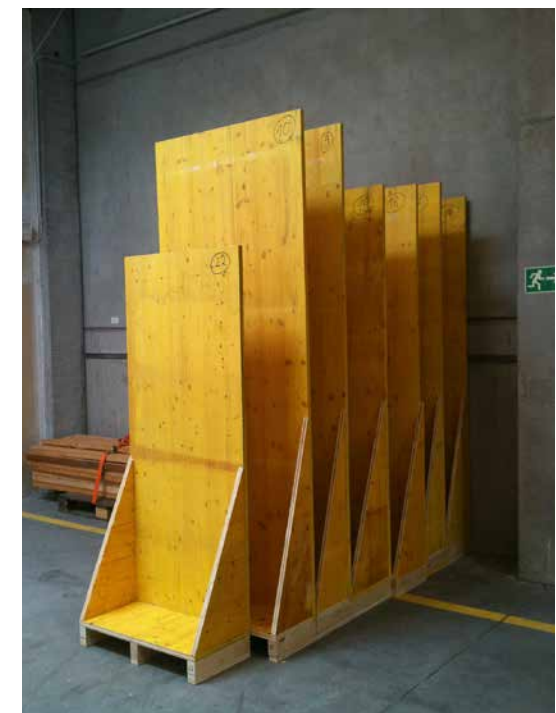
Fig. 38: L-shaped wooden boards for the transport and storage of stone reliefs and tombstones from the Collection of Greek and Roman Antiquities.

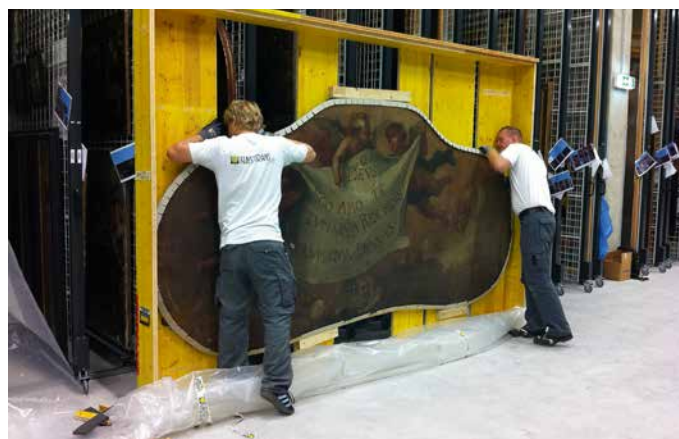
Fig. 39: Travel frame for the move of fragile paintings from the Picture Gallery.

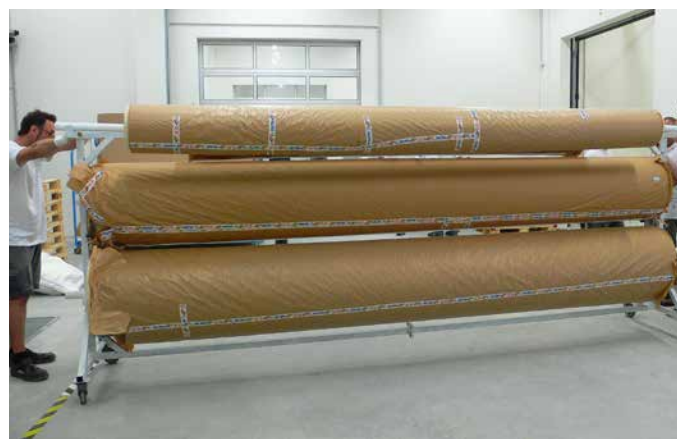
Fig. 40: Portable metal rack for the transport and storage of rolled paintings from the Picture Gallery. (©: Matthias Müller.)

For groups of objects that did not fit into commercially available standard transport containers due to their size, weight, or condition, customised packing solutions were developed by the relocation team in consultation with the collections' conservators. These were for the most part made by the in-house carpenters and metalworkers. As examples, we show here the wooden mounts for the amphorae and the transport boards for the stone reliefs and tombstones from the Collection of Greek and Roman Antiquities (figs. 37 and 38), along with the transport boards for the pianos of the Collection of Historic Musical Instruments (Fig. 2 in the contribution by Hoheisel – Huber). Fragile paintings of various sizes were moved with the help of travel frames (fig. 39). Portable metal racks simplified not only the moving of the rolled paintings, but were also used for storage in the new central facility (fig. 40).

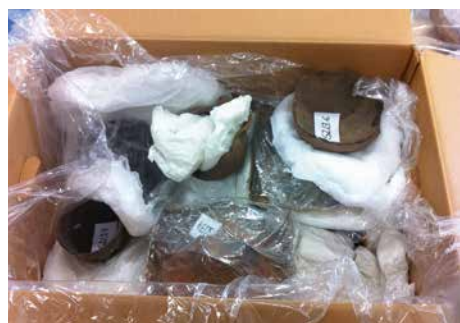
Fig. 41: Tissue paper padding around ceramic fragments from the Egyptian and Near Eastern Collection.

Hollow spaces had to be filled so that the objects could not shift in their containers during transport. Commercially available filling materials were used in most cases, like tissue paper and Tyvek cushions filled with low-density polystyrene granules (*figs. 41 and 42*). Only the Tyvek cushions and the PP sacks filled with polystyrene granules used to cushion the stone busts, sculptures and fresco fragments were custom-made in-house (*fig. 43*).

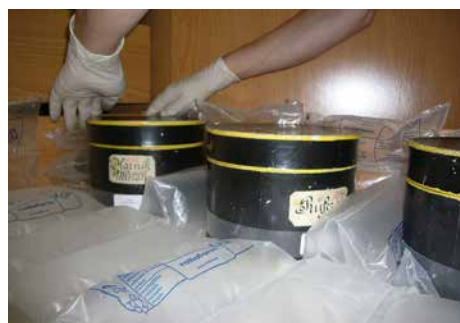
Fig. 42: Low-density polyethylene air cushions used as space fillers to prevent the shifting of objects from the Court Wardrobe during transport.

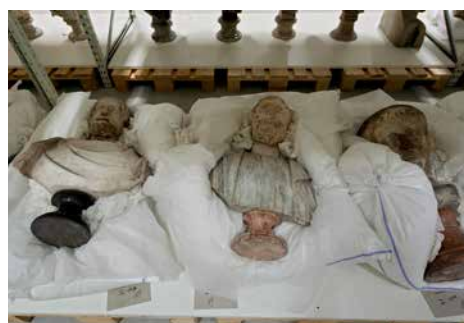
Fig. 43: PP sacks filled with polystyrene granules for the transport of stone busts from the Collection of Greek and Roman Antiquities.

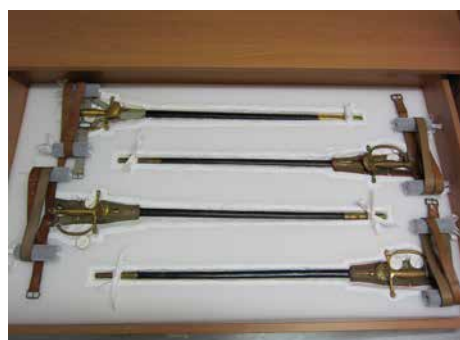
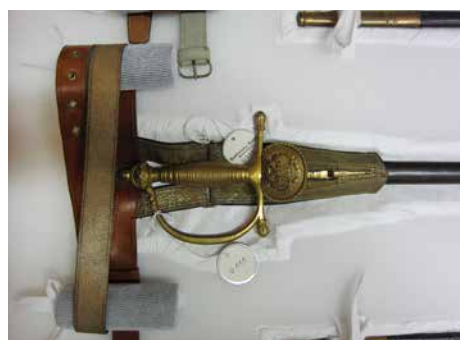
Fig. 44 b

Fig. 44 a
Swords with the accompanying sheaths and pendants from the Court Wardrobe, embedded into custom-made Ethafoam beds lined with Tyvek for transport and storage. View into the drawer of the old storage cabinet (left) and in detail (right).

Very fragile objects were embedded in Ethafoam sheets carved to fit their form. The melee weapons from the Imperial Carriage Museum and the Court Wardrobe are provided as examples (*fig. 44*). Load-bearing, tension, and tie-down straps served to stabilise objects during transport. Customised solutions had to be developed for the packing and manipulation of particularly large, heavy, or fragile objects. The stabilising reinforcement of large storage vessels is one example (*fig. 45*) along with the transport of over-sized paintings in a scenery truck (*see fig. 24 and fig. 46*). Customised solutions were also required when obstacles (e.g., a steep ascent) had to be overcome between the storage location and the moving truck (*figs. 47 and 48*).

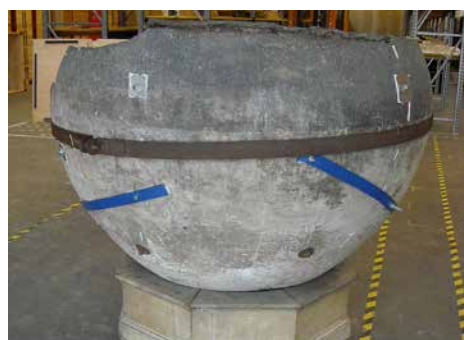
Fig. 45: Fish storage vessel from the Collection of Greek and Roman Antiquities prepared for transport with a stabilising outer band.

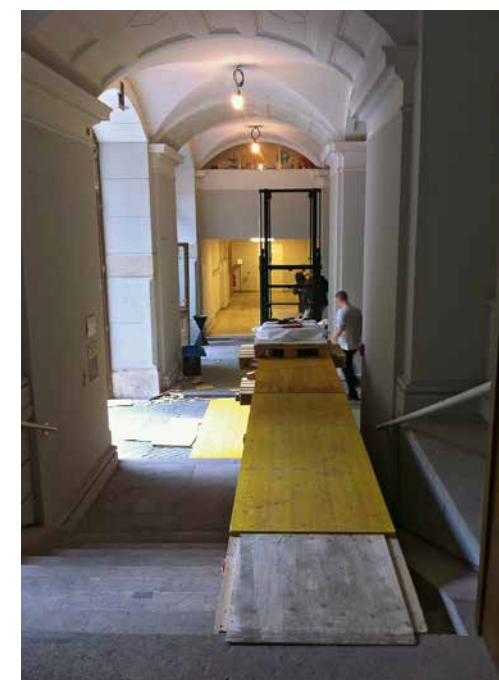
Fig. 47: KHM, a pallet tower with formboards for moving art up a slope for the move of objects from the Egyptian and Near Eastern Collection during the second relocation phase.

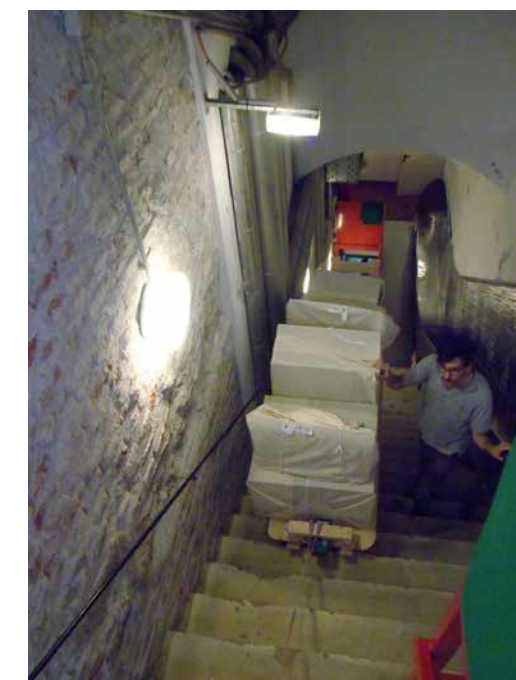
Fig. 48: Theatre Museum, cellar areas. Transport board with a pulley for the transport of theatre models during the third relocation phase.

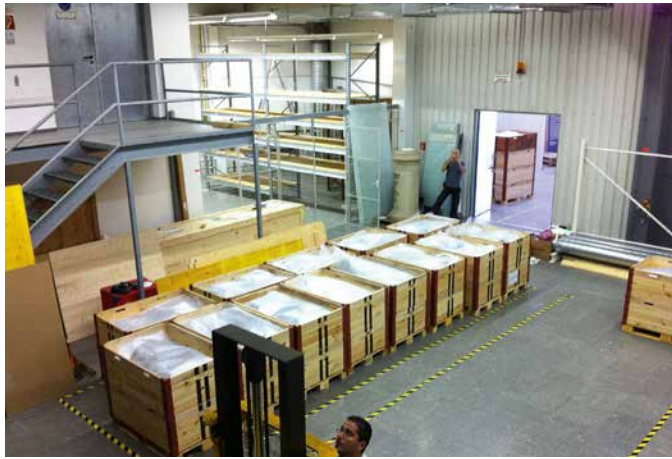
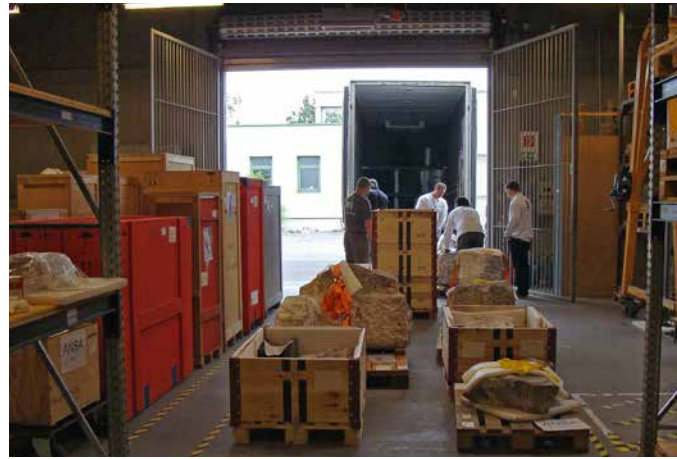
Fig. 49 a

Inzersdorf storage facility, objects ready for transport from the Court Wardrobe (left) and the Collection of Greek and Roman Antiquities (right). Floor markings designate the size of the moving trucks.

Space providing, objects could be packed in advance and placed in the loading area prior to transport. A space corresponding to the surface of the moving truck was marked on the ground (*fig. 49*). Packing and pre-placement for loading was not possible in all of the old storage areas. The Theatre Museum and the Imperial Carriage Museum were packed on-site and loaded directly into the moving trucks because either there was not enough space available or the objects had undergone anoxic nitrogen treatment (*figs. 50 and 51*).

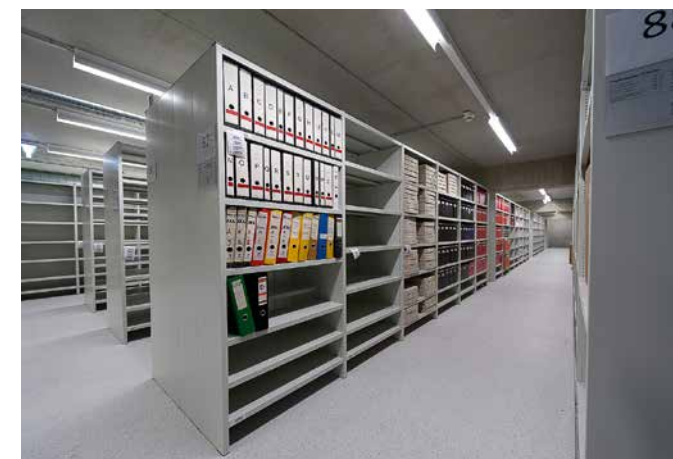
Fig. 52: Archival shelving from the company Compactus & Bruynzeel AG for the storage of library materials.

Various shelving units, such as archival, wide-span, heavy-duty, and rolling units from Compactus & Bruynzeel AG (figs. 52 to 55) as well as cabinets of different sizes with variable interior fittings like shelves, drawers and clothes rails (Magista Systems/Van Keulen Interieurbouw) (figs. 56 and 57) were installed. Openings were punched into the doors of the cabinets in order to allow for continuous air flow, thus preventing the creation of a microclimate. The cabinets housing the coin collection are outfitted with shallow, individual stainless steel trays, hindering corrosion of the sensitive metals (figs. 58 and 59). Furthermore, they are located in an appropriate climate-controlled room with a reduced humidity of 40 %.

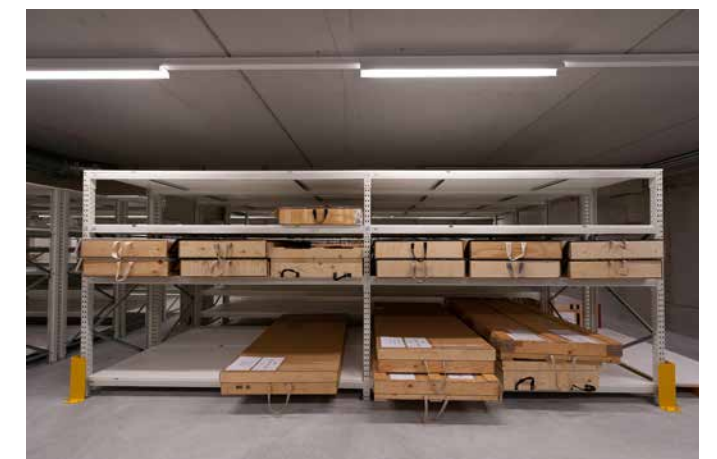
Fig. 53: Wide-span shelving units from the company Compactus & Bruynzeel AG for the storage of flat storage boxes from the Court Wardrobe.

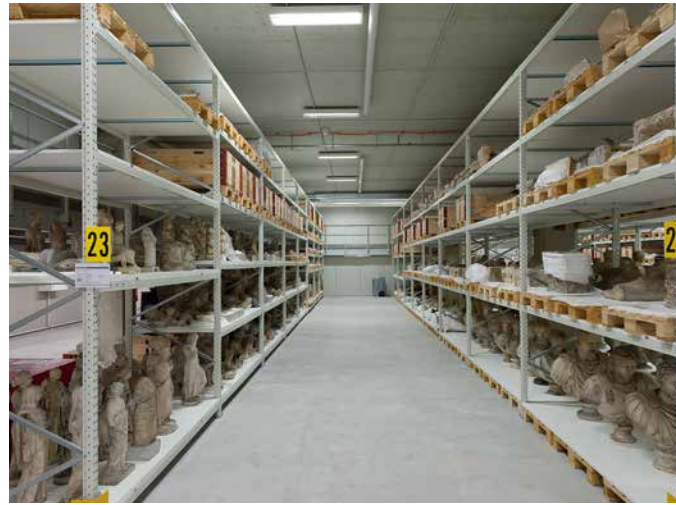
Fig. 54: Heavy-duty shelving from the company Compactus & Bruynzeel AG for the storage of objects from the Collection of Greek and Roman Antiquities.

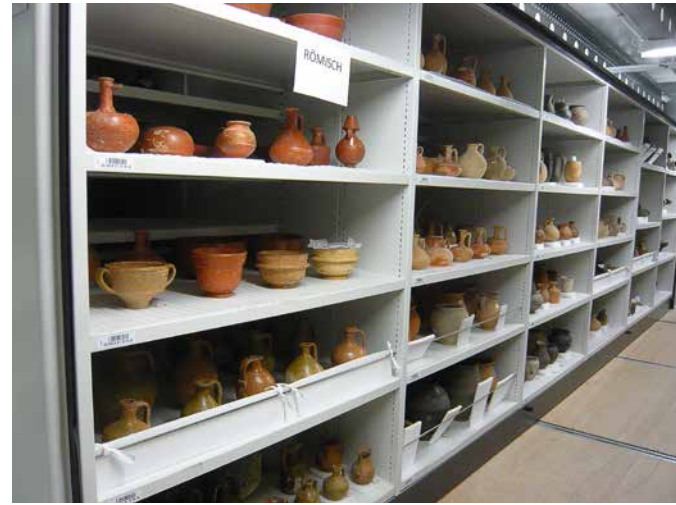
Fig. 55: View of the rolling shelving units from the company Compactus & Bruynzeel AG for the storage of objects from the Collection of Greek and Roman Antiquities.

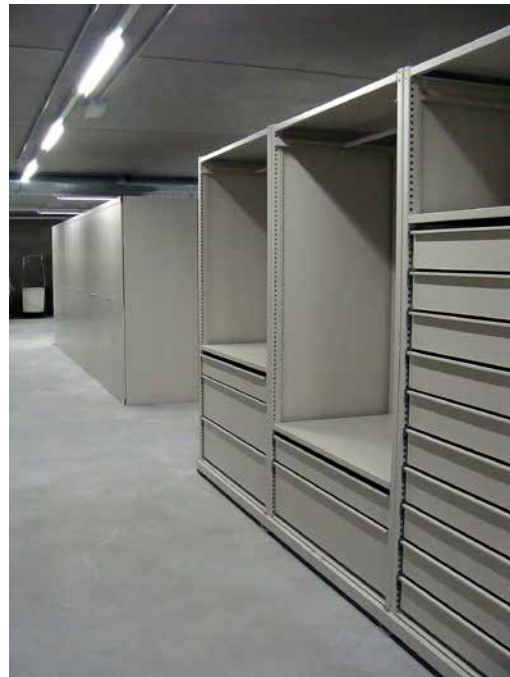
Fig. 56: Powder-coated steel cabinets from the company Magista Systems/Van Keulen Interieurbouw with variable interior fittings during assembly.

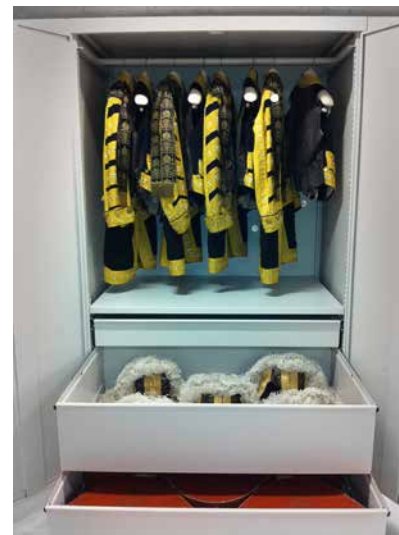
Fig. 57: View of the powder-coated steel cabinet from the company Magista Systems/Van Keulen Interieurbouw with objects from the Court Wardrobe.

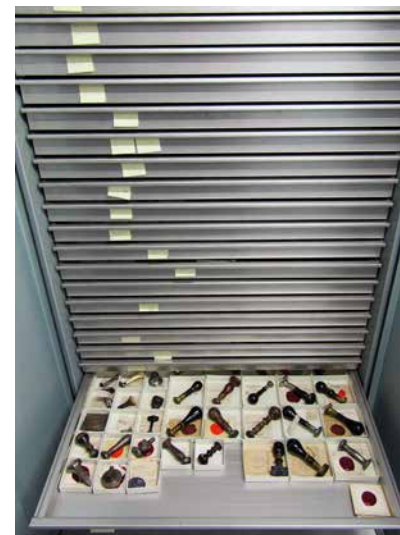
Fig. 58: View of the powder-coated steel cabinet from the company H. Schneider & Co.: Stainless steel trays with seals from the Coin Collection.

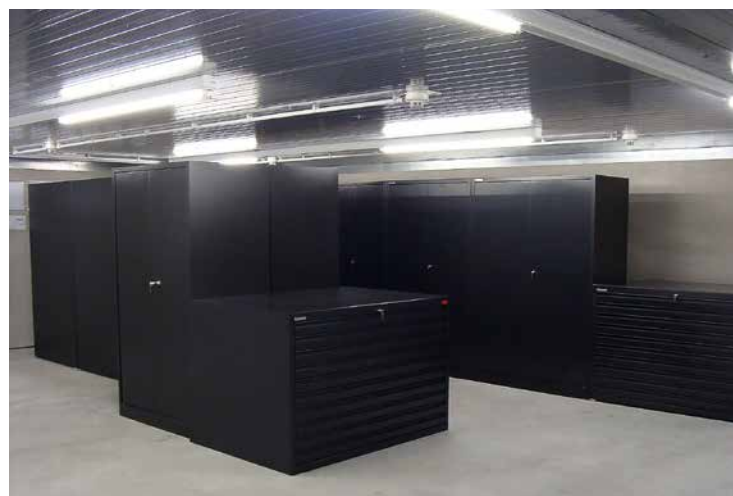
Fig. 59: Powder-coated steel cabinet from the company H. Schneider & Co. for the storage of objects from the Coin Collection.

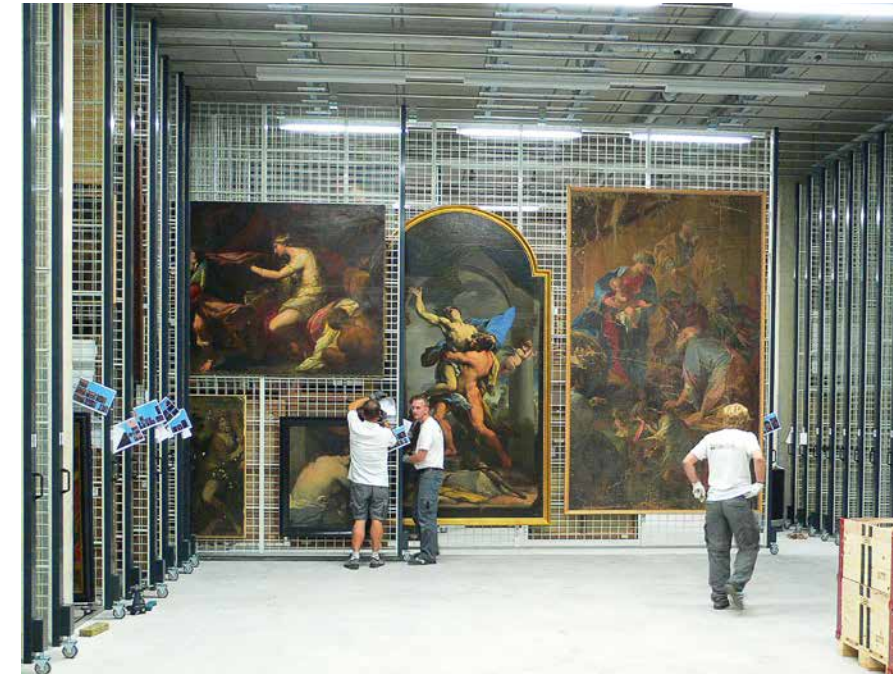
Fig. 60 a

Wire mesh storage racks (left: front view, right: side view) from the company Compactus & Bruynzeel AG for the storage of paintings from the Picture Gallery.

An innovative model for wire mesh storage racks in two sizes (ground level: height 5 m × width 8 m, second floor: height 4 m × width 6 m) (fig. 60), at the time not available on the market, was developed with the manufacturer Compactus & Bruynzeel AG for the paintings and framed works on paper from various collections. The hanging hooks, available in two sizes, were adjusted to the size of the loops in the wire mesh (fig. 61). They are protected from corrosion and have a capacity load of 50 kg (single hook) or 90 kg (double hook). Additional support elements, for example, support rails, are used for large-format or particularly heavy paintings (fig. 62).

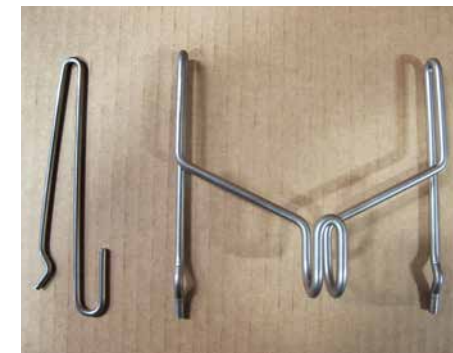
Fig. 61: Single and double hooks corresponding to the loop size of the wire mesh storage rack.

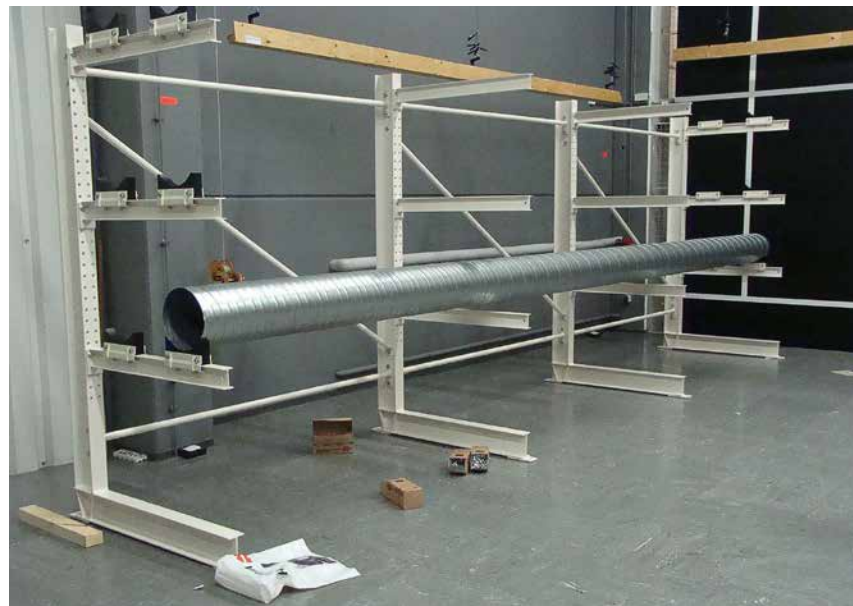
Fig. 63: Inzersdorf storage facility: Assembly of a prototype for the column-free rack from the company Magista Systems/Van Keulen Interieurbouw for storage of the Kunstammer tapestries.

The museum team developed a new, cantilevered storage with an adjustment grid for tubes up to 6 meters in length with the company Magista Systems/Van Keulen Interieurbouw for the tapestry collection of the Kunstammer (fig. 63 and cover image). This customised structure presented a cost-effective and maintenance-free alternative to traditional circulating shelving units (paternoster) that are commonly used for the storage of large and heavy tapestries.

The cantilever shelving system is comprised of vertical shelf posts to which the horizontal cantilevered arms can be attached at adjustable intervals. The shelves can be placed flush onto the arms without the use of tools. Full-extension drawers can also be assembled as needed in place of shelves; in this case, the cantilevered arm is reinforced, and extends into the transverse profile. The carrying capacity per linear meter of shelving or drawer is 40 kg. The call for proposals required that each company had to create a prototype for the customised storage equipment at the time of the granting of the contracts. This proved to be indispensable for the assessment of the quality of design and workmanship of the shelving units (see fig. 63).

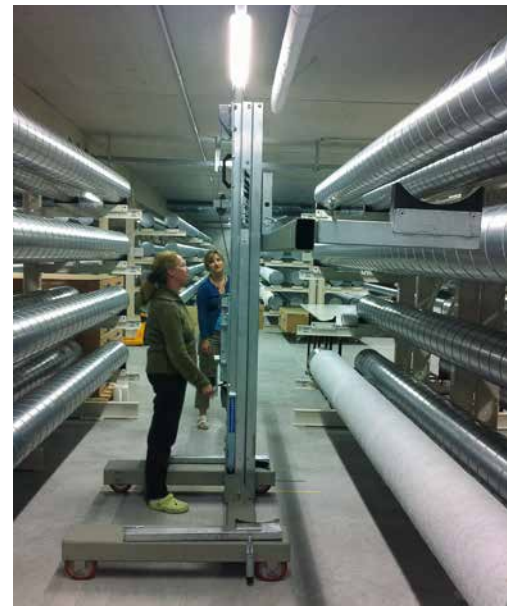
Fig. 64: Custom-made mechanical, mobile lifting apparatus (Stefan Fleck/Bernard Rendl GmbH) for manipulation of the commercially available folded spiral-seam pipes made of galvanised steel sheeting for later storage of the Kunstammer tapestries.

The racks are installed back-to-back in the storage area, and are accessible from one side when removing or storing a rolled tapestry. Two cantilevered arms can hold up to two rolled objects, one behind the other, and each side can carry up to eight tapestries. Going forward, the tapestries will be placed on so-called commercially available folded spiral-seam pipes made of galvanised steel sheeting reinforced with additional stiffening beads, when longer than 4.5 meters. Compared to the cardboard tubes commonly used, the spiral-form pipes have the advantage that they are lighter and do not sag. The tubes are lined with polyethylene foam (Plastazote) and polyester batting provides the necessary cushioning for the object. The rolls (core and object) have a maximum weight of 100 kg and are lifted into place with a mechanical, mobile lifting apparatus (fig. 64).

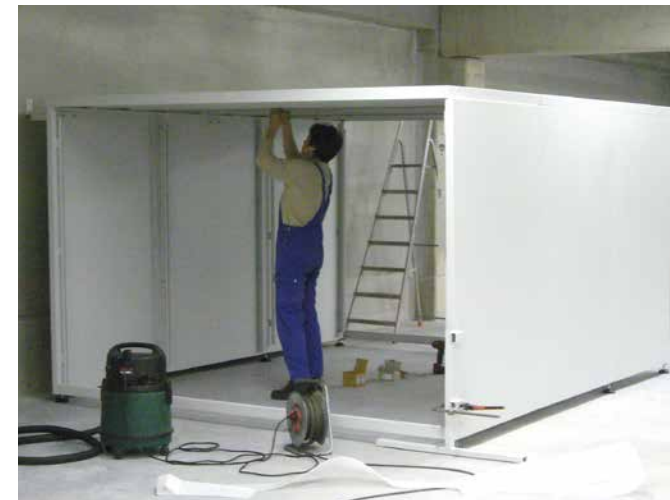
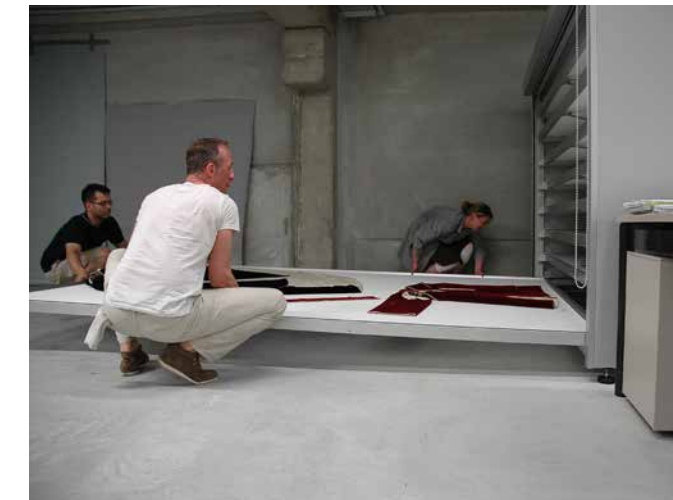
Fig. 65 a

Customised large cabinet with shelving by StabaArte company for the storage and presentation of over-sized textiles. On-site assembly (left) with storage of the robes from the Order of the Garter (right).

A customised large cabinet with shelving from the company StabaArte allows for adequate storage and presentation of large-format textiles from the Imperial Carriage Museum/Court Wardrobe (fig. 65). The corpus of the cabinet is exactly 180 cm high, 250 cm wide, and 350 cm deep. It is made of emission-free powder-coated steel and remains dust-tight when closed by the placement of fabric curtains on its front and back. U-shaped rails guide eight trays, which by means of slides, can be effortlessly pulled out and pushed back. Polyester fabric with a light-weight aluminium frame compose the so-called “maxi shelf,” whose maximum carrying capacity of evenly distributed weight is 10 kg. The corpus of the cabinet is placed on adjustable feet and is attached to the wall with brackets.

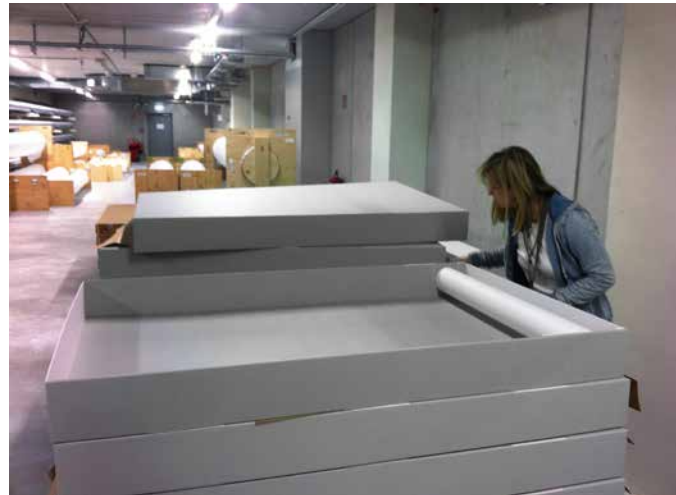
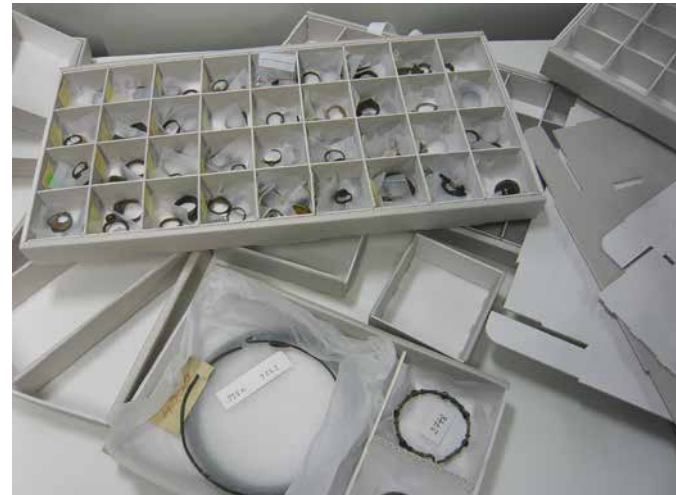
Fig. 66 a

Acid-free cardboard boxes from the company Klug-Conservation (left) and acid-free folding boxes from the company Schempp in various sizes for the new storage of metal objects from the Collection of Greek and Roman Antiquities (right).

In order to save on transport costs, the over-sized boxes were delivered flat and then assembled on site by an employee of the company Japico. When used for the storage of tapestries, the boxes were additionally outfitted inside with a tube (fig. 66 a).

A total of around 3,400 boxes in various sizes (ranging from 6.5 cm × 8.5 cm to 122 cm × 110 cm) were provided by the company Schempp for the Collection of Greek and Roman Antiquities, the Egyptian and Near East Collection, and the Coin Collection. The standard acid-free cardboard boxes SB 21 (with and without lid) were most commonly used, at times with an additional insertable subdivision for the smallest objects (fig. 66 b). A few custom sizes were necessary, in consultation with collection conservators.

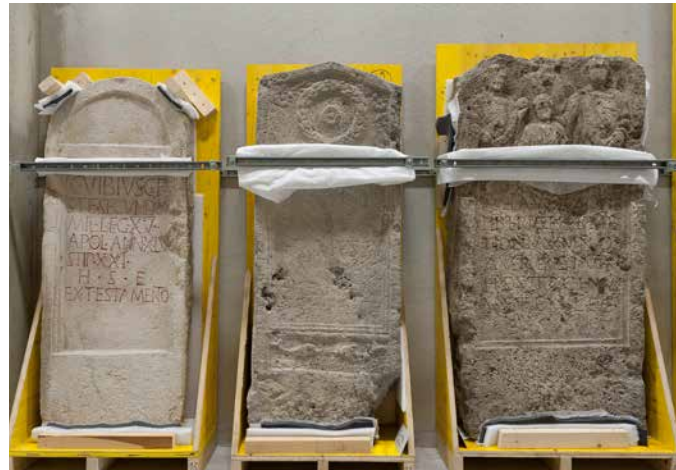
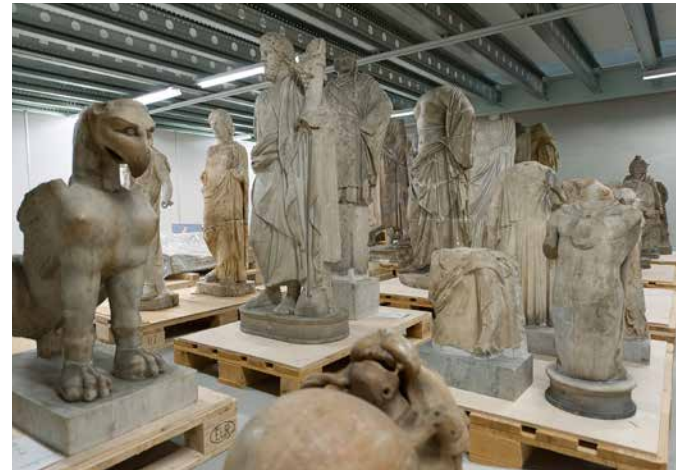
Fig. 67 a

Placement of tombstones (left) and stone sculptures (right) from the Collection of Greek and Roman Antiquities.

Not all objects could be housed in shelving units, cabinets, or other storage containers. Size, weight and shape sometimes demanded the placement of the corresponding artworks in open space. The tombstones and medium format sculptures from the Collection of Greek and Roman Antiquities along with the coaches and exhibition mounts from the Imperial Carriage Museum/Court Wardrobe, serve as examples here (figs. 67 and 68).

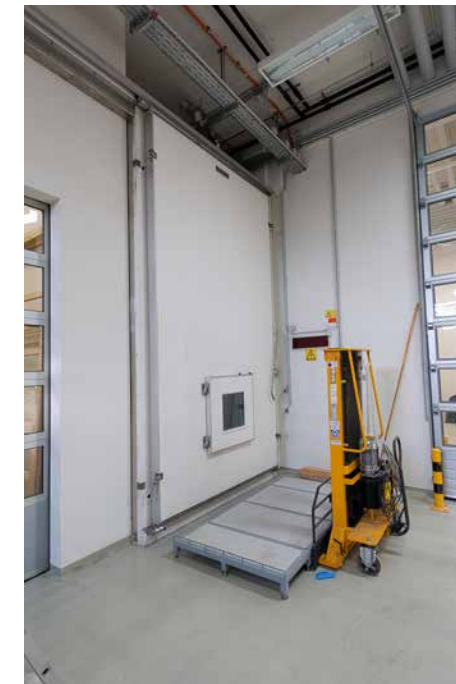
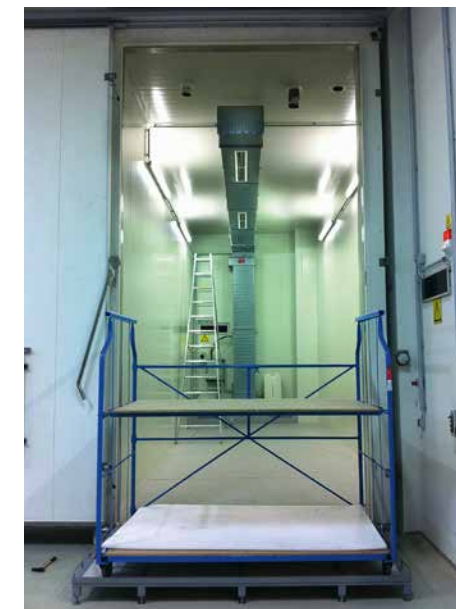
Fig. 69: Anoxic nitrogen treatment chamber in the central art storage facility of the Kunsthistorisches Museum Vienna.

Fig. 70: View of the anoxic nitrogen treatment chamber of the Kunsthistorisches Museum Vienna.

All artworks that return to storage after a special exhibition, and all new additions to the collections, undergo anoxic nitrogen treatment as a measure of preventive conservation in order to deter the possible introduction of insect pests to the storage areas. The anoxic nitrogen chamber is 4.5 m high, 3 m wide, and 7.5 m deep and has a volumetric capacity of ca. 100 cubic meters. It is located on the ground floor, in the vicinity of the unpacking room and immediately accessible from the delivery area (figs. 69 and 70). The system is run with a nitrogen generator; control and running of the equipment is fully automatic. Should the generator fail, a back-up supply of nitrogen in canisters is activated.
