Technological Studies

Kunsthistorisches Museum Vienna

Special volume: Storage
Vienna, 2015

Technologische Studien Kunsthistorisches Museum.
Konservierung – Restaurierung – Forschung – Technologie,
Sonderband Depot, Band 9/10, Wien 2012/13

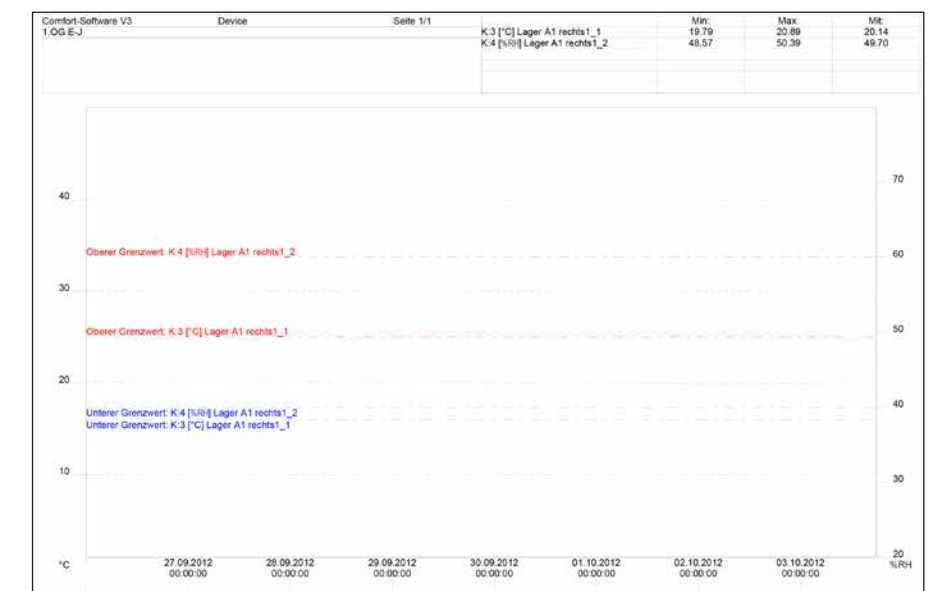
Fig. 71: Climate curve from the storage area for the Collection of Greek and Roman Antiquities. Temperature is shown in green and relative humidity is shown in red.

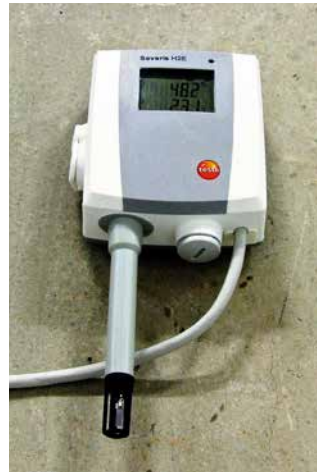
Fig. 72: Temperature and humidity sensors for the Testo Saveris System. (©: HLK, Heizung, Lüftung, Klima-Kältetechnik.)

The monitoring and documentation of the building climate is carried out with Testo Saveris, a system that automatically saves temperature and humidity values (fig. 72). The storage facility management looks at the program data; if current conditions exceed or fall below the stipulated values, the computer screen displays them and allows for corresponding measures to be taken to regulate the climate (fig. 73). Regular evaluation and analysis of the collected data will be undertaken by Angelika Stephanides, the climate specialist for the museum.

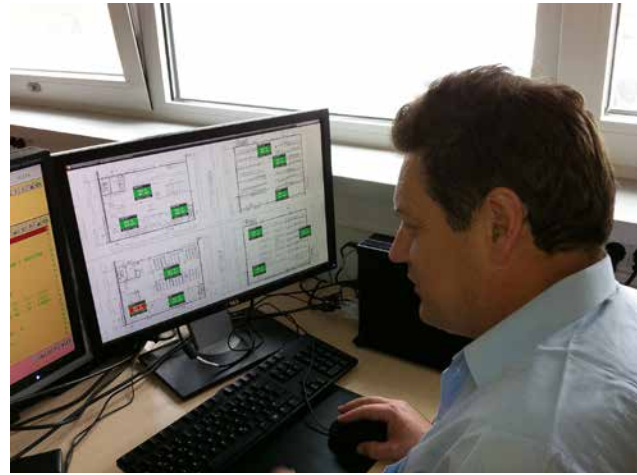
Fig. 73: Storage facility manager Peter Planegger at the computer, inspecting the temperature and humidity levels in the Testo Saveris program.

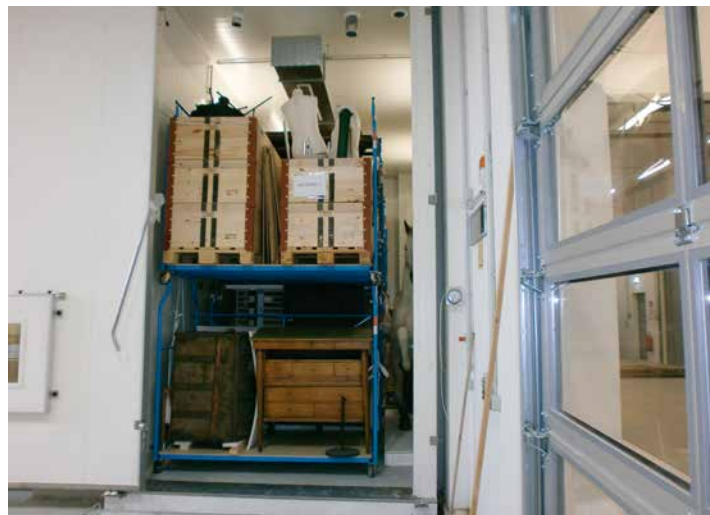
Fig. 74: View of the anoxic nitrogen treatment chamber in the central storage facility filled with objects from the Kunsthistorisches Museum Vienna.

The newly built anoxic nitrogen treatment chamber has a volume of ca. 100 m³ and is fed by its own nitrogen generator; the system's controls are fully automatic. During treatment (exposure time typically 5 weeks) the oxygen content of the chamber at a temperature of 26 °C and 50 %rH is reduced to 0.5 %. The reduction of the oxygen content from 20.9 % (oxygen content of ambient air) to 0.5 % takes about one week. If the nitrogen generator fails, a nitrogen cylinder bundle is automatically activated that maintains the low level of oxygen content in the air during the exposure phase. Should the amount of oxygen in the chamber increase above 0.9 % during this phase, the machine is automatically restarted. The surrounding rooms are also equipped with an oxygen warning system. If a leak in the machine causes the oxygen level in these rooms to fall below 19 %, the rooms are automatically flooded with air from the outside.

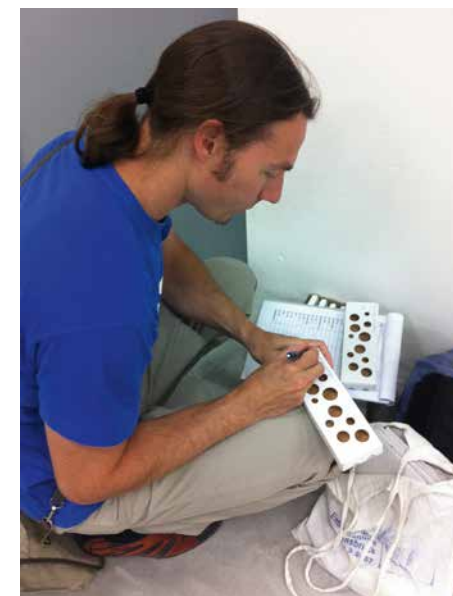
Fig. 75: The contractor of IPM, Dr. Pascal Querner, placing a pheromone trap in the central storage facility.

The IPM introduced in the old storage areas was continued in the new storage facility by Dr. Pascal Querner (fig. 75), assisted by Tanja Kimmel. She is the conservator responsible for all collections housed in the storage facility. The primary goal of the monitoring is to determine if the new storage facility is pest-free after the large influx of objects during the move in 2011. It also serves to identify early any presence of insect pests that may gain access to the building from outside through the gates in the delivery areas or the windows and emergency exits.

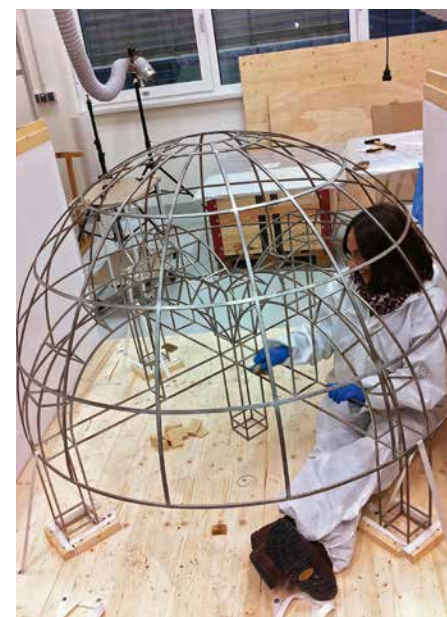
Fig. 78: Mould remediation of theatre models from the collection of the Theatre Museum.

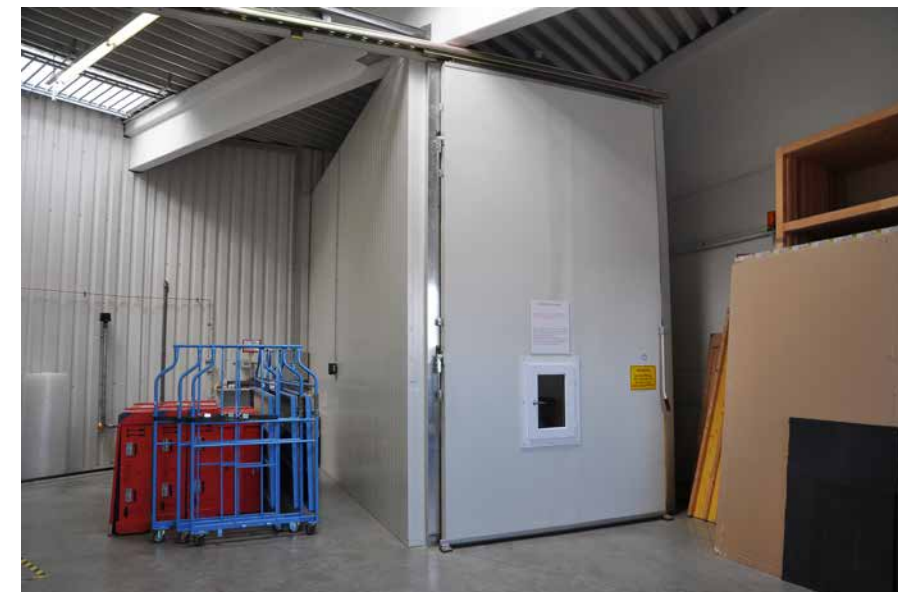
Fig. 1: First anoxic nitrogen treatment chamber in the KHM, which was continually in use from 1998 until 2011.

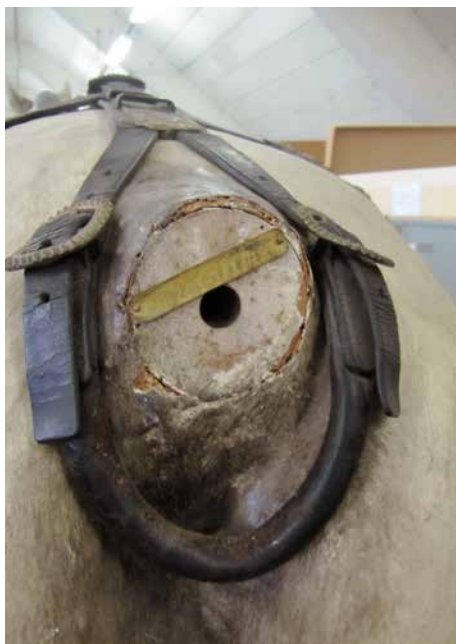
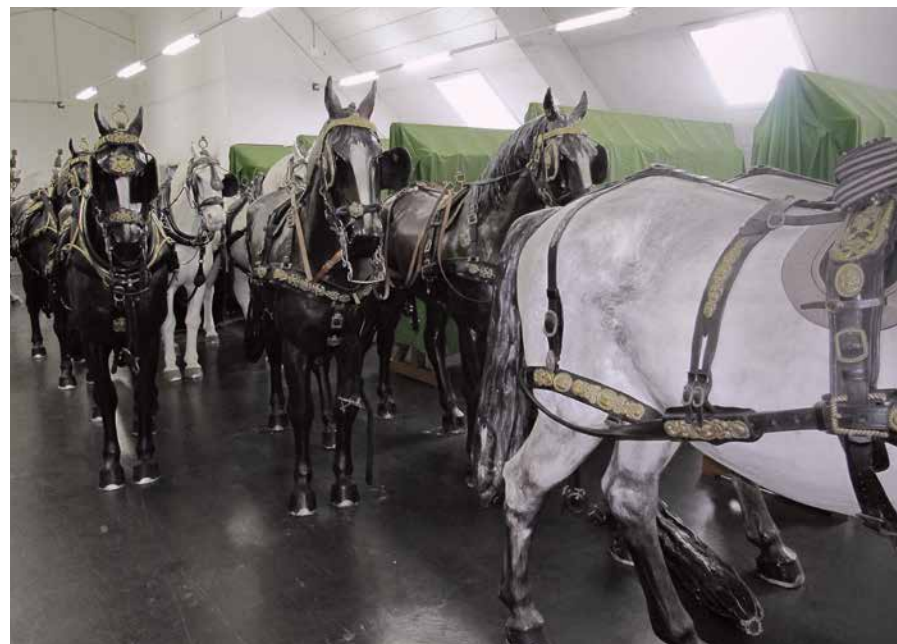
Objects (model horses) infested with biscuit beetles in the attic storage space for the Imperial Carriage Museum.

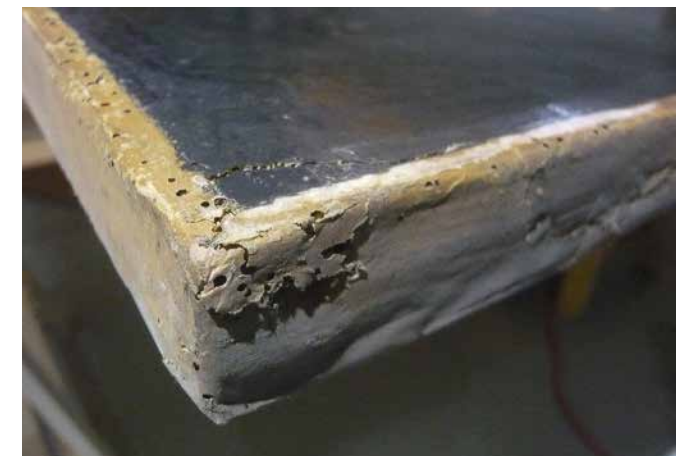
Fig. 3: Example of a painting infested with biscuit beetles.

The Kunsthistorisches Museum's Picture Gallery collection is comprised of ca. 8,000 historic paintings, only a small selection of which are exhibited in the main museum. The portion of the collection kept in storage has suffered from a repeated infestation of biscuit beetles *Stegobium paniceum*, which has led at times to marked damage to the paintings with starch paste linings (fig. 3).⁹ These paintings were fumigated with methyl bromide against pest infestation in 1993 and 1994, before the relocation of some of the paintings to the old storage area

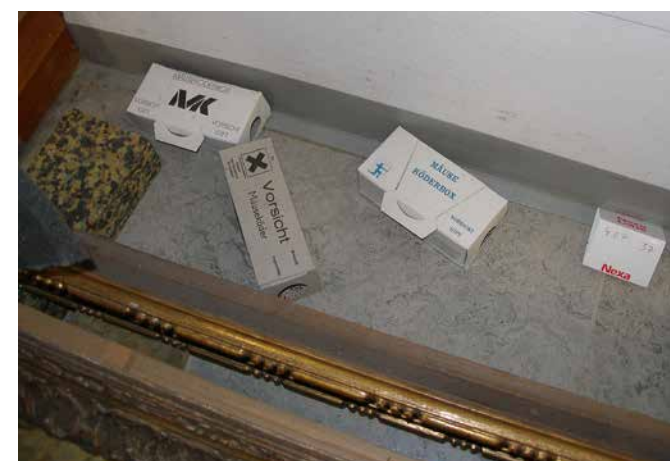
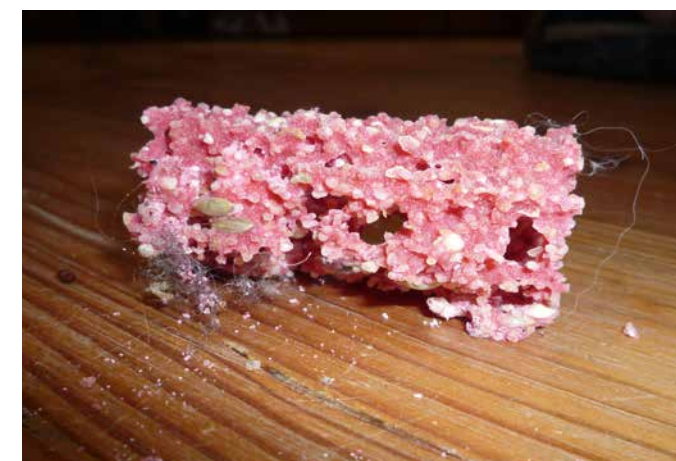
Old mice bait boxes and poison bait eaten by biscuit beetles.

Pest monitoring uncovered biscuit beetles not only in the former storage area, but in the conservation studio as well, where poison bait for mice served as a source of food for the insects (fig. 4). The baits had been put out by a pest controller, but were not regularly replaced. Removal of the old bait boxes improved the situation in both areas. All objects from the Picture Gallery that had been located in infested areas, however, had to be treated with nitrogen on-site in a tent before the move to the new storage facility.

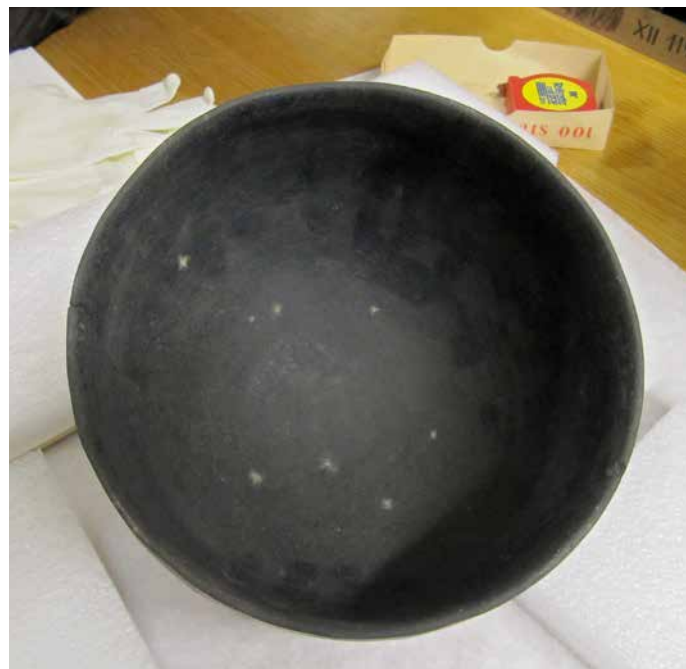
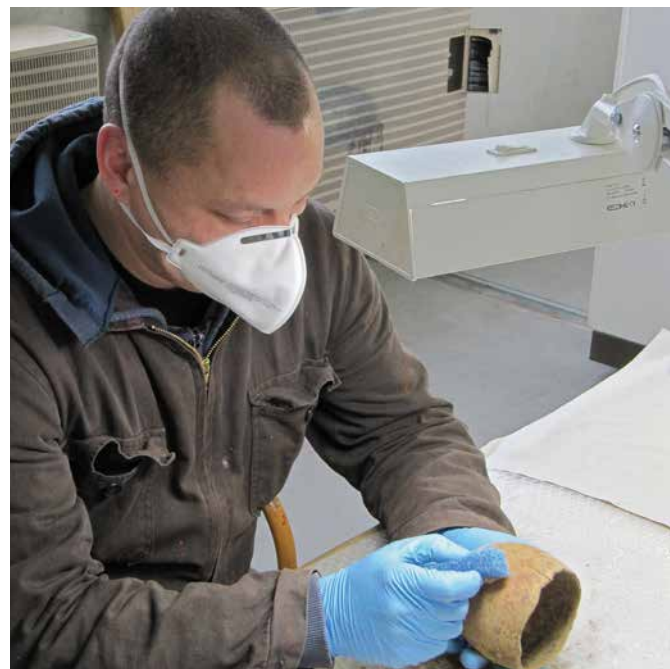
Fig. 7 a
Objects infested with microorganisms and mould remediation.

long-term climate conditions after cleaning.¹² Since October 2011, the cleaning and decontamination of mould-infested objects from the Theatre Museum and the Egyptian and Near Eastern Collection has been underway. The collections' conservators were working together with external colleagues. Until now about 6,300 objects (receptacles, groups of shards, and organic objects) from the Egyptian and Near Eastern Collection, 300 theatre models, 150 marionettes, and around 300 costumes and accessories from the Theatre Museum have been cleaned (fig. 7 b).

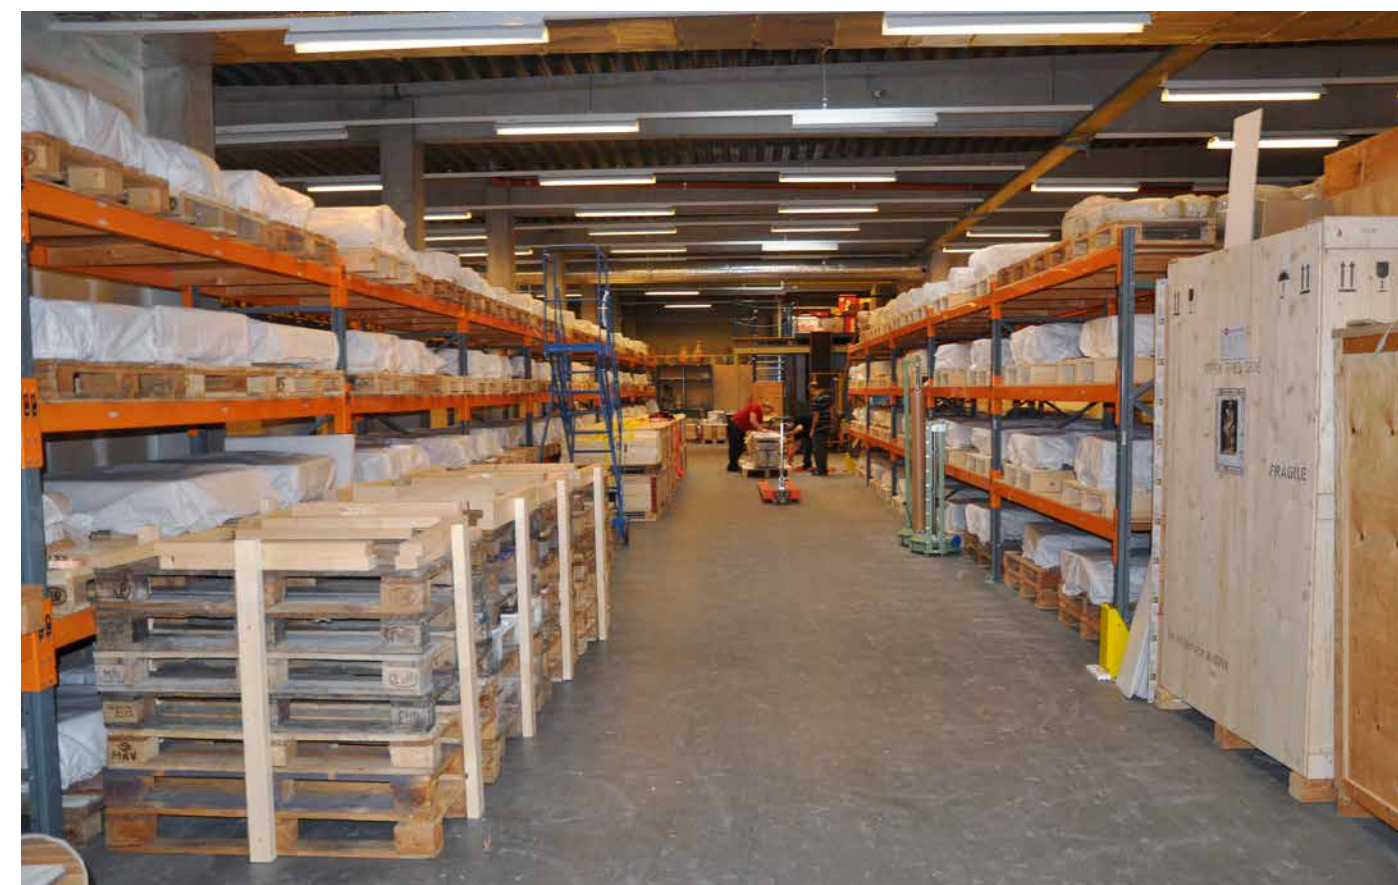
Fig. 8: Wooden pallets inspected for pest infestation in the storage area for the Collection of Greek and Roman Antiquities.

The 1,400 wooden pallets in the Collection of Greek and Roman Antiquities were, for example, only visually inspected in September of 2010 for wood-boring insects (fig. 8). Spaces next to and underneath the pallets were searched for exit holes and insect frass with the help of a flashlight. The inspections did not detect any signs of an old or active infestation of the wooden pallets in the shelving units on the floor and at eye level; the storage facility management also never discovered an infested wooden pallet in the past. It could be assumed, therefore, with great probability, that the wooden pallets were not infested. A recent contamination, however, would not necessarily have been detected: the incubation period of the larvae in the wood is several years. Since no infestation with pests was discovered in the storage area with the pallets during IPM, no treatment was carried out. Instead, pallets were replaced only when they were too old and potentially unstable. New and replacement pallets were heat-treated before use in the new storage area.

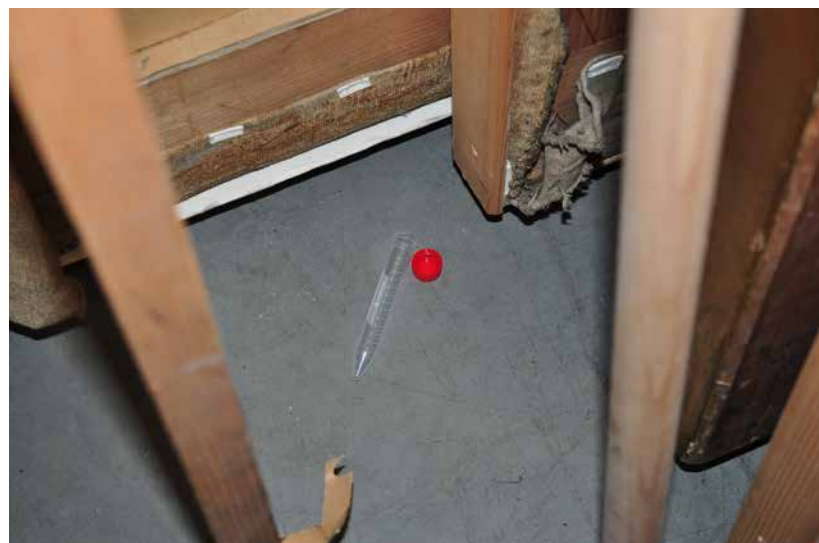
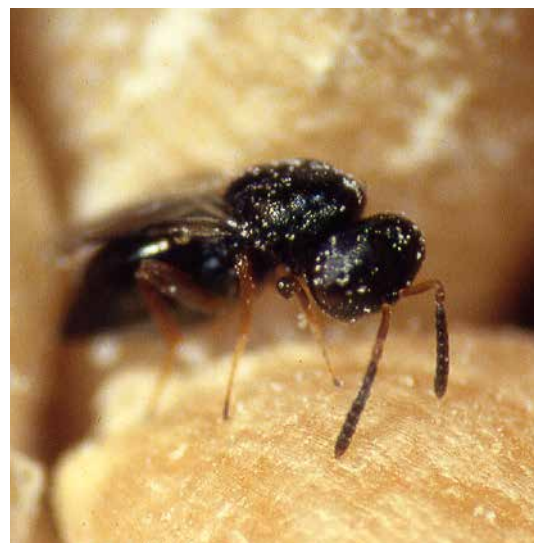
Release of parasitoid wasps (*Lariophagus distinguendus*) against biscuit beetles in the Picture Gallery storage area. (Fig. 9 b: © BiP, Biologische Beratung Ltd.)

The containment of the biscuit beetle infestation in the Picture Gallery's storage area was aided by a relatively new method. Parasitoid wasps (they are about 0.5 mm in size) were released in controlled distances near an infestation of biscuit beetles.¹³ The female wasp (*Lariophagus distinguendus*) lays its eggs on the larvae and pupae of the biscuit beetle, killing them in the process. In 2010, the wasps were released a total of three times in the three paintings storage areas (July, August, and September: *fig. 9*). This proved to be a useful, immediate measure to impede further damage until later anoxic treatment. Because the move was relatively far in the future (about 12 months after the discovery of the infestation), and due to inadequate information about the efficacy of this method in the literature,¹⁴ this measure was not considered sufficient to exterminate the biscuit beetles. The introduction of the parasitoid wasps in 2010 against the biscuit beetle in the Inzersdorf storage facility led clearly to the reduction of the infestation (*see table 1*), nevertheless, in 2011 a few living and dead beetles were found in the traps and on the track lighting in the ceiling. Whether these beetles originated from infested paintings or from the building could not be determined.

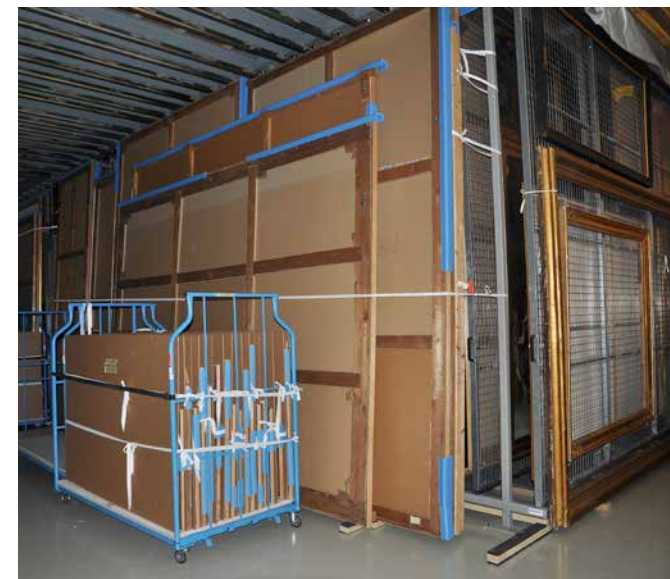
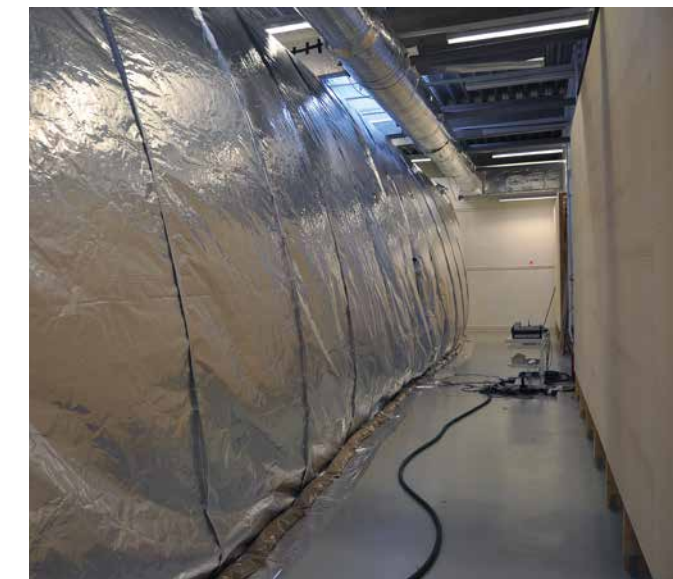
Anoxic nitrogen treatment in the storage facility in Inzersdorf, anoxia tent from the pest company (left: inside, right: outside).

The quantity of objects that needed to be treated from two collections was so high that three stationary tents in two locations had to be erected by an external company (Michael Singer GmbH & Co. KG). In the Inzersdorf storage facility, a ca. 1,000 m³ tent was set up (*fig. 10*) and used for two anoxic nitrogen treatment cycles of the paintings and decorative frames. The first treatment cycle in Inzersdorf was completed without incident. The second cycle as well as the treatment on-site the Imperial Carriage Museum had to be repeated, because a technical problem led to an increase of the residual oxygen content in the tent. In order to be sure that all pests in all stages of development had been killed, the treatment was correspondingly extended, maintaining a constant residual oxygen content of 0.4 % for 5 weeks (documentation of the necessary treatment period in the literature is contradictory because few studies have investigated all relevant museum pests and all relevant factors that have an influence on the efficacy of the treatment: temperature, relative humidity, residual oxygen content, and fumigation time). In order to prevent recontamination of the treated objects by biscuit beetles that had survived in the building envelope, a contact insecticide (active ingredient: cyfluthrin) was sprayed in all mortises and corners of the paintings storage area shortly before the opening of the nitrogen tent. In addition, a fogging fumigant (active ingredient: pyrethrin piperonyl butoxide) was released in the immediate vicinity of the tent so that the area above the tent could be disinfested.

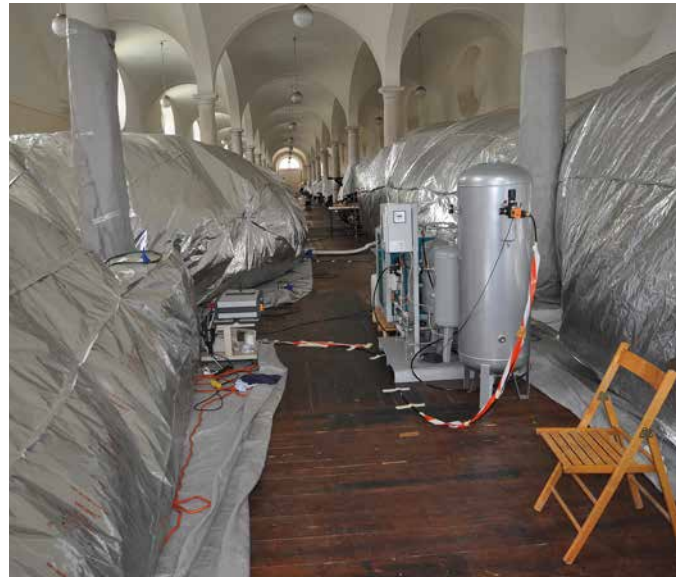
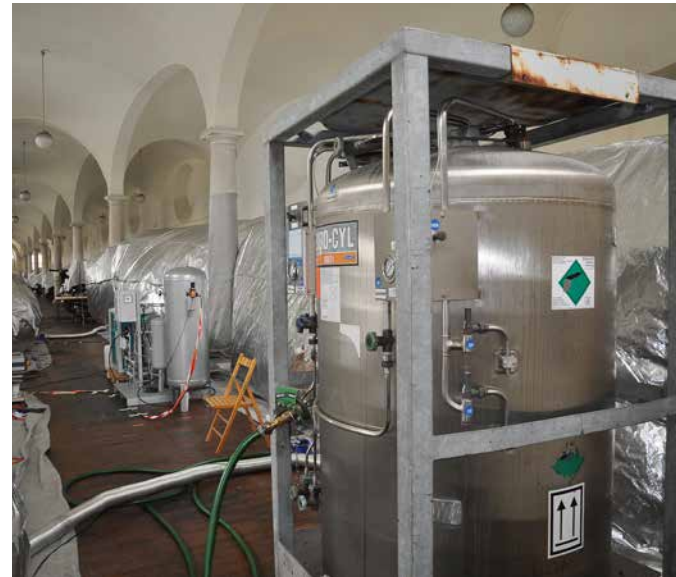
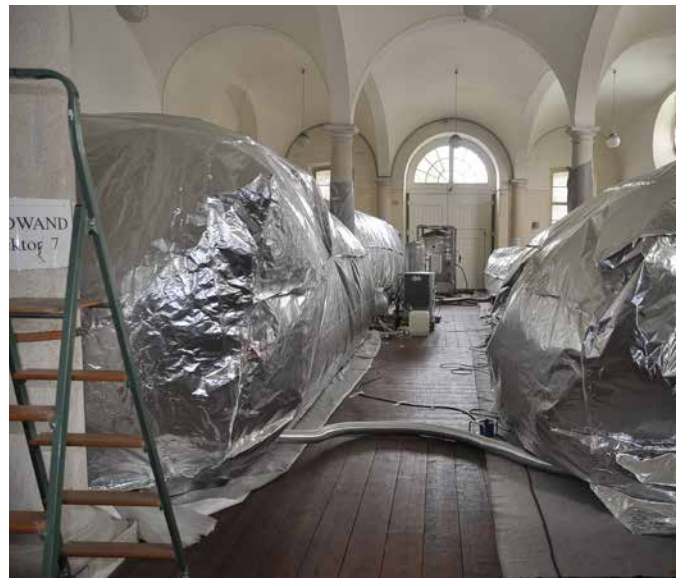
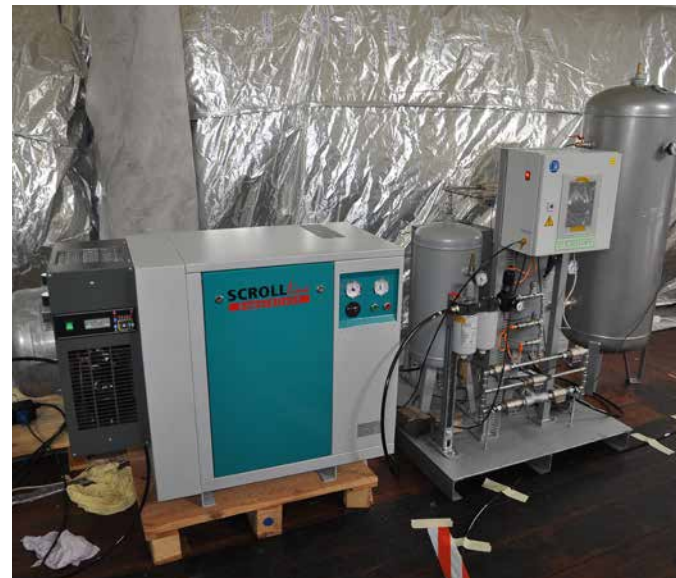
Anoxic nitrogen treatment in the Imperial Carriage Museum, anoxia tent from the pest company.

Two more large tents were built (together containing a volume of 100 m³) (*fig. 11*) in the English riding stable, a storage area for coaches from the Imperial Carriage Museum in Schönbrunn, where vehicles, furnishings, and exhibition mounts were treated. After successful treatment, all objects were immediately moved to the new storage facility in Himberg, in order to prevent re-infestation.

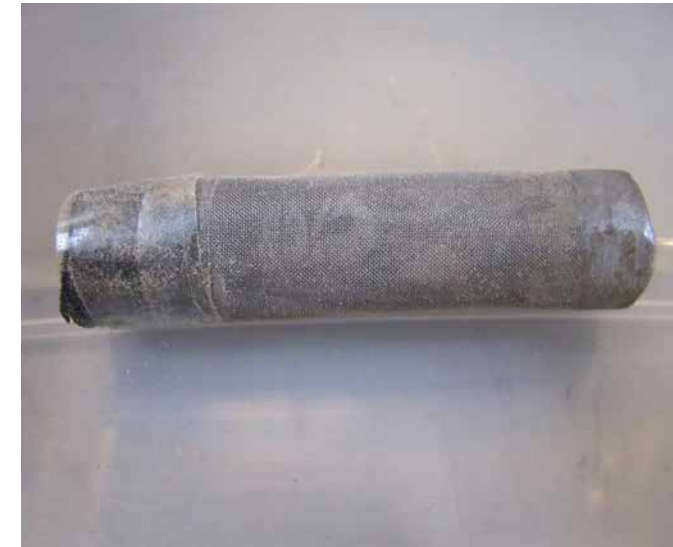
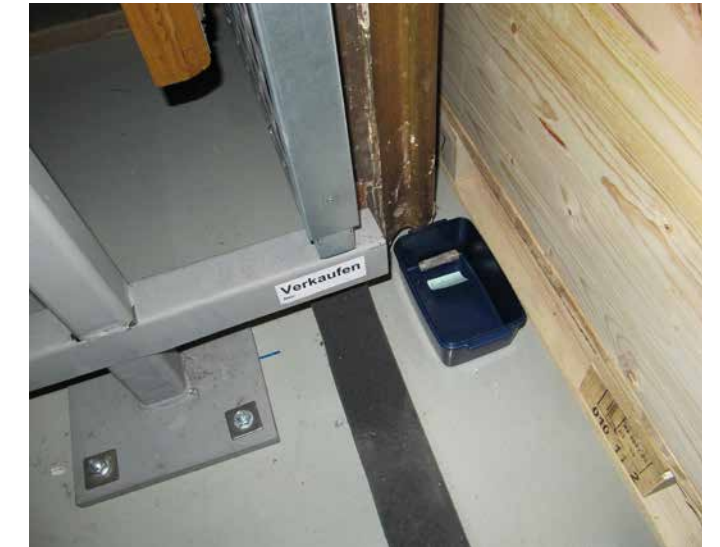
Samples with living biscuit beetles and placement of the reference set inside the tent for verifying successful treatment.

Along with constant monitoring of the residual oxygen levels during the entire treatment period, additional controls were used to confirm the efficacy of anoxic treatment with nitrogen: test insects (pests) were placed in the tent and checked after treatment (figs. 12 and 13). The pests found in the collection being treated (webbing clothes moths for the coaches from the Imperial Carriage Museum and biscuit beetles for the paintings) were used. In order to exclude other external factors possibly leading to the death of the insects, living pests were also kept in closed containers outside of the tent. Only when the insects in the treatment tents are dead and those outside of the tent are still alive, can the control of the treatment be considered successful. The external company also placed longhorn beetle larvae (*Hylotrupes bajulus*) in the nitrogen tent as a further control method for the treatment. The samples were inspected after the tents were opened and it was determined that the pests in the anoxic nitrogen tent were dead and those outside the tent had survived.

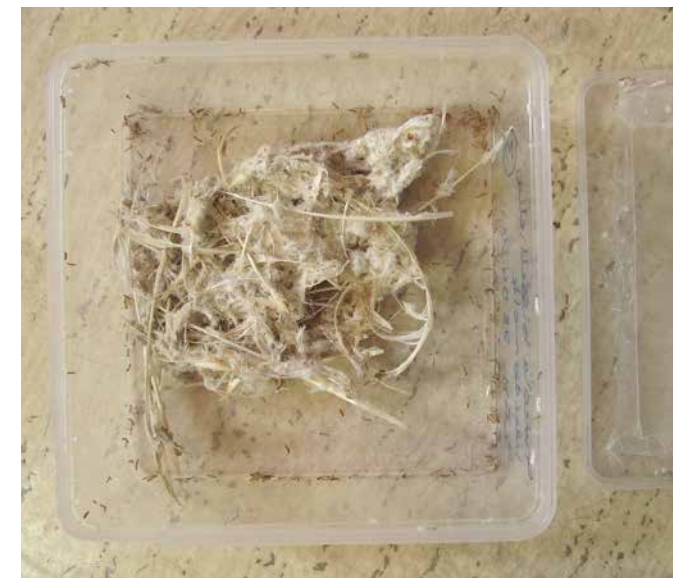
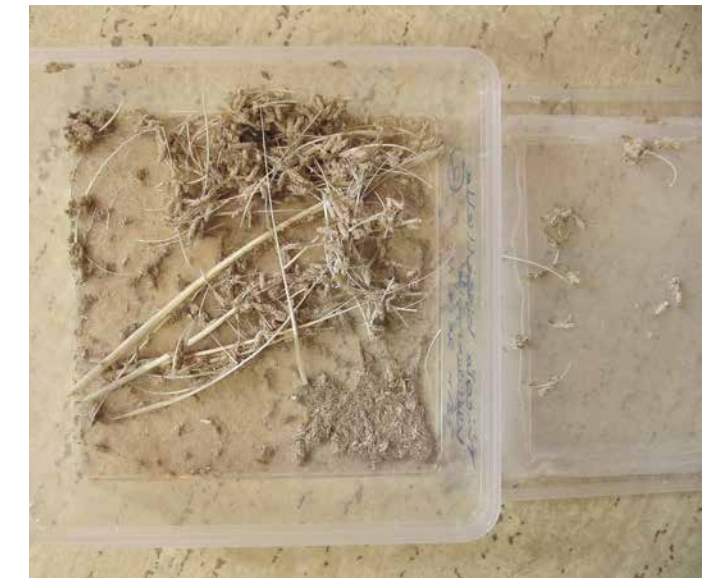
Samples with dead and living webbing clothing moths (inside and outside of the anoxic nitrogen tent) serving as reference test verifying successful treatment.

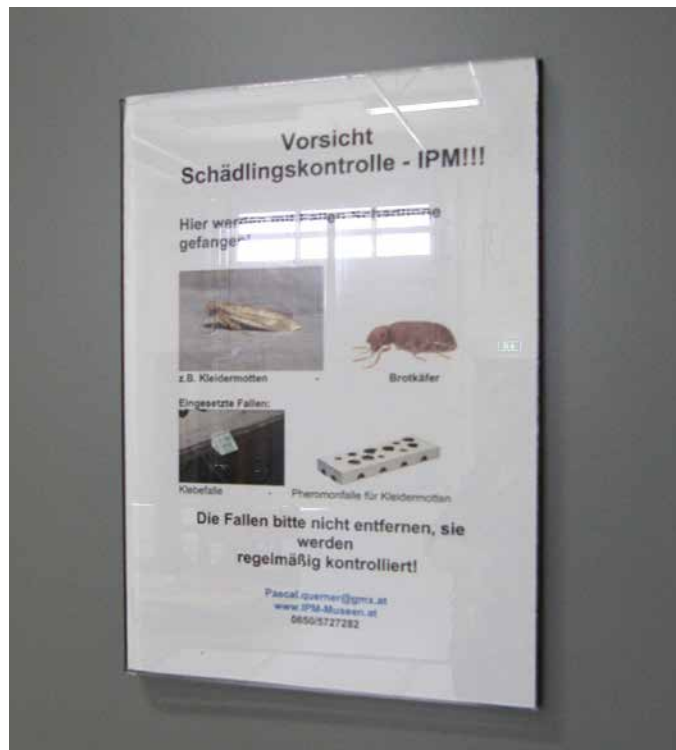
Fig. 14: Informational sign regarding traps in use and possible pests in the new storage facility.

In March 2012, after moving to the central storage facility, the monitoring system was set up again in order to confirm the efficacy of the IPM. The same traps as had been previously used were employed once again and checked five times during 2012. The trap locations were marked in the facility's floor plan, which is available for reference in the storage facility management office together with general information collected in an IPM folder. Furthermore, information signs indicating the traps in use and possible pests were installed at all of the entrances to the individual storage areas (fig. 14). The results of the monitoring showed that many collections are pest free and that the IPM has worked well. One area could not be included in the IPM and monitoring phase before the move because time was too limited. The emptying of the furniture storage facility in Korneuburg meant that the general storage area was relocated at very short notice. As a result, monitoring with traps and a corresponding cleaning of the furniture to be moved could not be conducted because of a lack of staffing and a shortage of time. As a consequence, numerous webbing clothes moths were caught in the general storage area in 2012 and this area had to be identified as a problem zone. Thorough cleaning of the already stored showcases and new incoming furniture in this area also solved this problem.

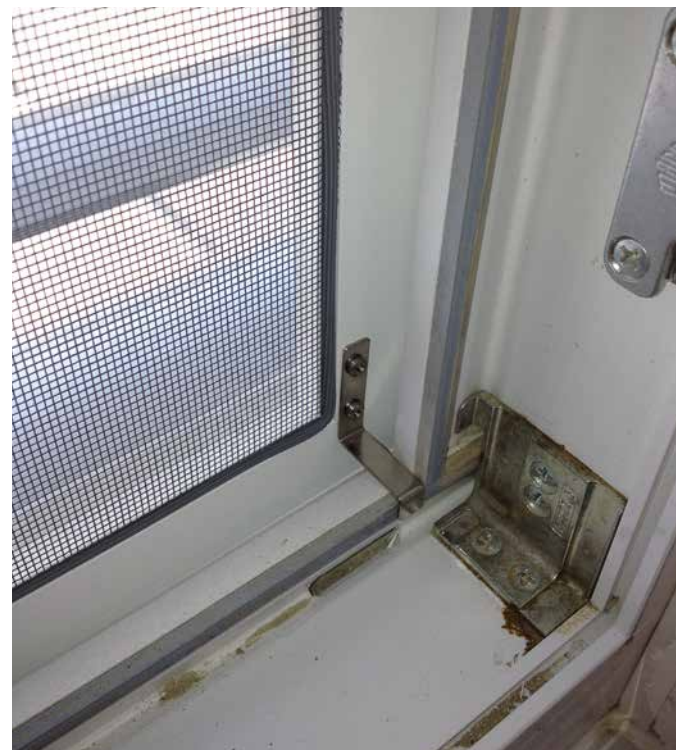
Fig. 15: Insect screens on the windows of the new storage facility.

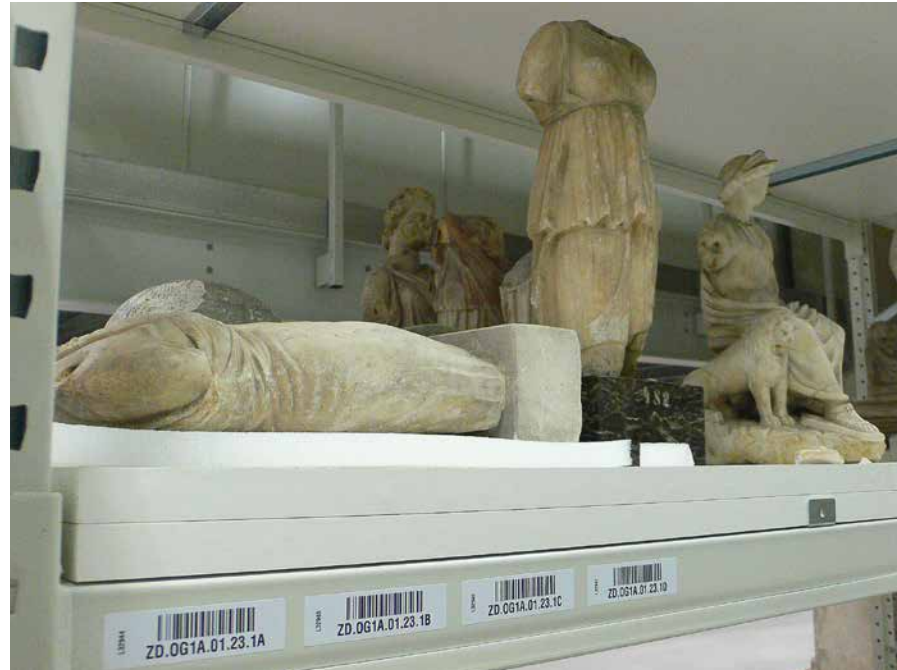
Fig. 1: Central storage facility, Himberg: shelving units for the Collection of Greek and Roman Antiquities with the barcodes for the adjacent shelves, here storage rack No. 23, section 1, shelf B.

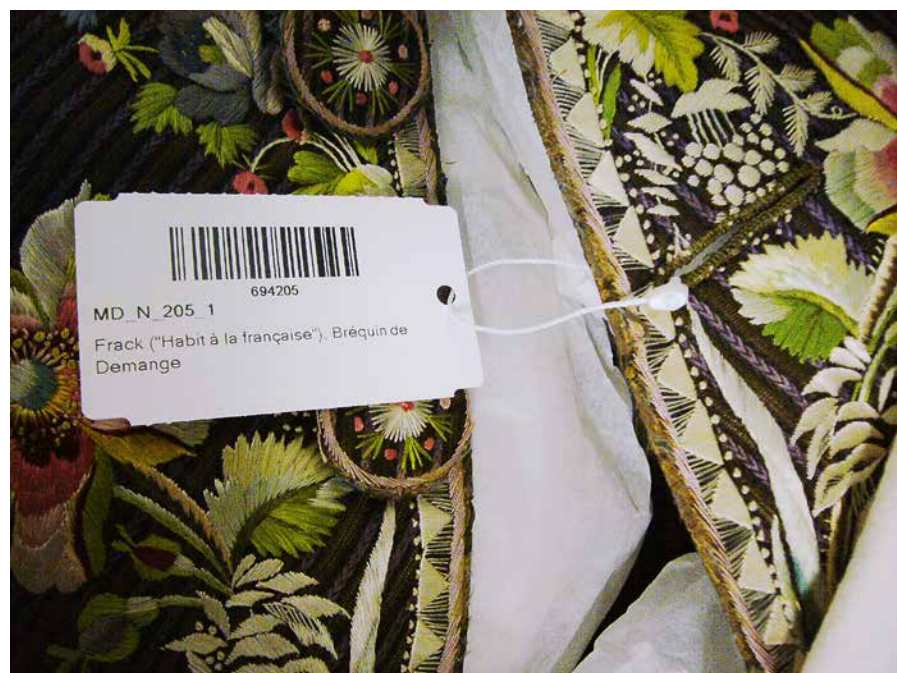
Fig. 2: Detail of a rococo tailcoat with its barcode label attached with a polypropylene security loop.

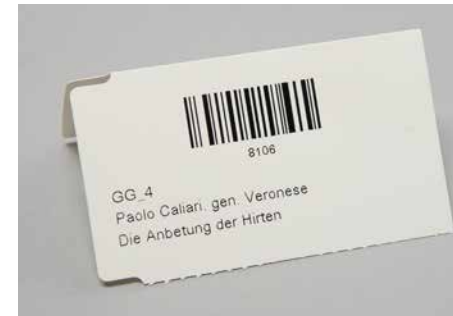
Fig. 3: Barcode label.

The inclusion of all relevant objects in the central object database TMS was an important preliminary step. The Conservation Science Department, together with the Conservation Workshops, had to find a material for the attachment of barcode labels that would not react with materials found in the collections, would not emit harmful substances, and that could not cause mechanical damage. Finally, a PE-based product was agreed upon with the dimensions 70 × 40 mm and with a pre-punched hole for attachment.

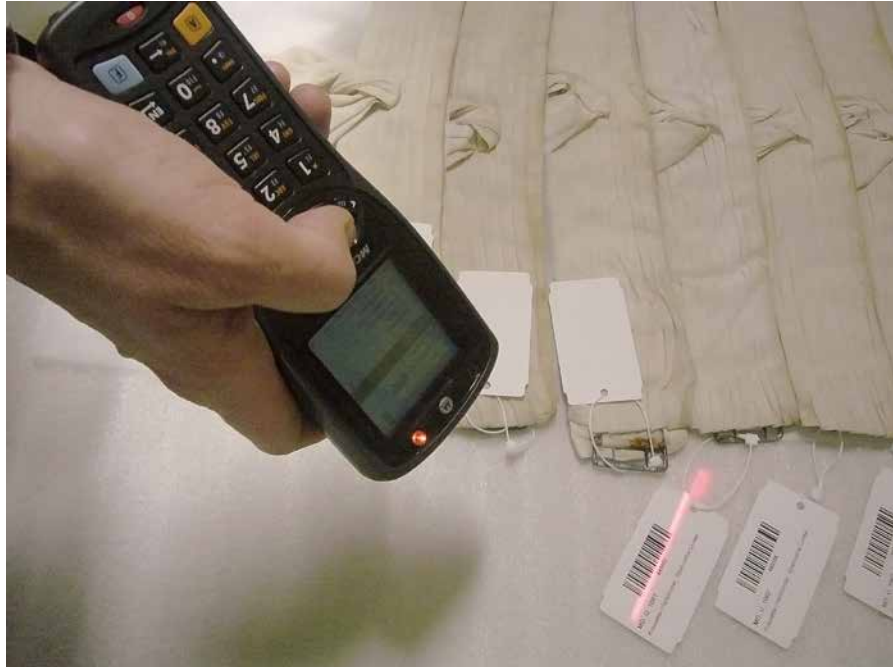
Fig. 4: Scanning a barcode with the laser scanner (Motorola MC 1000 Scanner) for location logging in TMS.

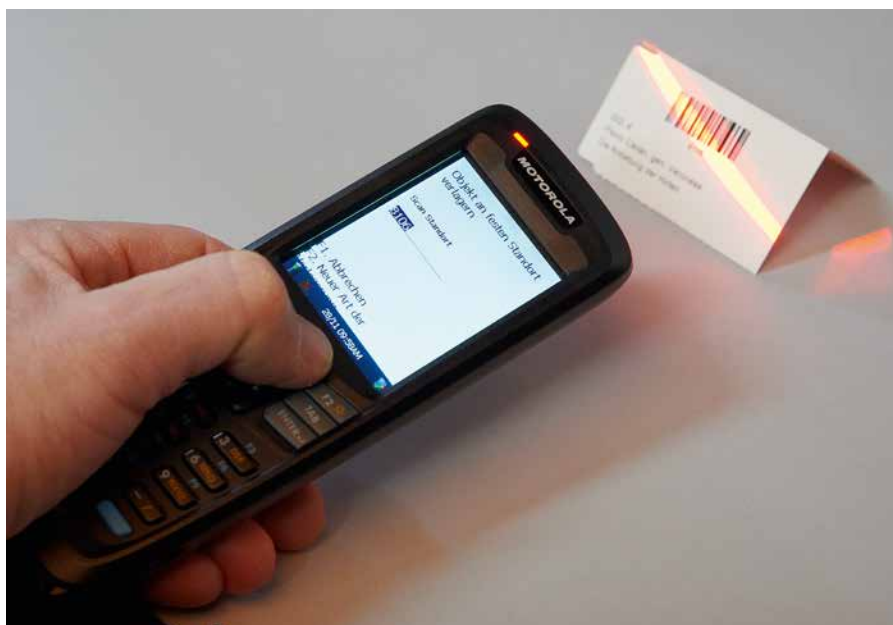
Fig. 5: A barcode label is scanned for the software “BarApp” with a laser scanner.

The software “BarApp” was developed to facilitate working in storage areas with hand-held scanners. At the outset, the identity of the person operating the scanner and their purpose is recorded. Then, whether a temporary move of the object is taking place, or whether it is going to its permanent location, is defined. Finally, the location information and afterwards all objects associated with it are recorded with the scanner (fig. 4). If a new location is encountered, it is scanned first and then the objects. At the end, the data, which are now saved in the scanner, are synchronised with the database. For this task, the database privileges are limited to staff members whose job responsibilities include registrarial duties for the collections. The software is designed such that, before synchronising the data, it can be reviewed again and any evident mistakes can be discarded (fig. 5).

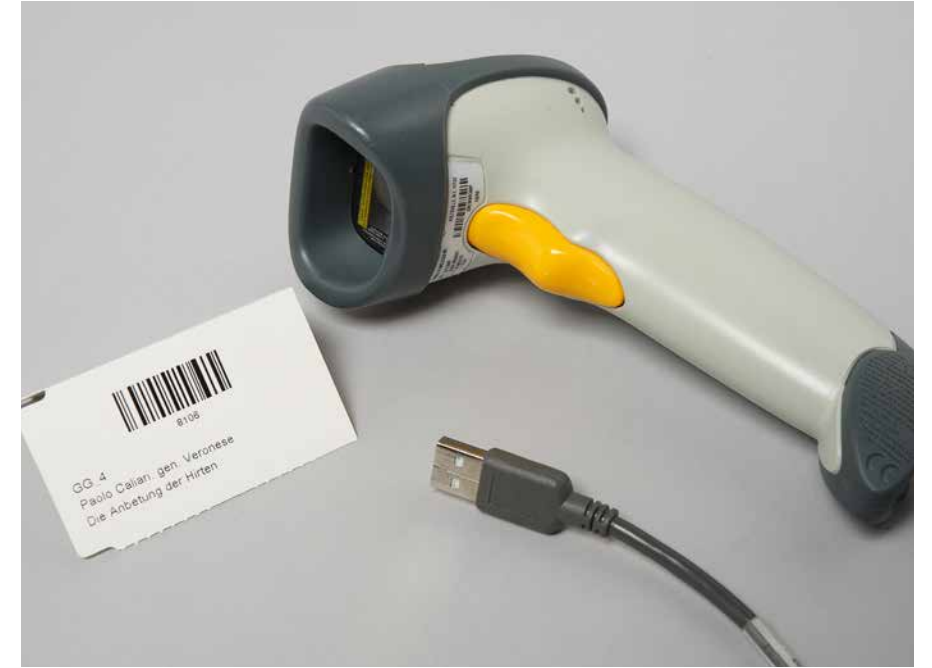
Fig. 6: Laser scanner with USB connection for the software “Move”.

“Move” is an alternative software design. In contrast to “BarApp,” however, a computer must be available in the immediate vicinity to use it because it must connect “live” to the database. The corresponding link between the computer and the server with the database must also be in place, as well as a scanner that can be connected to the computer either via cable or wirelessly. The initial data indicating the responsible staff member, the type and purpose of the move, is carried out as described above (fig. 6).

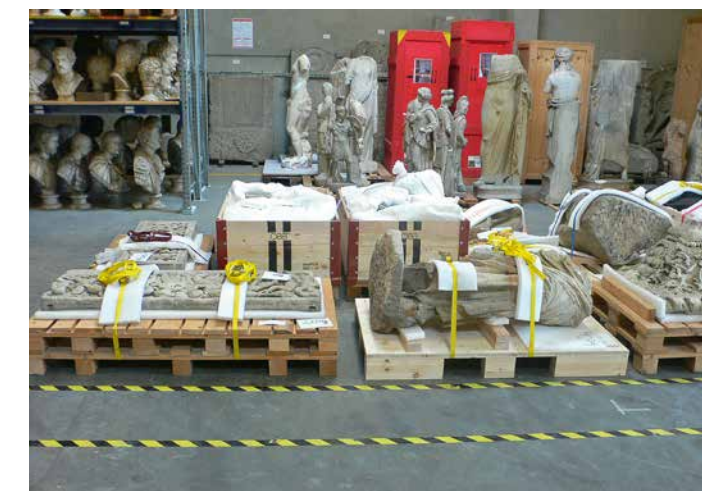
Fig. 3: Old shelving units for the busts and sculptures; in the foreground, pallets prepared for loading into the moving trucks.

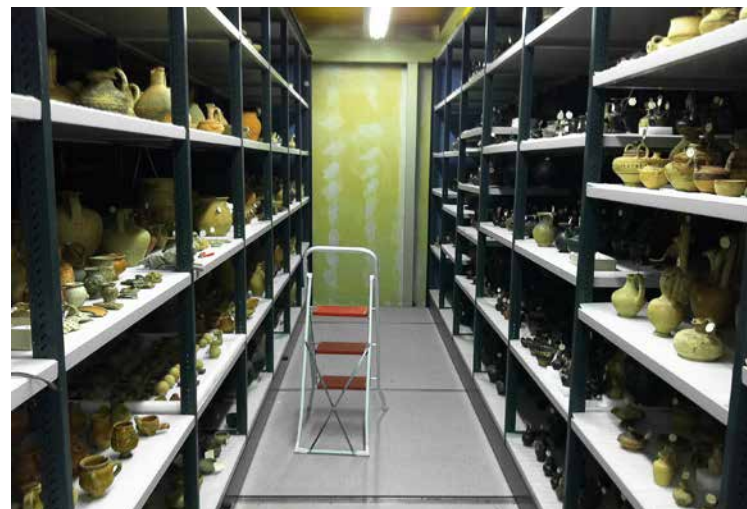
Fig. 7: Old rolling storage unit.

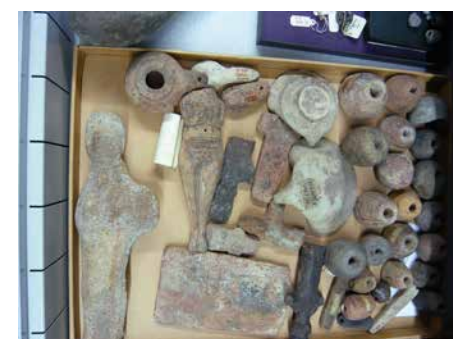
Fig. 12: Small finds loose in boxes.

As already mentioned, small finds, shards, and the like were stored loosely in drawers or boxes (fig. 12), at times next to or on top of one another. A month before the move was scheduled to begin, these small objects were separated and individually wrapped in tissue paper and placed in temporary transport containers (figs. 13 and 14). In most cases, the old storage containers were used and reinforced as necessary, or improvised boxes constructed from cardboard or Ethafoam were prepared with basic tools (hot glue guns or packing tape; fig. 15).

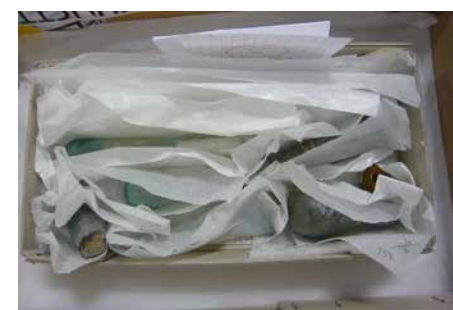
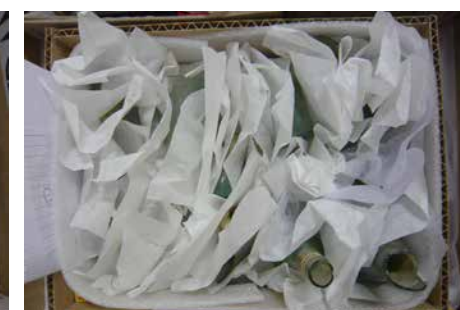
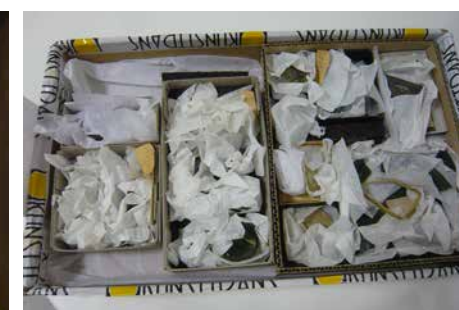
Glass objects packed in tissue paper (Fig. 14 a and b) as well as in tissue paper and transport box (Fig. 14 c).

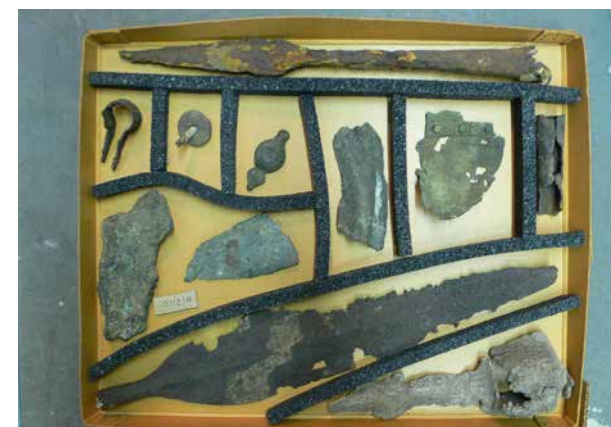
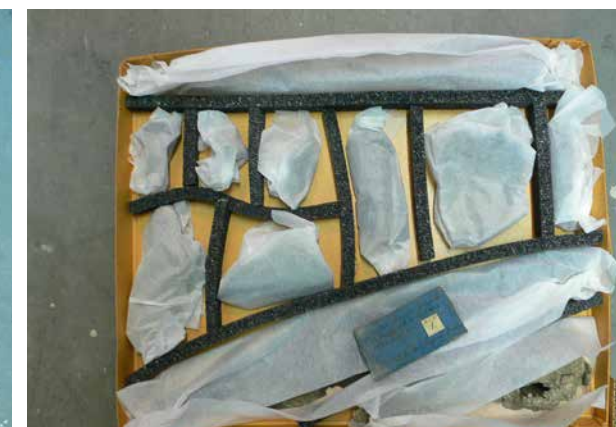
Metal finds separated by Ethafoam strips in an old box (left) and packed in tissue paper (right).

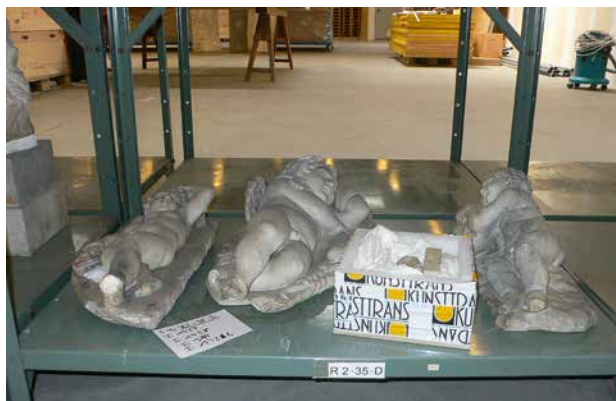
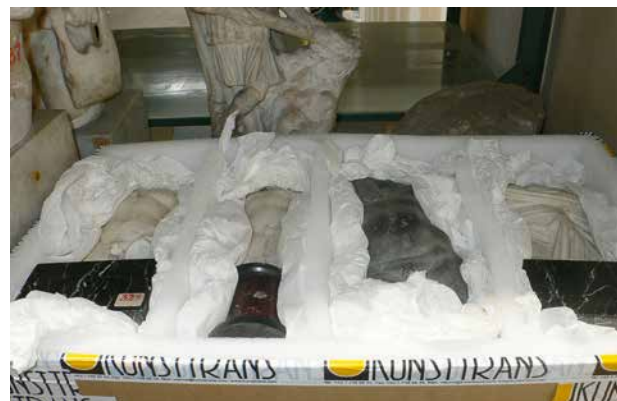
Fig. 16 a
Stone objects, small objects packed for transport.

Some of the small stone sculptures were also comprised of many fragments; small pieces were packed separately in boxes of differing sizes, reducing the amount of work immediately preceding transport (fig. 16).

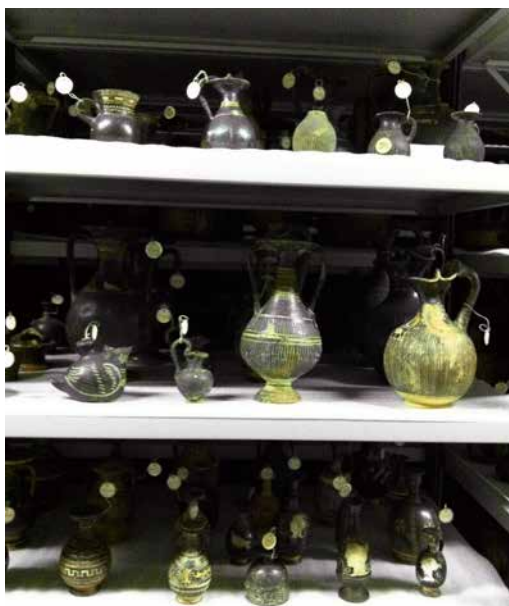
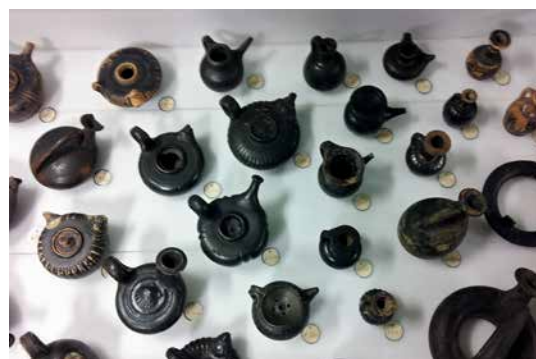
Fig. 17 a
Old inventory labels placed directly on, or later next to the objects, as seen in the drawer in the new central storage facility.

Inventory labels had been attached to a large part of the collection of vases; small, circular pieces of cardboard were attached to the objects with wire wrapped with thread. The wire was removed and the labels were placed next to the objects in the new storage system, where they proved to be very helpful for rapid identification of the objects (fig. 17).
