Technological Studies

Kunsthistorisches Museum Vienna

Special volume: Storage
Vienna, 2015

Technologische Studien Kunsthistorisches Museum.
Konservierung – Restaurierung – Forschung – Technologie,
Sonderband Depot, Band 9/10, Wien 2012/13

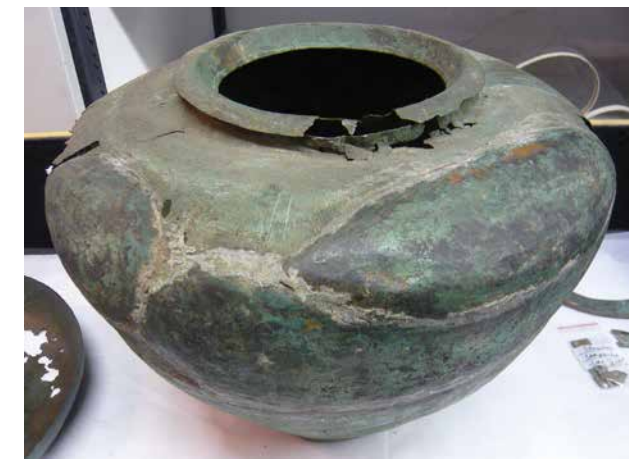
Fig. 19: Basin-shaped bronze urn with very fragile walls and an old repair.

Two teams consisting of two people each – a conservator and registrar or intern (archaeology student) – worked together with two teams made up of two employees from the moving company Kunststrans. Because there was limited space within the rolling storage unit for accessing the objects, the second team began working one day after the first, so that the same team could pack the objects one day and unpack them the next day in the new storage facility (fig. 18). The division of labour was clear: the conservators took care of the handling, dry cleaning and securing of the objects for transport. Condition photographs were taken of all objects where previous treatment was apparent, corrosion was visible, or that were particularly at risk during transport. At the time of packing, the registrars prepared the packing lists, in which the photographs were also documented in three condition categories (corrosion, recent repair, fragments) (figs. 19 to 21).

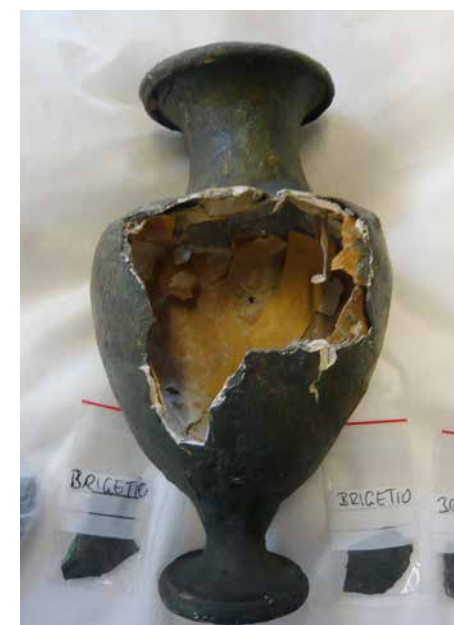
Fig. 20: Ceramic vessel from Brigetio with recent reinforcement and fragments.

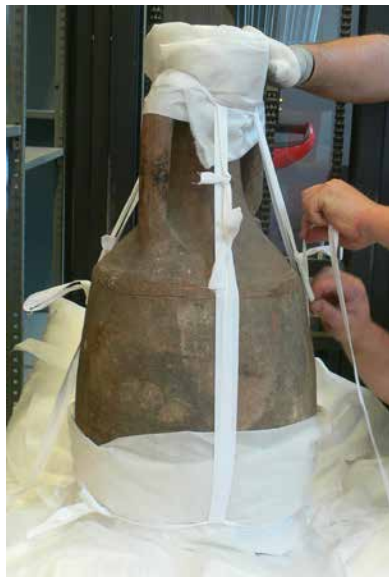
Fig. 22: Stabilising a Pithos for transport.

Packing of the objects for transport to the new storage facility became much easier after this preparatory work had been carried out, yet, some objects still required extra measures in order to secure them for the move (figs. 22 to 24). Large moving crates with up to three shelving inserts each were outfitted with PE cushions filled with styrofoam pellets. The stone objects, as well as the large amphorae, were placed in these crates and covered (figs. 25 and 26).

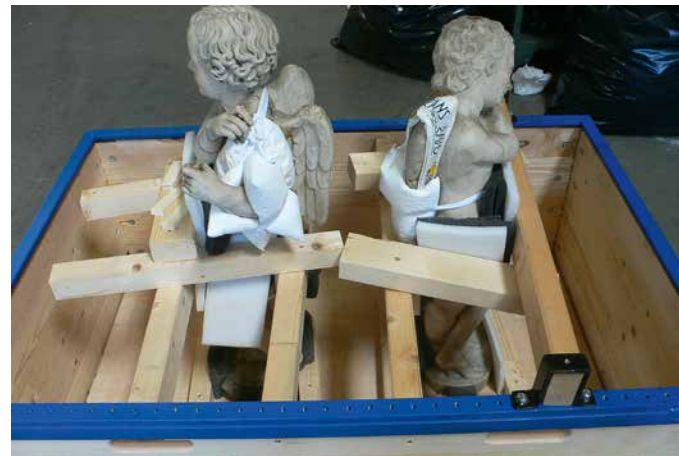
Fig. 23: Stabilisation of stone objects for transport in a pallet crate.

Wooden pallets provided with uniform, stackable wooden crates were another standardised solution. U-shaped mounting rails made by Markus Lenhart (KHM metalworking shop) were attached to the top edges of the wooden crates. Wooden braces stabilised with metal U-shaped clamps held the stone objects in place and were in turn secured to the rails with screws; internal screw threads built into the mounting rails allowed for easy loosening of the screws during unpacking in the new central storage facility (see fig. 23).

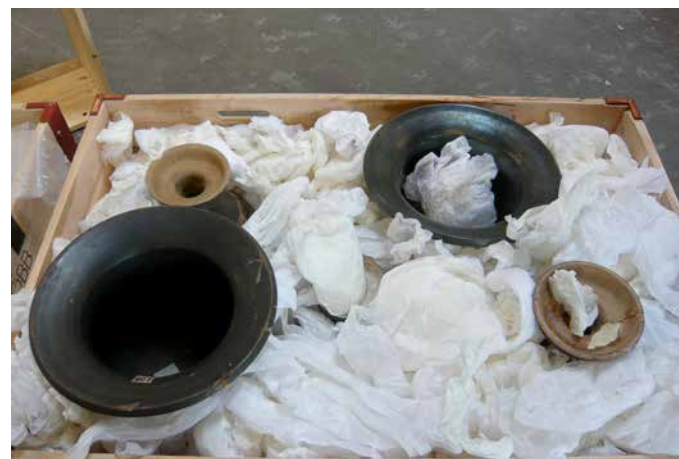
Fig. 25: Amphorae in a pallet crate.

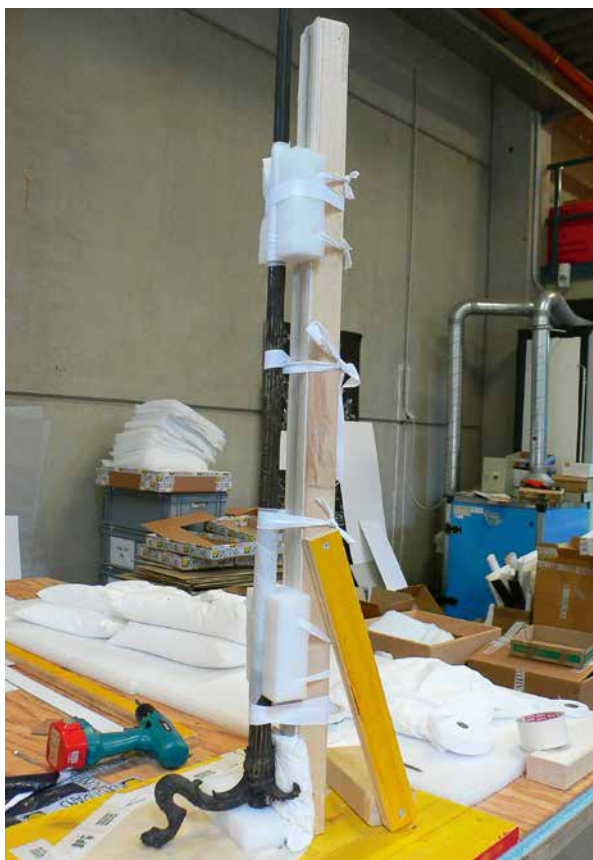
Fig. 24: Stabilisation of a metal object for transport.

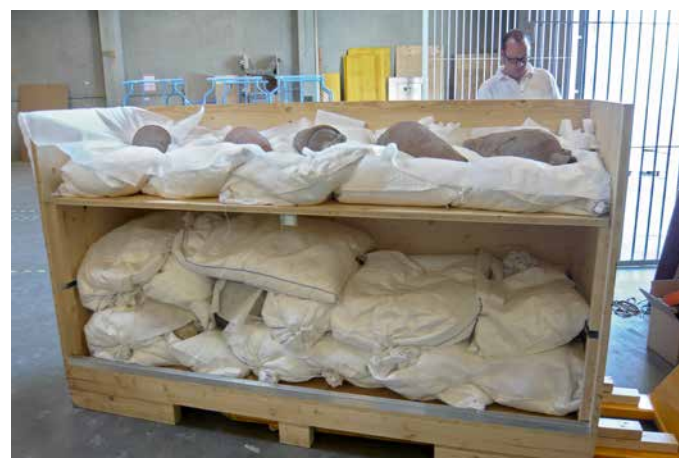
Fig. 26: Moving crate with insertable shelves.

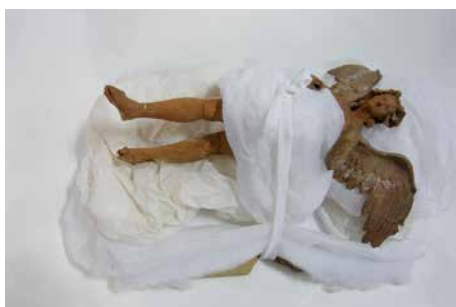
Fig. 27 a

Small objects were wrapped individually in tissue paper and were packed in transport or plastic boxes of varying sizes. Additional stabilisation was provided as needed, like for example, the addition of Ethafoam spacers or styrofoam filled cushions (fig. 27).

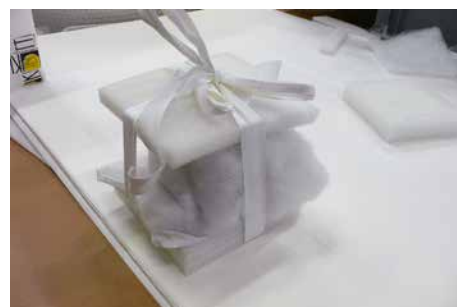
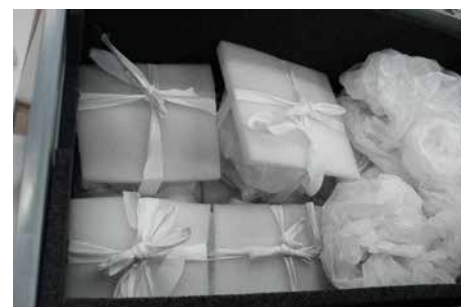
Stabilisation for transport (left) and packing for transport (middle) of a fragile ceramic; in the photograph on the right, stacked in a moving crate.

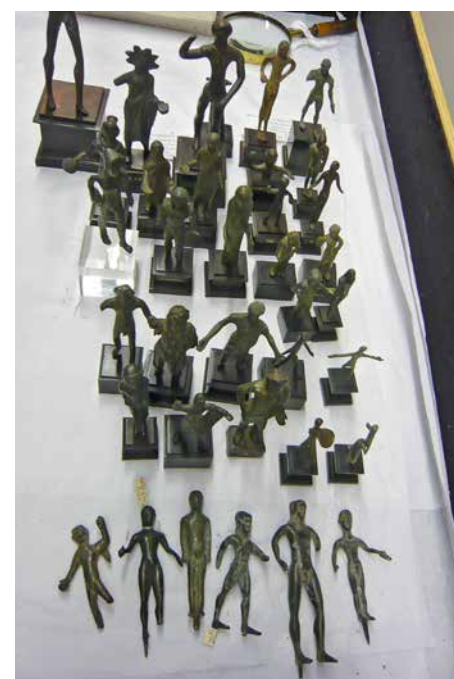
Fig. 30: After unpacking onto the trolley.

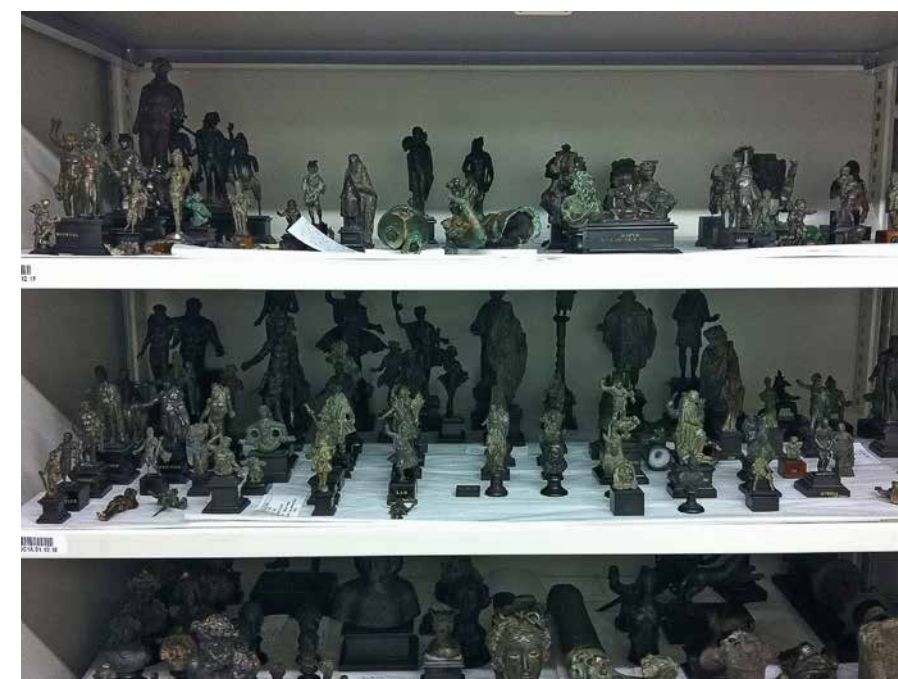
Fig. 31: Placement on the shelves.

If the objects previously had been placed close together in the shelving unit, as was the case for the bronze statuettes, the identical order was to be maintained in the new storage facility. The transfer of the original sequence was carried out in serpentine lines: the numbering system, beginning with one, started with the row closest to the frontmost edge of the shelf, snaking back and around until reaching the last row (figs. 28 to 30). In this way, the placement of every single object could be maintained throughout the process: from shelf to packing table and inside the packed box. Placement in the moving boxes began with the last number so that when unpacked, the numbering could simply be followed from one until the end, placing the objects again in the same order in the new shelving units (fig. 31).

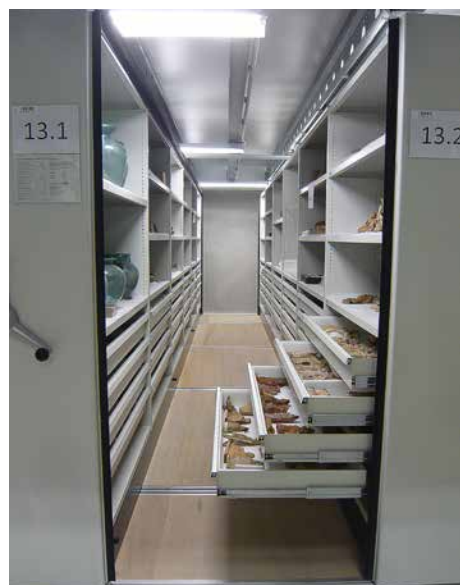
Fig. 32: Rolling shelving units with drawers.

The project director prepared the location plan for the 14,000 objects stored in 13 rolling shelving units and nine metal cabinets. The distribution in the drawers and on the shelves was decided, however, at the time of unpacking according to the space available. In this way, the shelves could be quickly loaded (figs. 32 to 34).

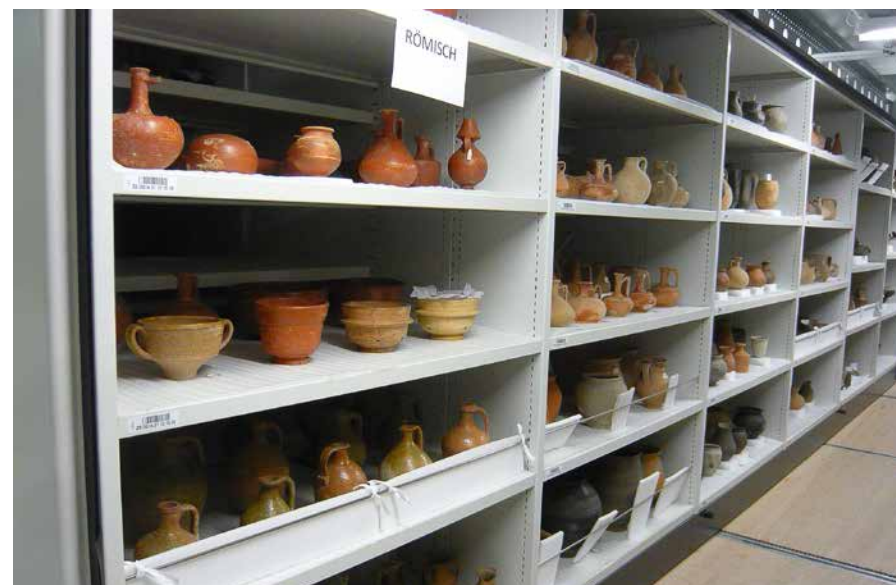
Fig. 33: Rolling shelving units with unpacked objects.

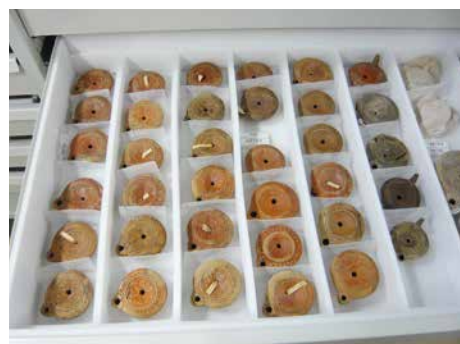
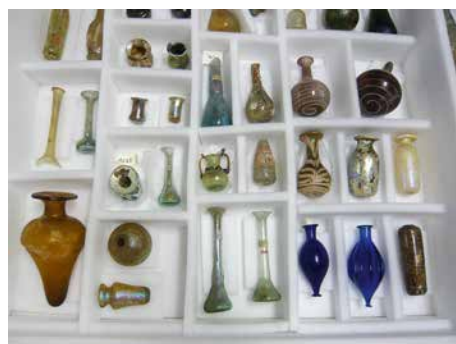
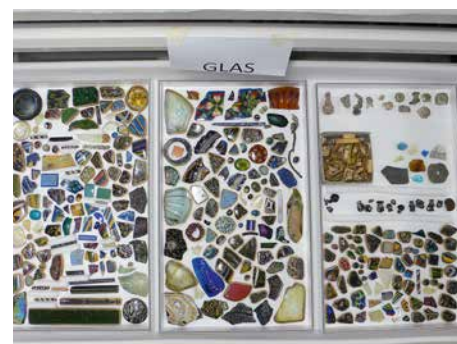
Fig. 34 a
Drawers with lamps (left), ointment jars (middle) and glass fragments (right).

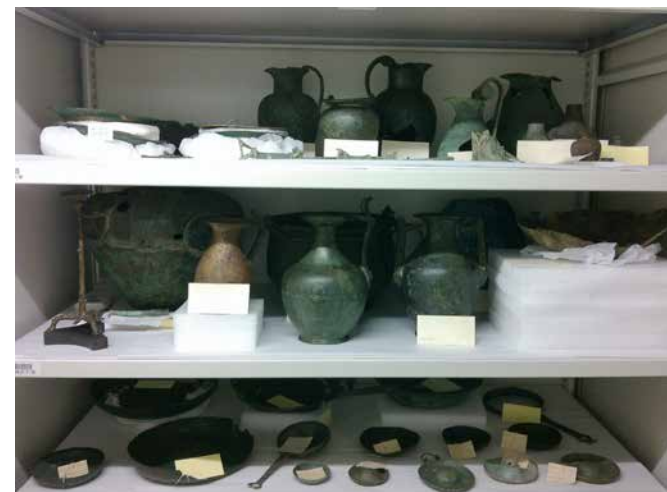
Fig. 35: Unstable objects with Ethafoam supports.

Unstable objects were outfitted with customised Ethafoam supports. Objects on the shelves of the rolling storage units can be additionally protected with an adjustable guard rail (figs. 35 and 36).

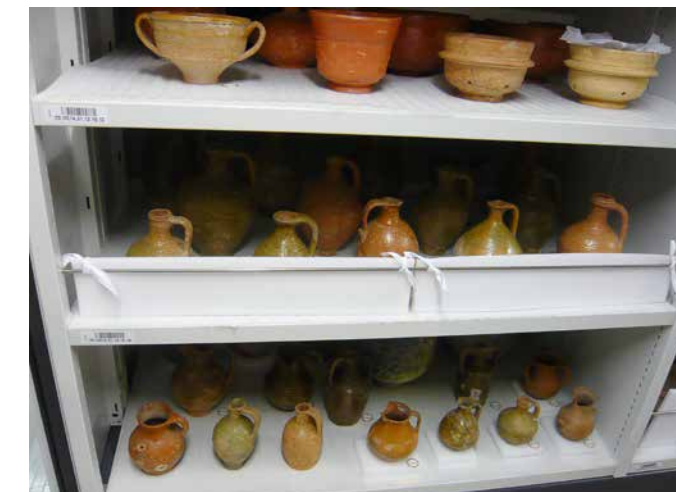
Fig. 36: Adjustable guard rail additionally secured with Ethafoam strips.

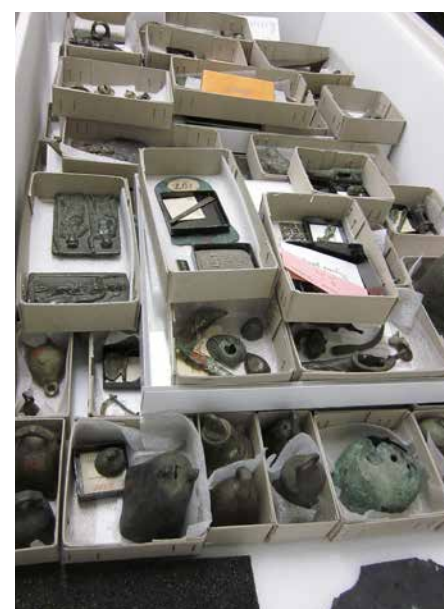
Fig. 37: Metal objects in the old storage boxes.

During relocation, the packing materials and old storage boxes were temporarily stored on the shelves and in the drawers. The rehousing of metal objects with new, acid-free archival cardboard boxes in five standard sizes was prioritised, and eventually all of the old boxes used during the move of the small objects were replaced (figs. 37 and 38).

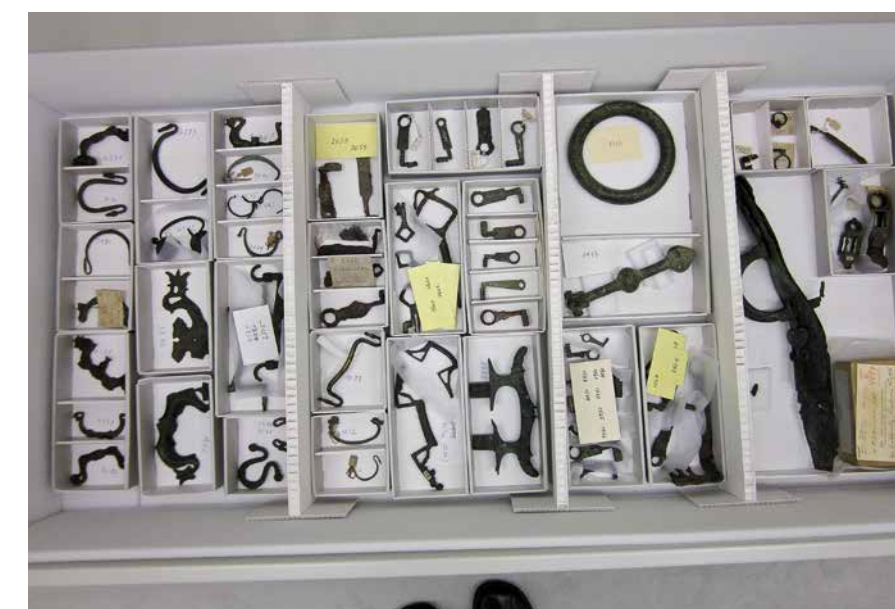
Fig. 38: Drawer with metal objects placed in archival boxes.

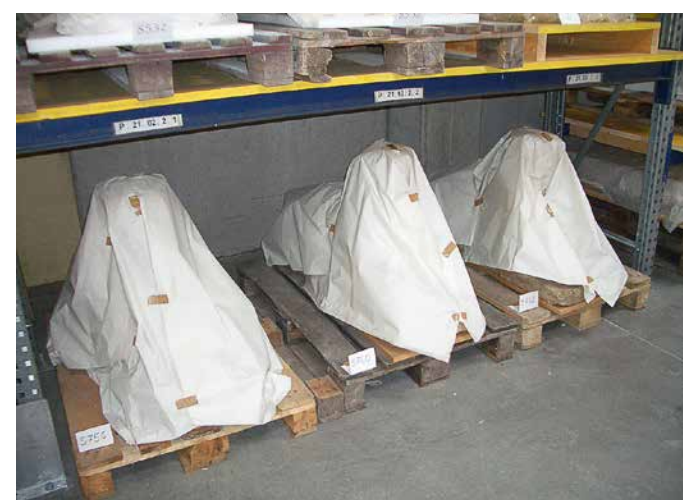
Fig. 39: Covered sphinxes placed on old, deteriorated pallets.

With the help of inventory lists, the location of the entire collection and its readiness for transport could be determined. This information was updated on a case-by-case basis. Many of the Euro-pallets were in a deteriorated state due to their age (figs. 39 and 40); others were too small, making handling and transport a risk. As a result, new customised pallets were produced that were somewhat larger than the objects, reducing the danger of mechanical damage occurring during transport (fig. 41). The dimensions of every pallet were measured and documented in an Excel list. The goal was not only to calculate the number of customised pallets that needed to be ordered, but also to consider the distribution of the objects taking into account their size and weight. Since I alone had to record all of this information and enter it into the Excel list, this task required a lot of time in addition to the work of transferring the artworks to the new pallets. It provided, however, an important basis for further planning and procedures. The new, very stable customised wooden pallets were made in-house by Kurt Schopfhauser and Alfred Schodl (carpentry workshop, KHM).

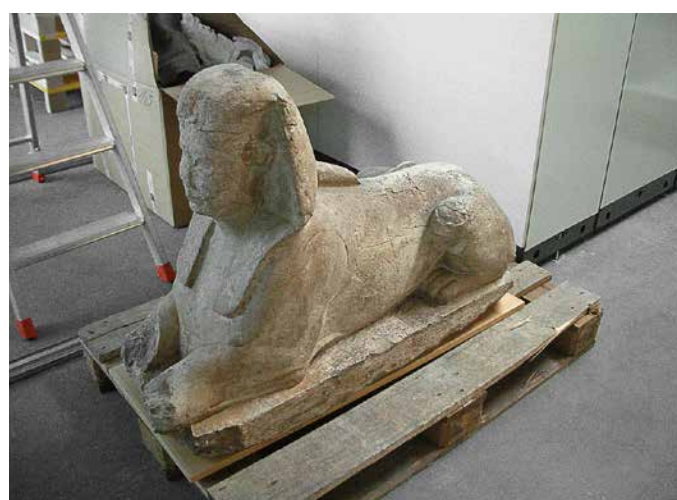
Fig. 40: A sphinx on a damaged pallet.

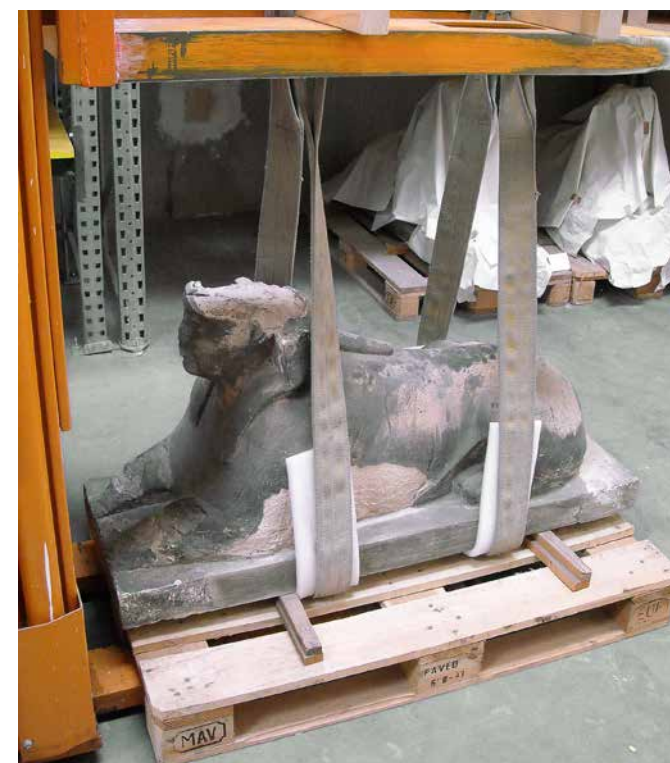
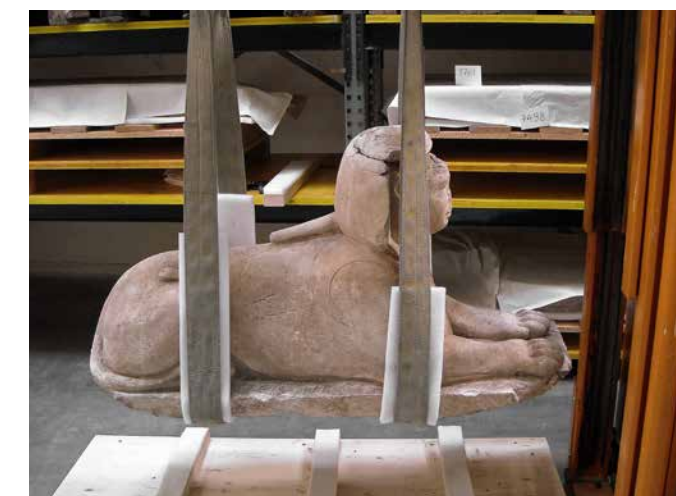
Fig. 41 a
Transfer of a sphinx to a new custom-made pallet.

The decision to make the new pallets out of wood was important: as a result, the pallets had to be heat-treated according to international standards as provided in the ISPM 15 guidelines.¹ During heat treatment, the wood is heated to a core temperature of 56 °C for at least 30 minutes, which prevents the introduction of harmful organisms.² Heat treatment has the additional advantage of drying out the wood, leaving only 20 % residual moisture, thereby greatly reducing the probability of the wood warping when stored under good conditions. Every delivery of pallets had to be carefully inspected because most manufacturing plants are located outside of Austria; one can never be sure that the storage conditions at the point of production or during transport were clean. Pallets made from synthetic materials were not considered because the plasticisers can damage objects during long-term storage, and adequate compressive strength for heavy objects cannot be guaranteed.

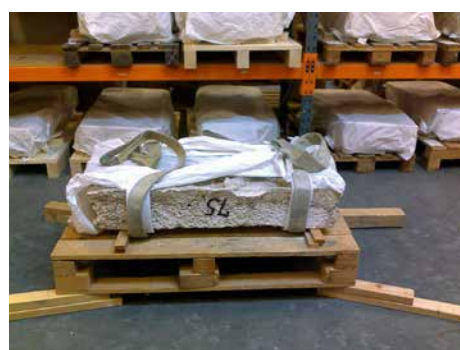
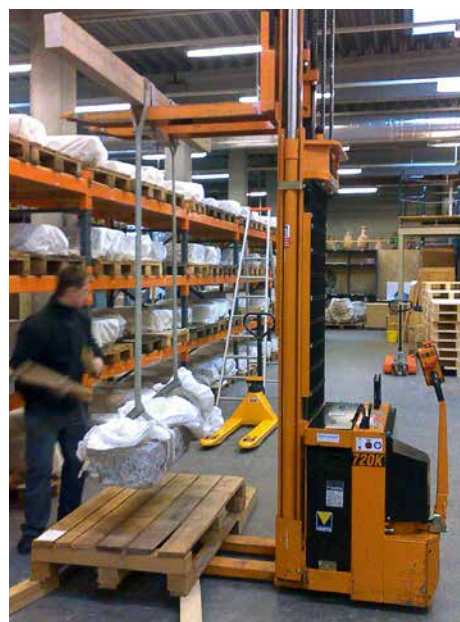
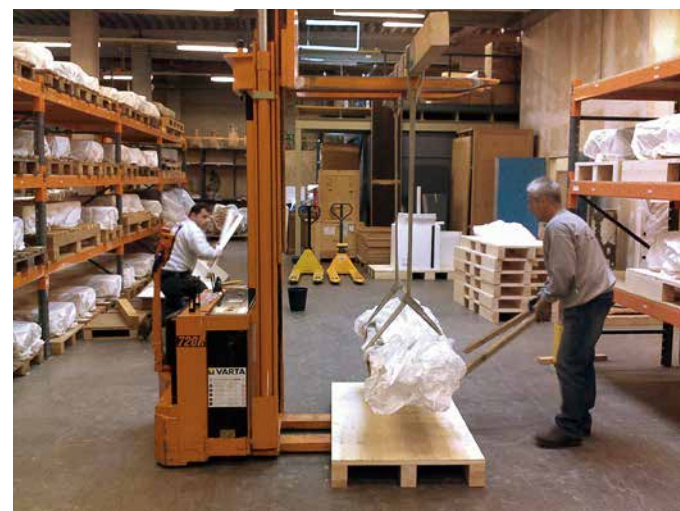
Removal of a stone relief block from an old pallet and transfer to a new, customised pallet.

Up until this time, many of the stone relief blocks were stored directly on thin, mostly unplanned wooden planks with insufficient distance between the stone and the wooden pallets. Going forward, five cm thick wooden boards placed on the pallet provide adequate air circulation and enable easier placement of the Ethafoam lined hoisting sling; the Ethafoam provides extra protection of the object's surface. Before lifting, each object had to be inspected for capillary cracks, which determined the placement of the sling. The objects could not be approached from the side with the forklift because the pallet supports run longitudinally to the ground. As a result, each pallet had to be propped up on wooden blocks (fig. 42).

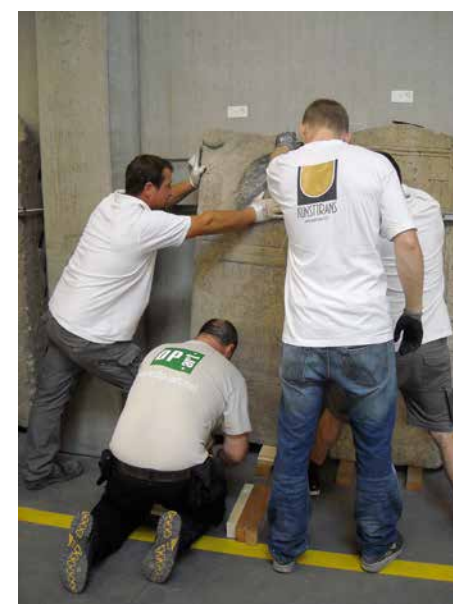
Fig. 44: Removal of tombstones from the wall.

Detailed workflow: loosening of the wall mount and placement of the lower, narrow side on wooden blocks the same height as the Euro-pallet (fig. 44). Very heavy or deteriorated stones had to be lifted with a lifting device and straps.

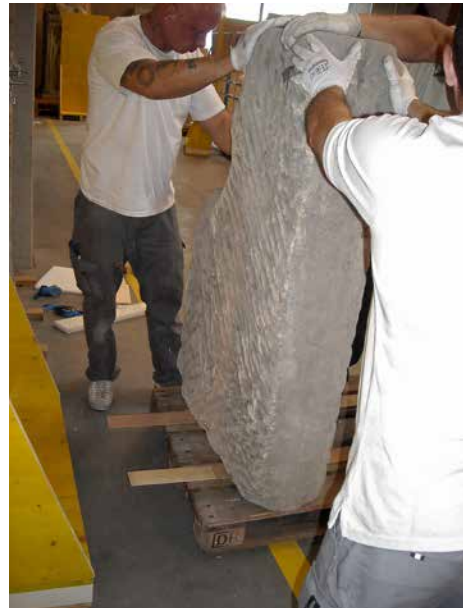
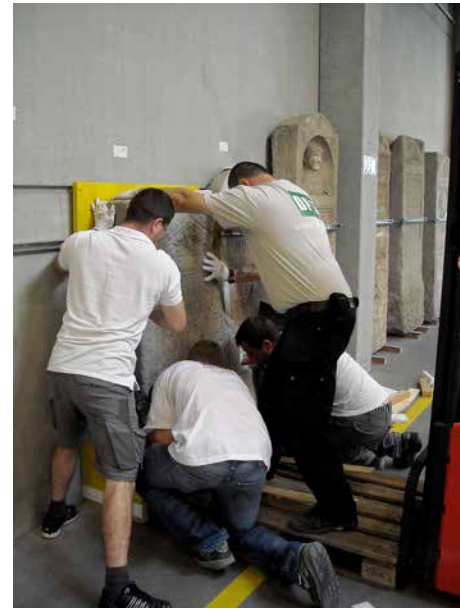
Fig. 45 a
Sliding the tombstones onto the “wooden shoe” construction by means of soaped boards.

Placement of soaped boards and sliding of the stone onto an awaiting pallet. Thin, planed hardwood boards were coated on one side with soap. In order to slide the stone, the coated sides had to lie on top of one another. In this way, even very heavy objects could be moved without a problem (figs. 45 and 46).

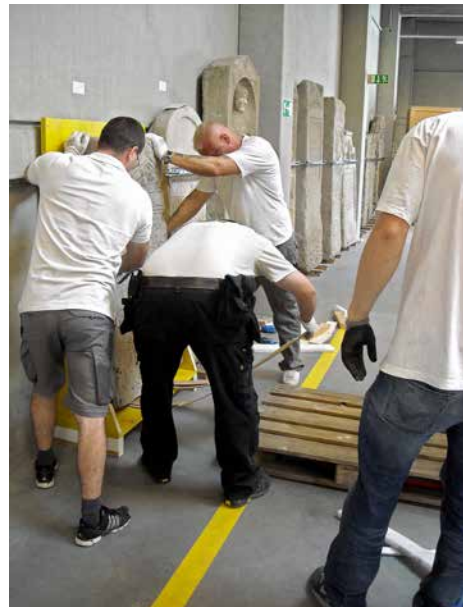
Fig. 46: Removal of the soaped boards.

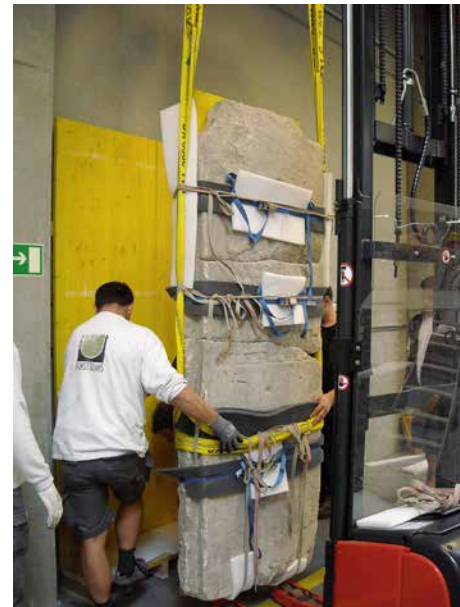
Fig. 47: Positioning and lowering of the tombstone into the “wooden shoe” construction.

Positioning of the “wooden shoe” construction along the back side of the stone and sliding it into the “wooden shoe”. With the help of lifting devices, the stones could be directly placed into the “wooden shoe” (fig. 47).

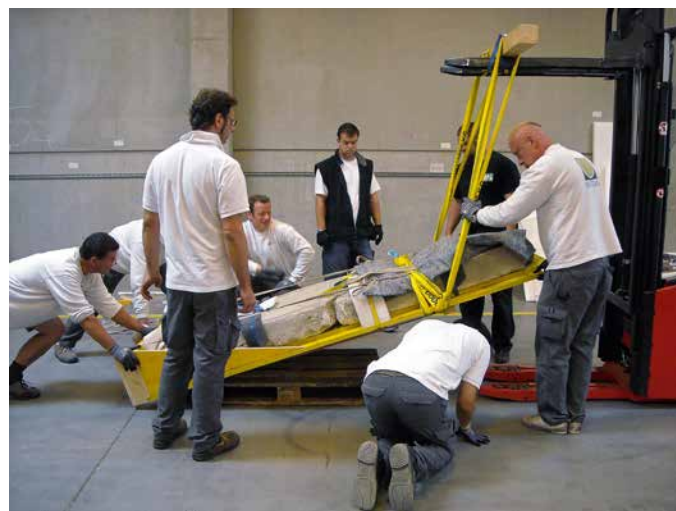
Fig. 48: Lowering of the tombstone with a lifting device.

Stabilisation with load-binding straps and lifting straps. Transfer of the stone with a lifting device or by hand (figs. 48 to 50).

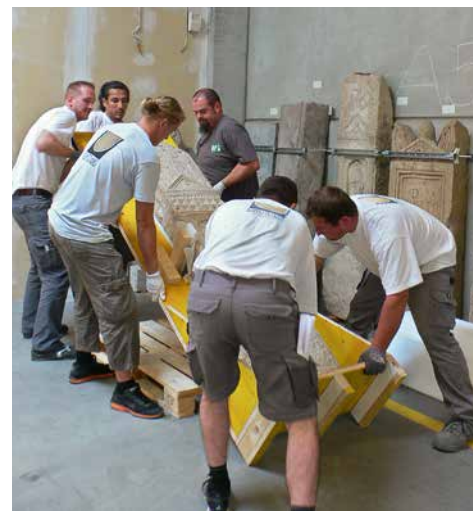
Fig. 49: Transfer of the tombstone by hand.

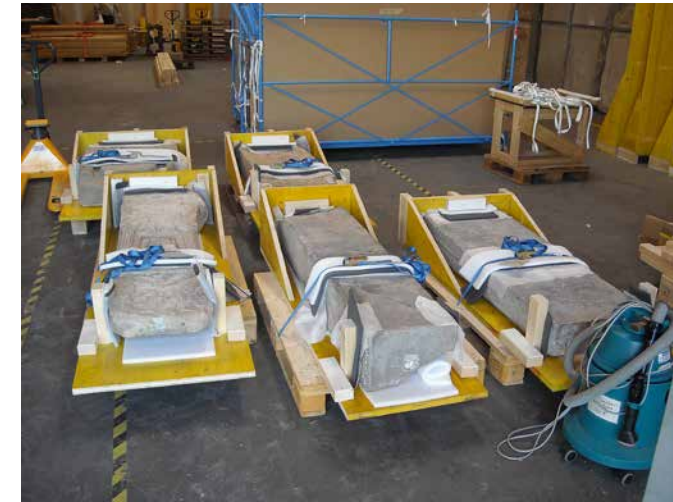
Fig. 50: Tombstones on Euro-pallets prepared for transport to the new storage facility.

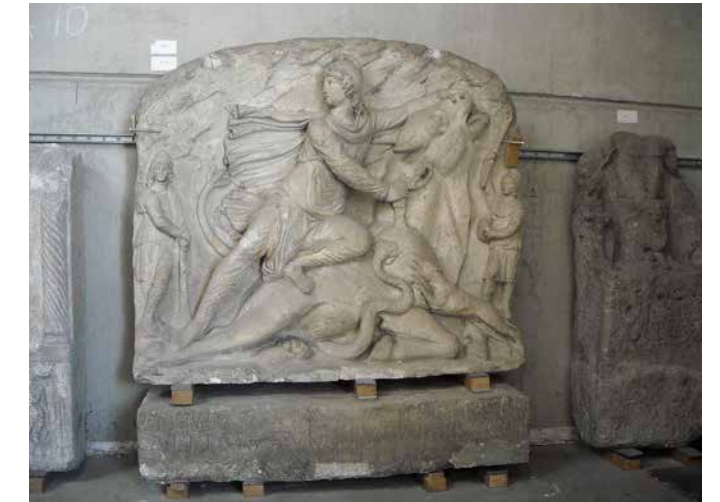
Fig. 51: A two-piece tombstone in the old storage facility of the Kunsthistorisches Museum Vienna.

“Wooden shoe” constructions made from formboards were prepared for the two-piece tombstones (figs. 51 to 53).

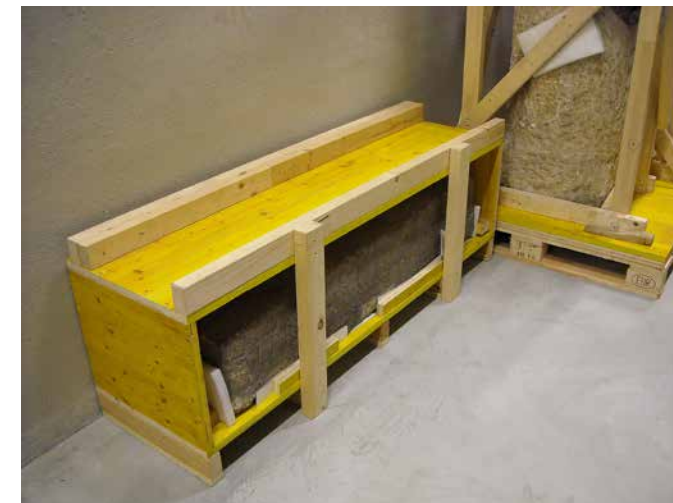
Fig. 52 a
Lower and upper part of a two-piece tombstone in the new central storage unit.

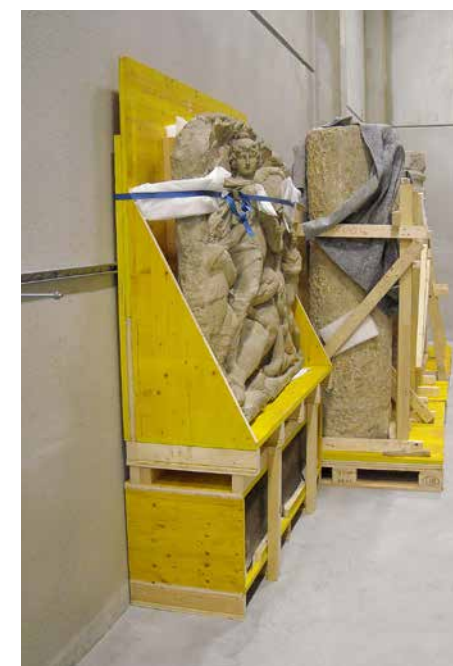
Fig. 53: Placement of a two-piece tombstone with wooden storage container mounted on the concrete wall in the new central storage facility.

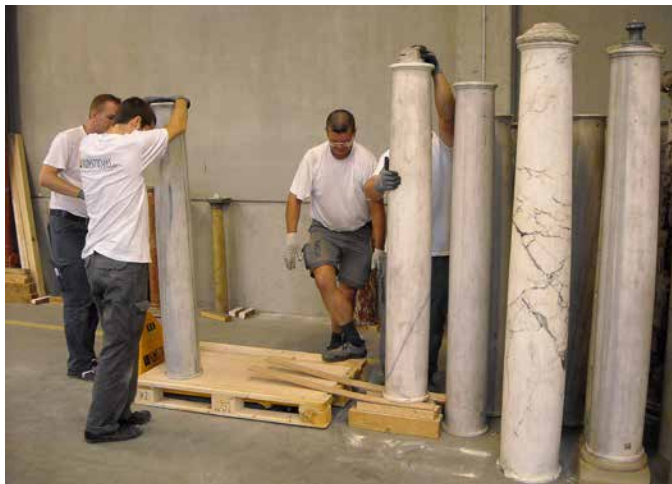
Fig. 54: Transfer of historic marble columns with soaped boards.

Whenever possible during the relocation of large, heavy objects, soaped boards were used as a safe and quick method to move, or slide, them onto the new pallets, proving to be very helpful for the entire project (fig. 54).

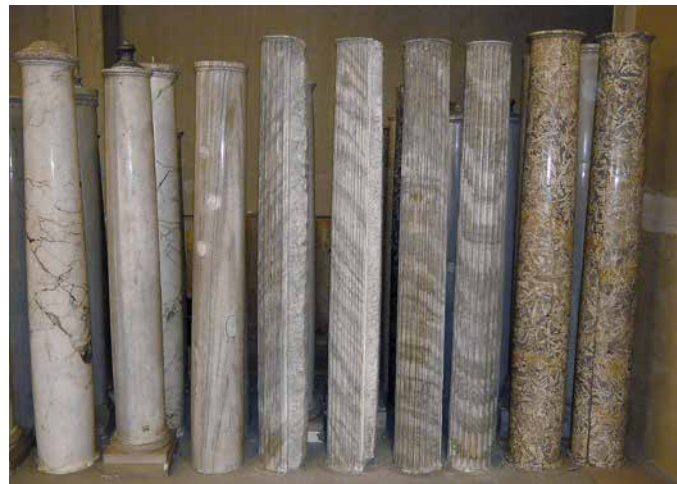
Fig. 55: Placement of marble columns in the old storage facility of the KHM.

The historic marble columns with vertical crack formations, however, had to be additionally secured (Ethafoam and load-binding straps) and could not be moved with the help of the soaped boards because the danger that they could fall apart was too great (figs. 55 to 57). In this case, the stabilisation methods used for transport were also suitable for later, long-term storage in the new storage facility (fig. 58). The use of Euro-pallets and stackable wooden crates, which could be stabilised on the inside with wooden braces, worked well in this case and proved reliable over continued use. Rectangular metal plates or wooden boards were screwed onto the crates from the outside, preventing the detachment during transport (fig. 59).

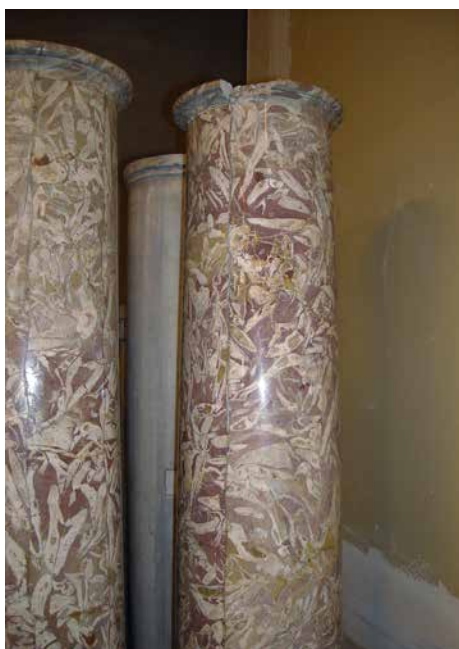
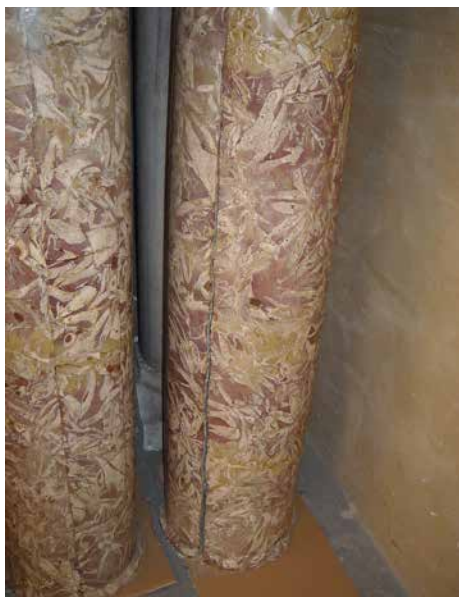
Fig 56 a

Upper and lower sections of a stone column with continuous dispersed crack formations.

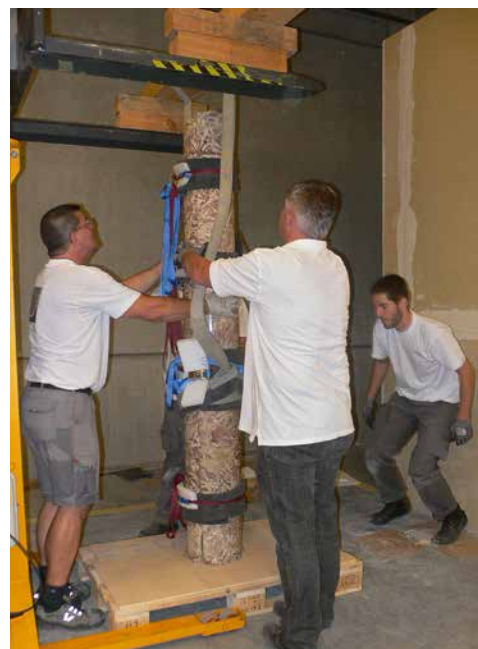
Fig. 57: Raising a stabilised stone column with a continuous crack formation with the help of a lifting device.

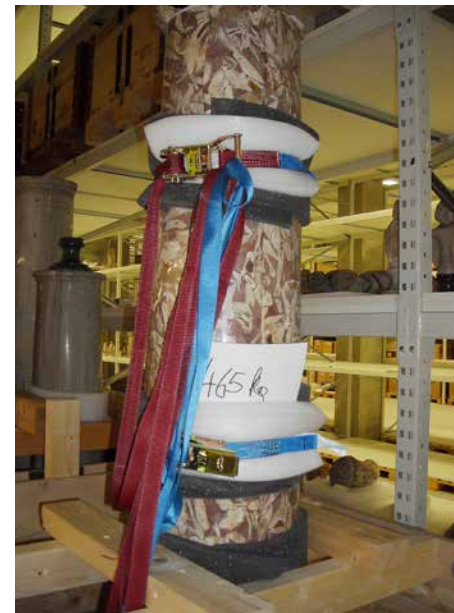
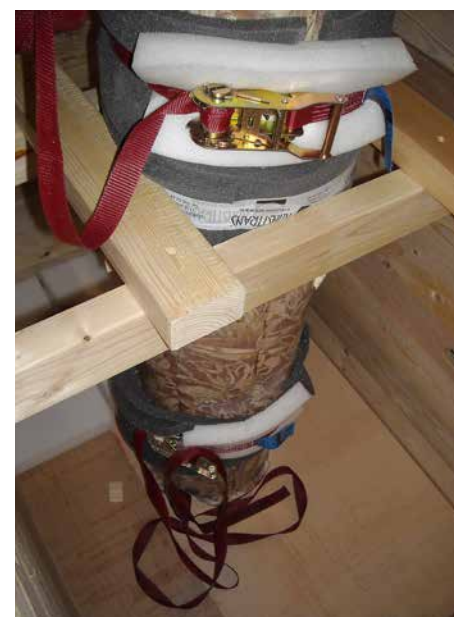
Fig. 58 a

Lower and upper sections of a stone column with stabilisation for transport to the new storage facility.

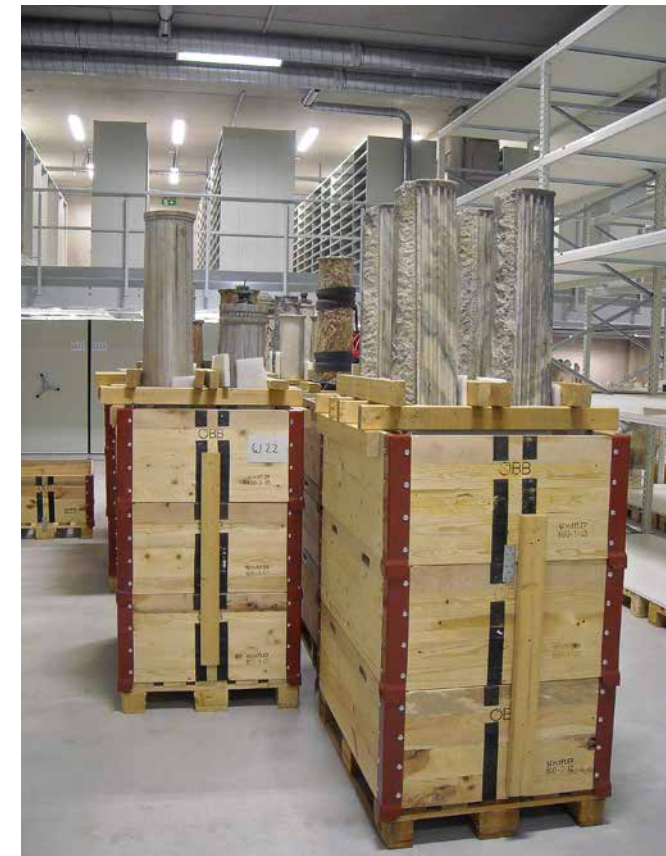
Fig. 59: Marble columns in the new storage facility on Euro-pallets with stackable wooden crates.

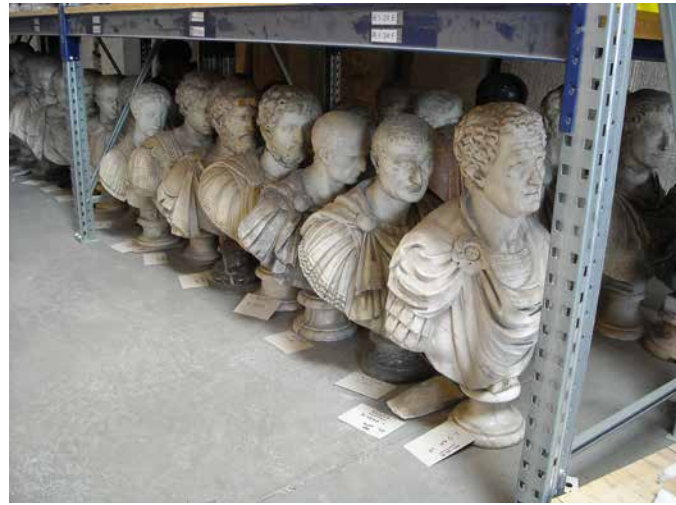
Fig. 60: Roman portrait busts in the old storage area of the KHM.

2.2.4 PORTRAIT HEADS AND BUSTS (FIG. 60)

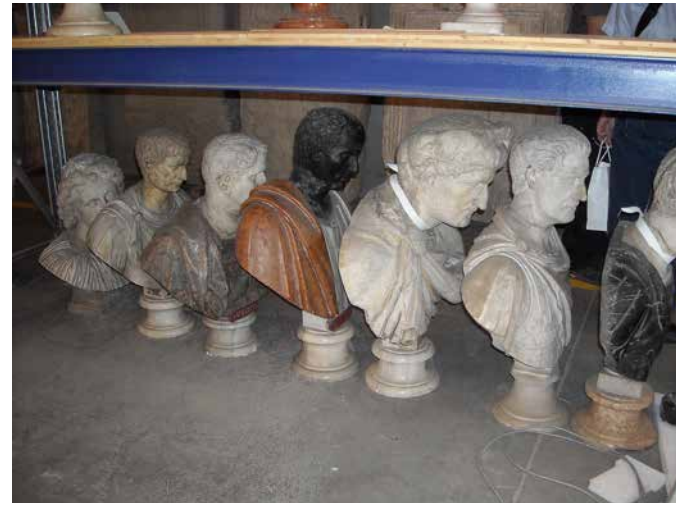
Fig. 61: Portrait busts in the old storage area that have been inspected and designated with cloth bands.

The historic stone pedestals that had been custom-made for the busts of Roman Emperors were built somewhat small, making them problematic for use during transport or for long-term storage. In an upright position, the weight of the objects became concentrated on a limited area due to the relatively small, and in some cases damaged pedestals. This less than optimal distribution of weight during transport would have been too dangerous, as the vibrations could have caused the rupturing of localised, capillary cracks already present in the pedestals, leading to their possible collapse. In addition, the preparation of a support construction for all of the busts would have been very time-consuming and was not possible within the constraints of the project's schedule. As a result, it was decided to move the objects in a horizontal position, which was successfully executed with the placement of the busts on cushions filled with styrofoam pellets. Portrait busts with statically problematic crack formations were designated with a white band around the neck before transport and also placed on cushions, but not stored in an upright position in the new storage facility (figs. 61 to 65).

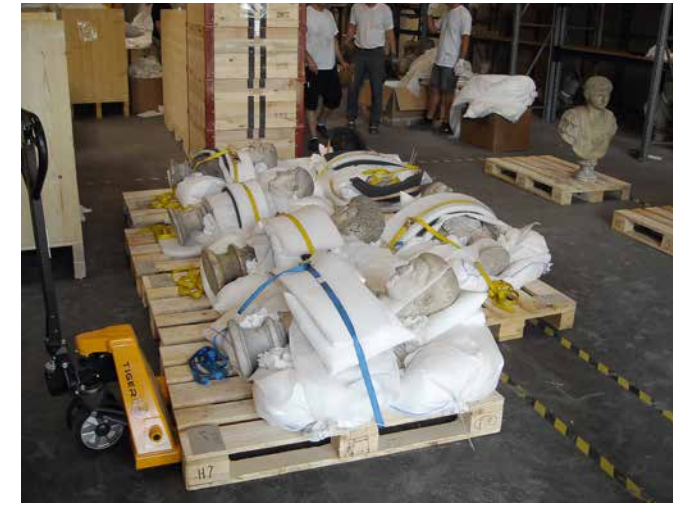
Fig. 64: Portrait busts awaiting transport to the new storage facility.

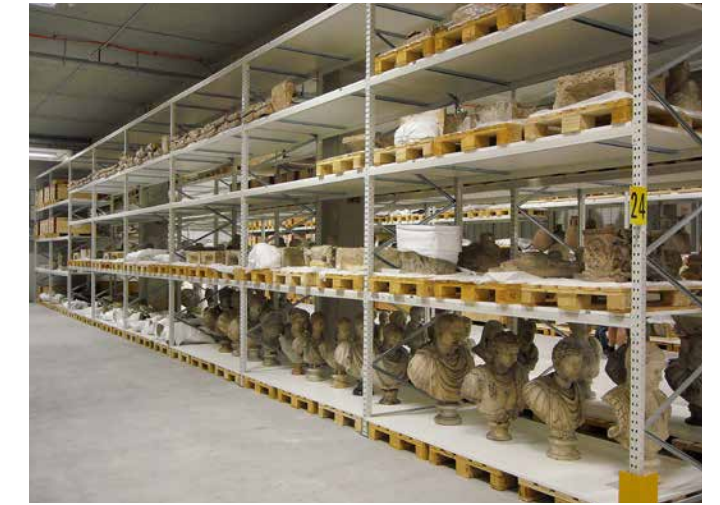
Fig. 65: Long-term storage of the Roman portrait busts in the new central storage facility.

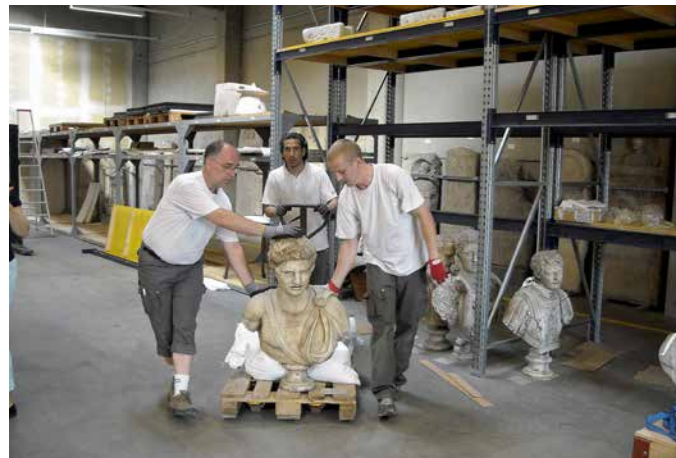
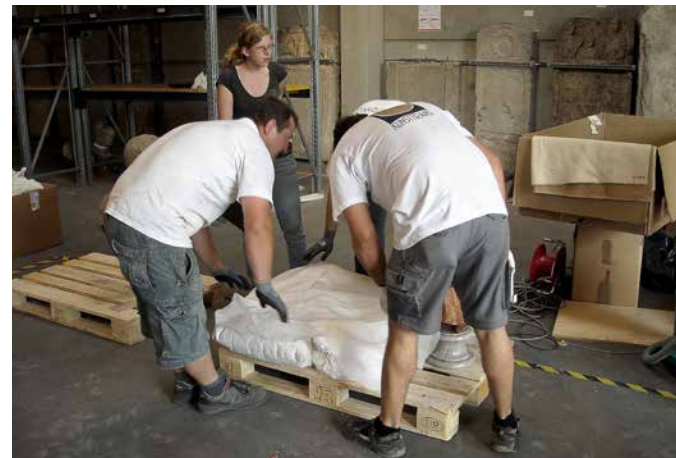
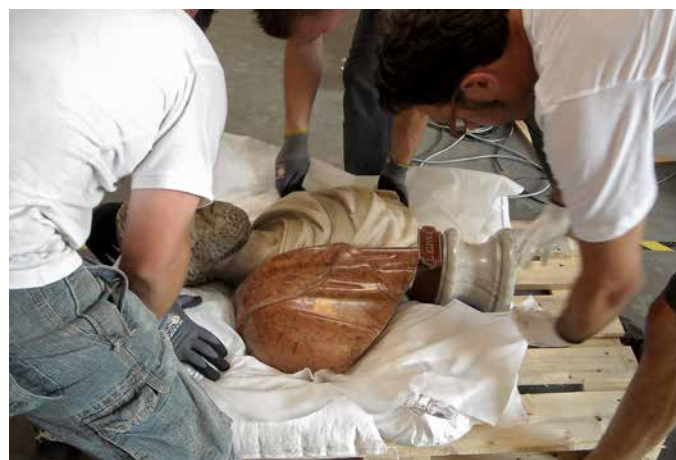
Fig. 62 c
Moving and transfer of portrait busts onto cushions filled with styrofoam pellets.

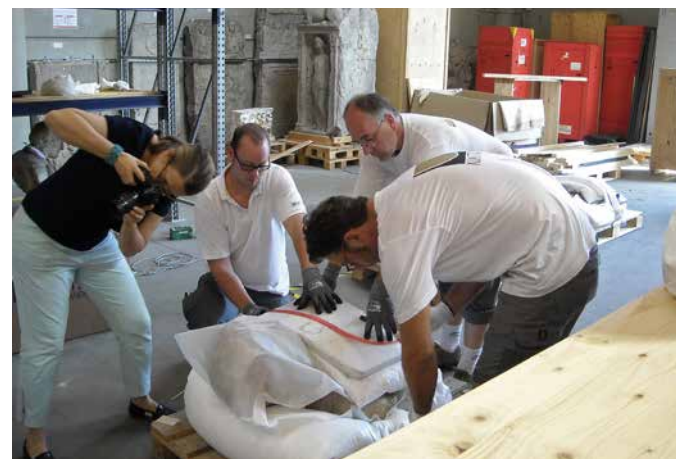
Fig. 63: Stabilisation of portrait busts with adjustable straps.

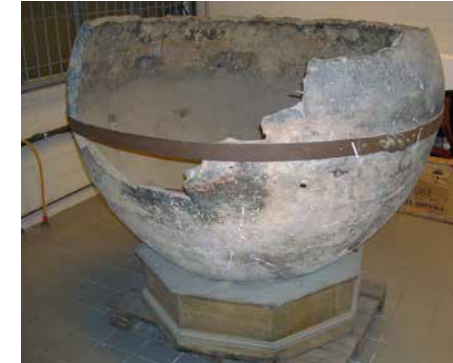
Fig. 66: Fish storage vessel without new stabilisation in the old storage facility.

Viktor Freiberger carried out another special stabilisation method for the transport of two damaged fish storage vessels. The vessels had been previously stabilised with a metal band encircling the outer wall of the container, preventing the vertical crack formations from causing it to break apart. This method alone, however, was not stable enough. Additional supporting threaded rods were fixed to the inside of the container and secured with screw nuts to additional curved metal bands placed on the exterior of the vessel.

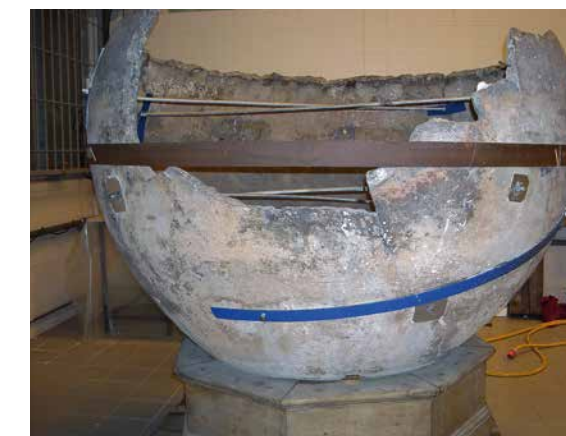
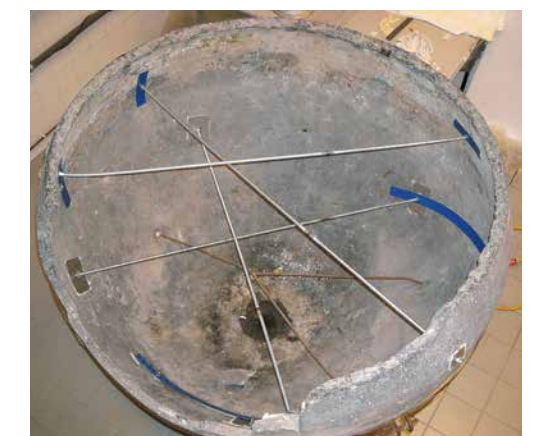
Fig. 68 a

Outside and inside of a fish storage vessel with new stabilisation for transport.

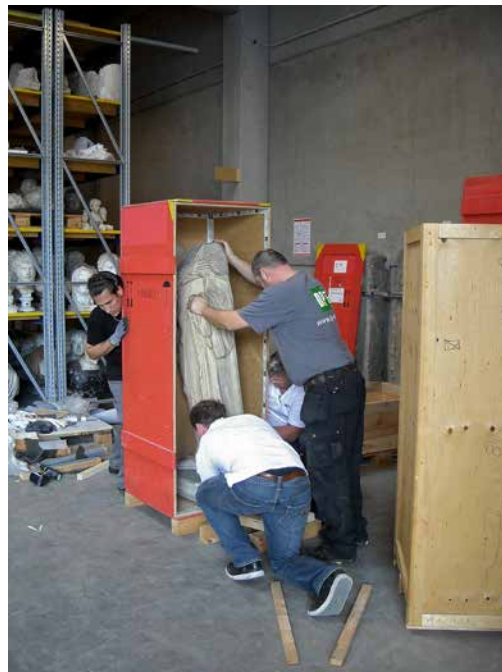
Fig. 70: Moving a stone sculpture with wooden studs and soaped boards.

The freestanding, in part life-size stone sculptures were transported in existing crates. Wooden braces, felt and Ethafoam fittings on the inside of the crates served to stabilise the sculptures during transport. In some cases, the crate fittings had to be improved with additional supports. Opportunely, some of the crates could be reused for the transport of additional sculptures (figs. 70 and 71).

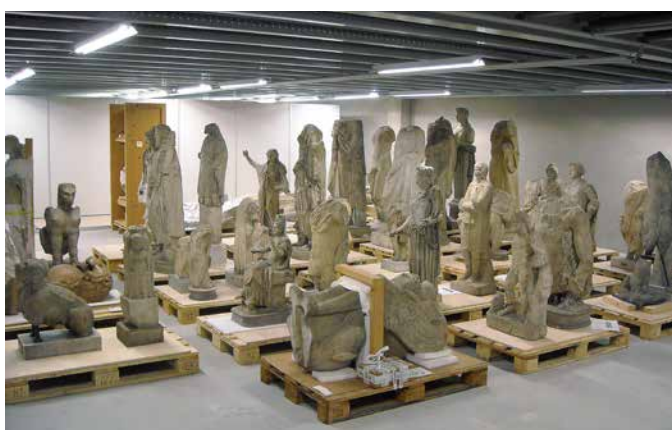
Fig. 71: Long-term storage of freestanding stone sculptures in the new central storage facility.
