Technological Studies

Kunsthistorisches Museum Vienna

Special volume: Storage
Vienna, 2015

Technologische Studien Kunsthistorisches Museum.
Konservierung – Restaurierung – Forschung – Technologie,
Sonderband Depot, Band 9/10, Wien 2012/13

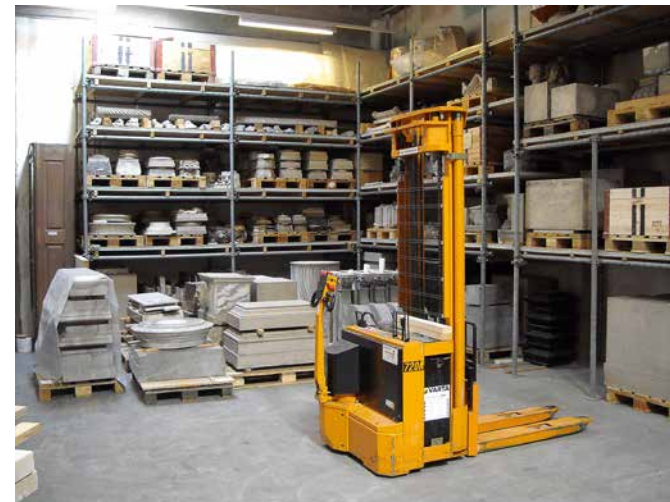
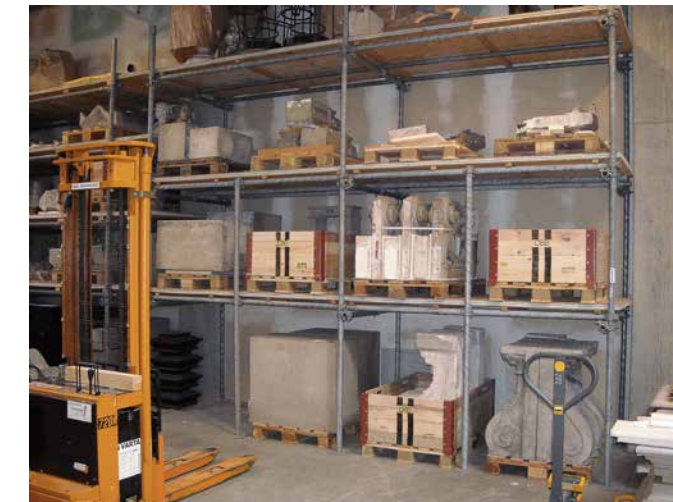
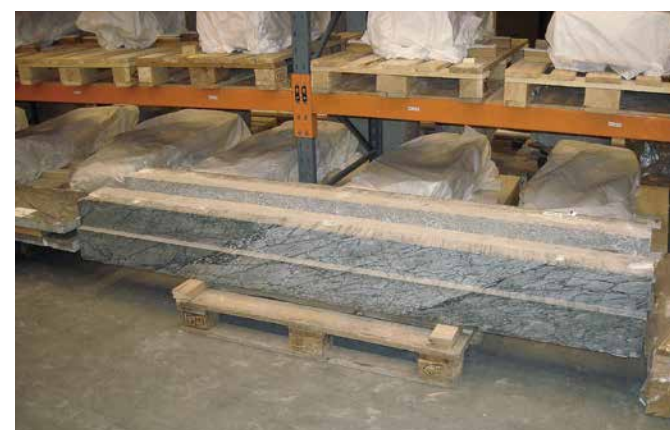
Fig. 72 a

Pieces of stone architectural elements reorganised and partially packed in scaffolded shelving units in the old storage facility.

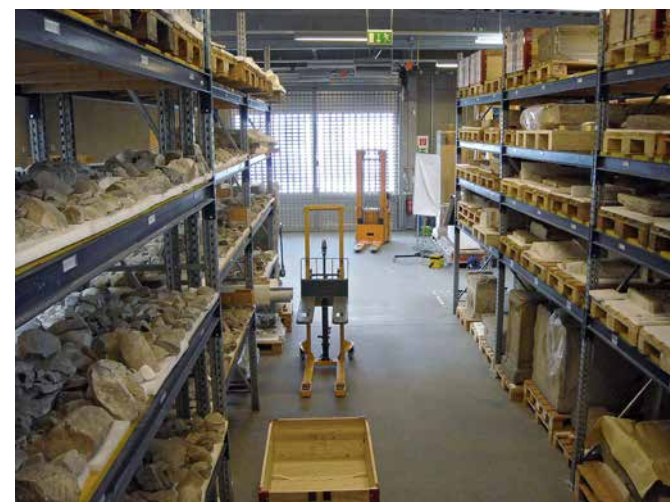
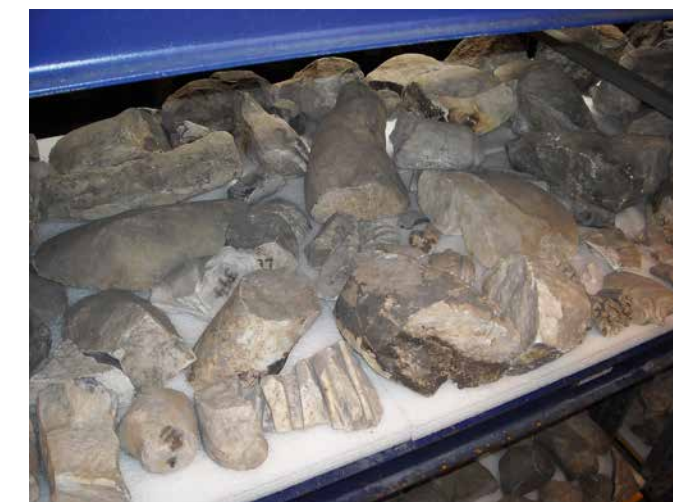
Fig. 73 a

Numerous stone fragments and pieces in the heavy-duty shelving units in the old storage facility.

A simple, easy to execute solution for transport had to be found for the many small stone fragments and broken pieces stored in part without a pallet directly on the shelves. The solution – Euro-pallets with standardised wooden crates and Ethafoam-lined insertable shelves – should have been at the same time useful for long-term storage in the new central storage facility. Numerous fragments and pieces were packed in about 35 hours by two to three people (figs. 73 and 74).

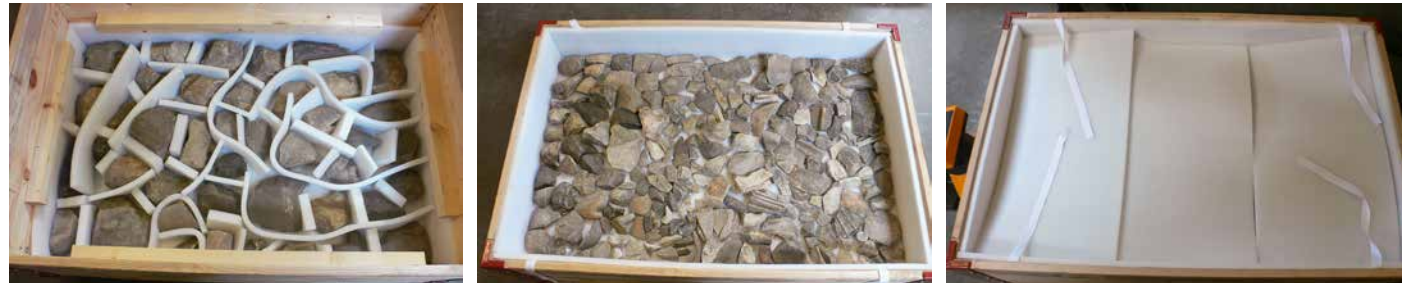
Fig. 74 a
First and second layer of packed fragments with enclosing Ethafoam cover.

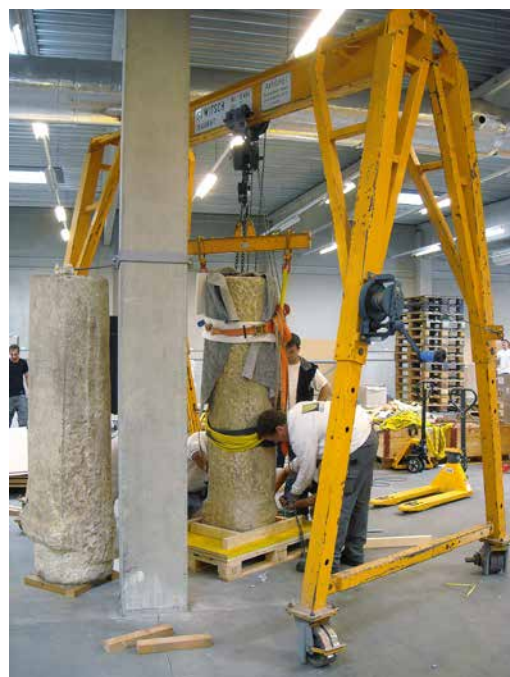
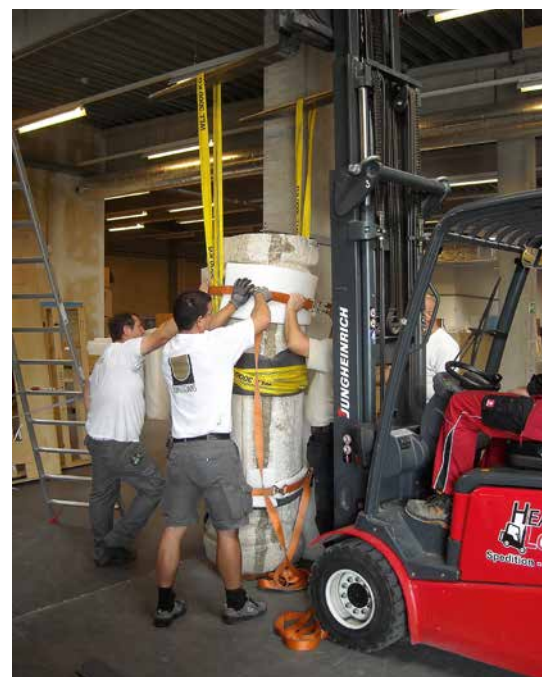
Fig. 76 a
Transfer of milestones with a gantry crane and forklift.

The extremely heavy objects from the Greek and Roman Antiquities Collection, the Egyptian and Near Eastern Collection, and the Kunstkammer had to be moved and transported using a variety of methods. These freestanding objects, which were stored in part without a pallet, also had to be transferred to new pallets in preparation for the move. Some of the milestones from the Greek and Roman Antiquities Collection were secured in the old storage facility with massive iron fittings attached to concrete support pillars. In this case, movement with a gantry crane proved to be appropriate (fig. 76 a). The heaviest milestone weighing ca. 1,250 kg had to be lifted with a hoisting sling and a drawbar forklift because the maximum height of the gantry crane was insufficient (fig. 76 b). As a measure of extra protection, the objects on the customised pallets were further stabilised with wooden braces (fig. 77). The heaviest object in storage from the Egyptian and Near Eastern Collection is a stone sarcophagus made out of rose granite with a total weight of ca. 3,208 kg without the lid (lid: 1,302 kg). It had to be lifted and moved with special hoisting machines. Because of the low ceiling height in this part of the storage area, movement with a forklift was unfortunately not possible. It was finally removed from the storage area with the aid of special hoisting machines and industrial casters, followed by loading with an electric forklift. A “pallet tower” was built to support the loading platform of the moving truck so that it could bear the weight of the 3.2 metric tons during loading. The sarcophagus was supported from both sides in the moving truck by horizontally placed pallets, protecting it during transport (figs 78 to 83).

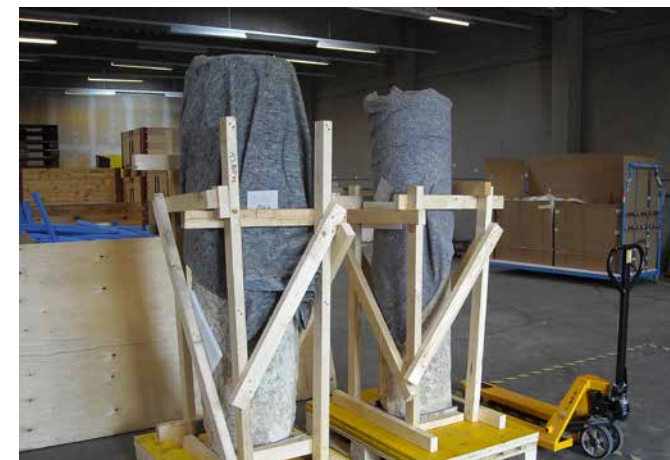
Fig. 77: Packed milestones awaiting transport to the new central storage facility.

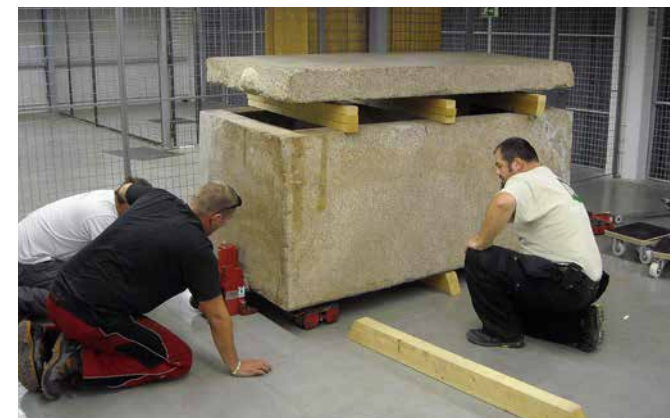
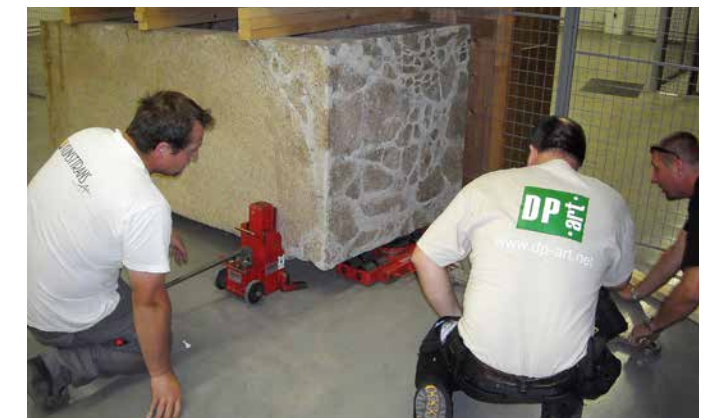
Fig. 79 a
Lifting and placement of casters with lifting machines.

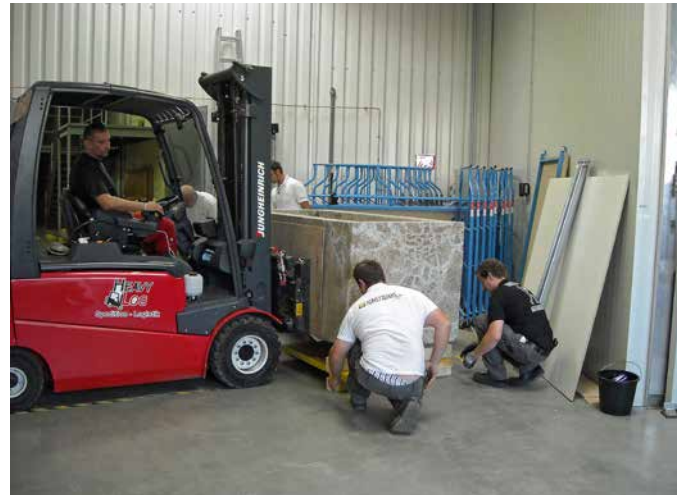
Fig. 81: Transfer of the sarcophagus with forklifts onto a transport pallet made of formboards and wooden beams.

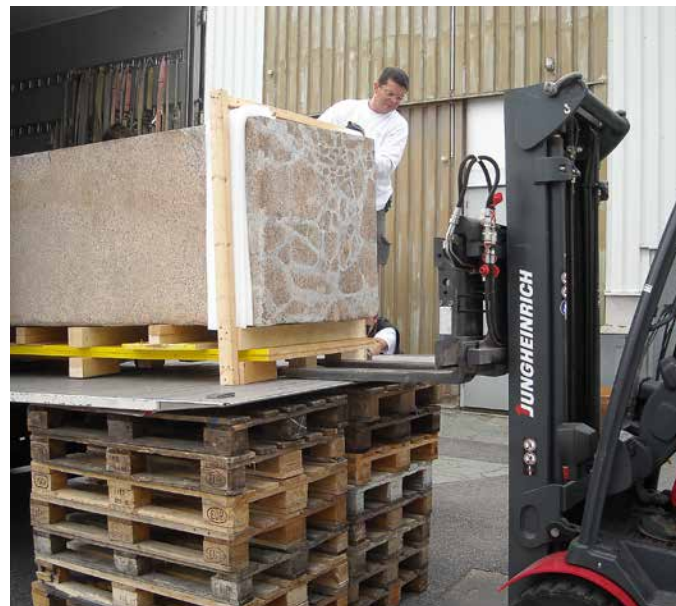
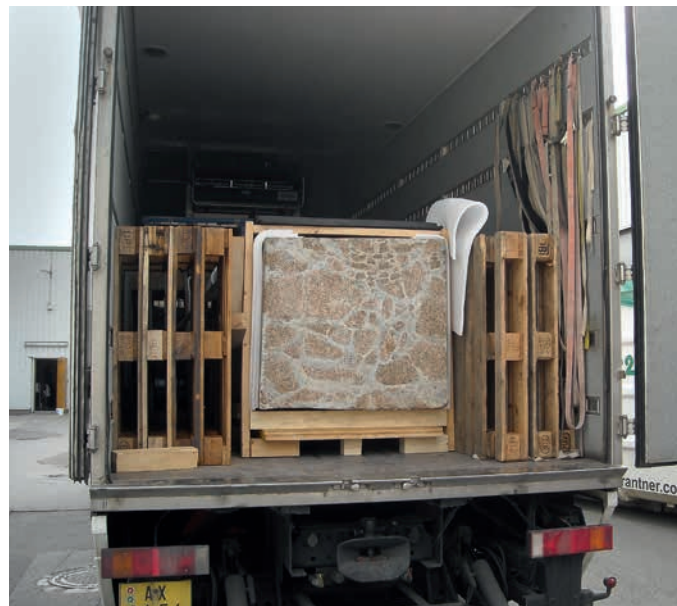
Fig. 83 a
Loading of the sarcophagus with forklifts.

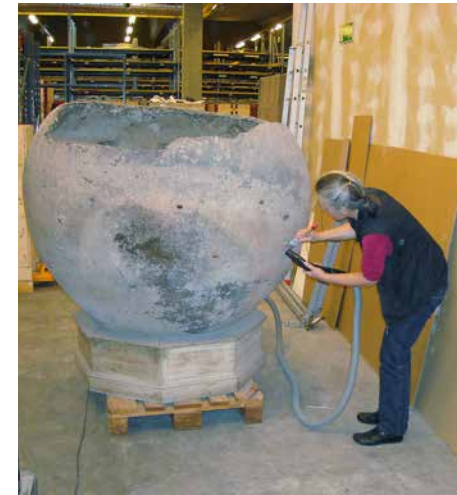
Fig. 84: Vacuuming the objects with vacuum cleaners and brush.

In order to save the new central storage facility from an inundation of dust-covered objects, the surfaces of all stone objects were cleaned with a brush and vacuum cleaner prior to transport (fig. 84).

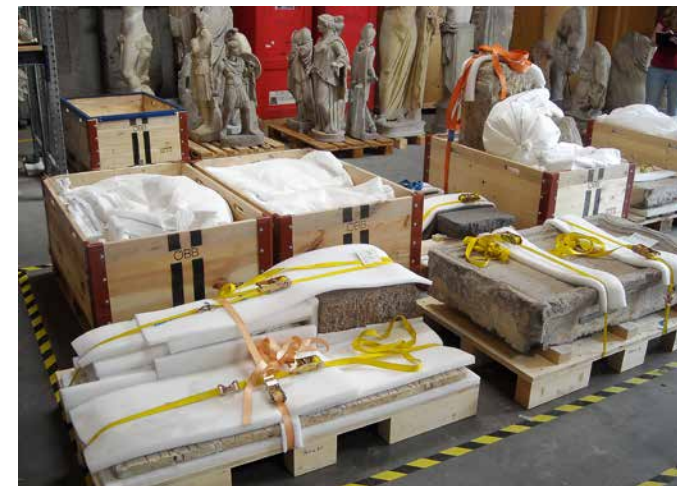
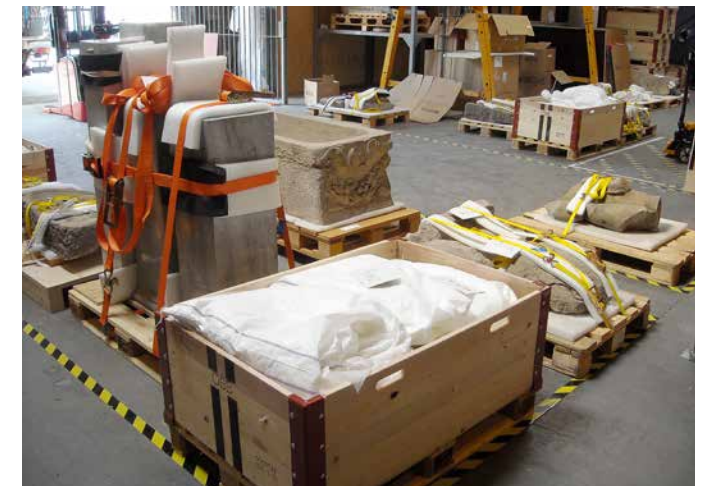
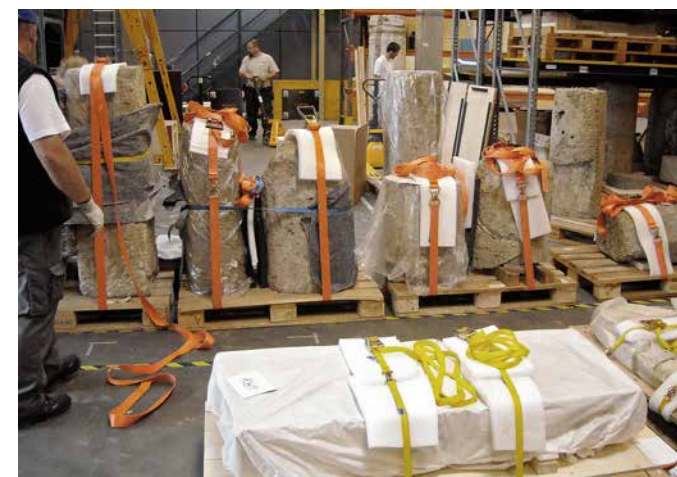
Fig. 85 c
Packed objects in loading area.

The art moving company Kunsttrans completed the entire move, also collaborating on the preparation and movement of the heaviest objects. In order to load the moving trucks as quickly as possible, their dimensions were drawn on the floor of the loading area; within these two designated areas, the objects – packed and ready for transport on their pallets along with any additional packing materials to be used during transport – could be prepared, avoiding delays due to “down time” during loading (fig. 85). The good planning, preparatory work, and excellent collaboration of all people involved allowed for 53 truck shipments with a total of 250 metric tons to be brought to the new central storage facility in one work week, beginning with the first transport of stone objects. The move of all stone objects that were stored in the old storage facility of the Kunsthistorisches Museum Vienna was carried out between August 1st and September 29th, 2011, and constituted a total weight of approximately 450 metric tons. During a second relocation phase between May 2nd and May 11th, 2012, additional stone objects were moved that had been located in the cellar and mummy storage area of the Egyptian and Near Eastern Collection of the Kunsthistorisches Museum Vienna.

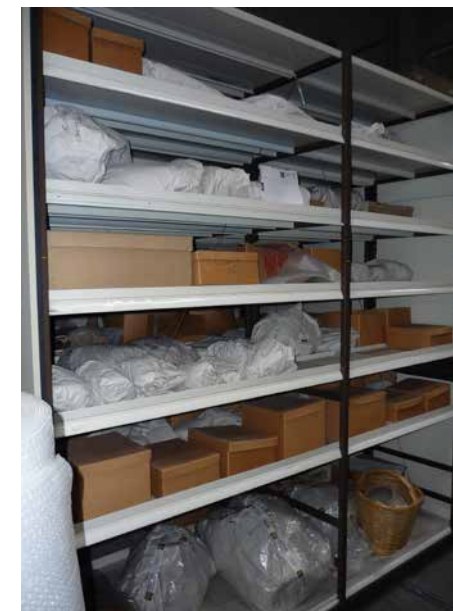
Fig. 1: Storage facility in Inzersdorf: large, compact storage unit with objects that have been wrapped in tissue paper since January, 2001 due to mould infestation; large objects are wrapped in bubble wrap; cardboard boxes with various groups of objects.

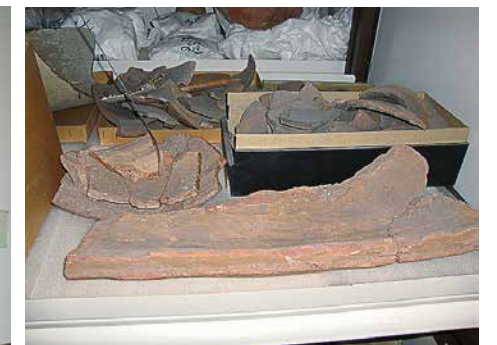
Fig. 3: Various shards of vessels: in the foreground, a large fragment from a coffin. Condition: restored, adhered with plaster fills, large sections inpainted (or overpainted), in fragments.

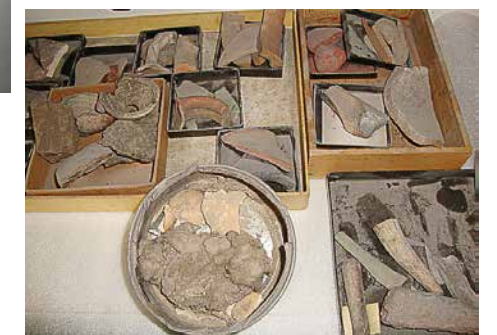
Fig. 4: Generally dirty storage shelves and objects; in the foreground a fragment of an ostrich egg in a can, bone fragments to the right.

- ostrich eggs (shells) (see fig. 4);
- bronze – fragments of statues, vessels (e.g., large dish-shaped objects, very fragmented);
- fragments of gold leaf; a few particles (see fig. 71 a);

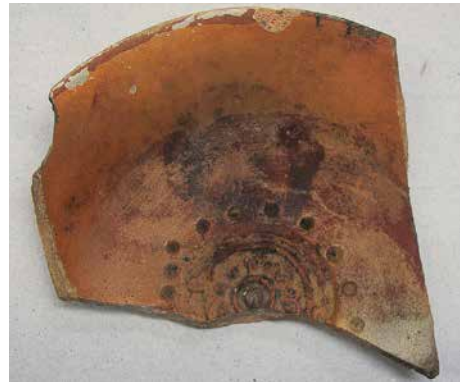
Fig. 5: Orange-coloured vessel fragment with red mouth and stamped pattern in the centre.

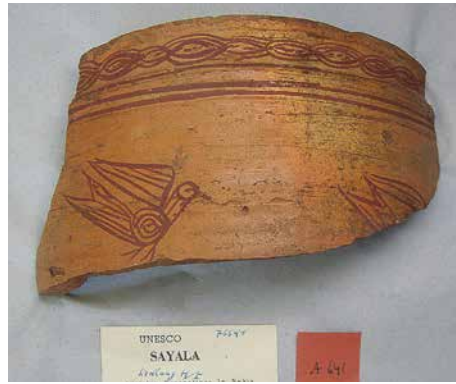
Fig. 6: Orange-coloured vessel fragment, the exterior is painted with linear ornamentation and birds.

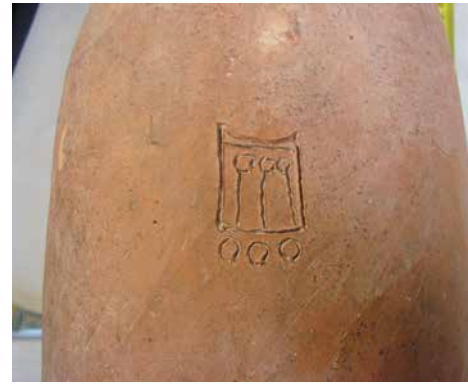
Fig. 7: Detail, potter's mark on a large, thin vessel.

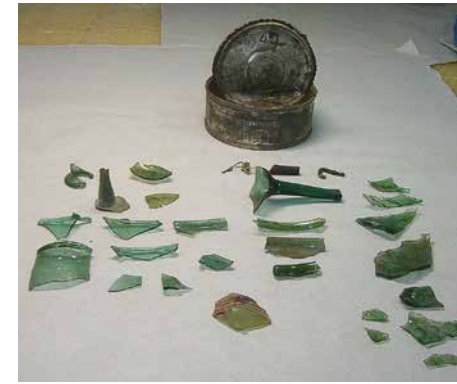
Fig. 12: Various transparent green glass fragments, decorated, a dried flower, a bone fragment, a hook-like piece of metal with green patina (contents of a fish can with "47" inscribed in black), cleaned.

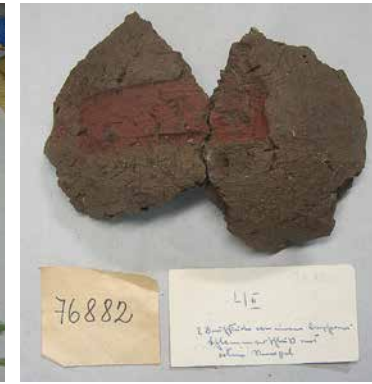
Fig. 13: Two large, curved, seal fragments from the remains of an amphora, rectangular seal surface is coloured red; cleaned.

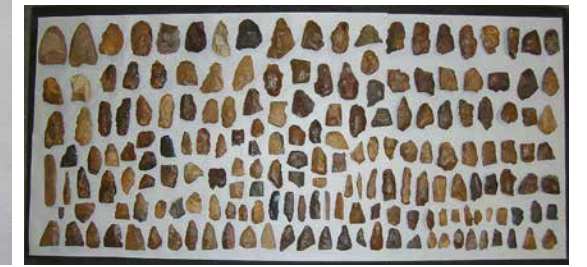
Fig. 14: Flint fragments of different colours; cleaned.

- stone – colourful flints (and slivers) (fig. 14), colourful muller; alabaster (calcite); fragments of stele and statues, large green slate plates;
- mosaic fragments – parts of mosaics made out of stone (limestone, porphyry, serpentine – in mortar bed) (fig. 15, see fig. 64);

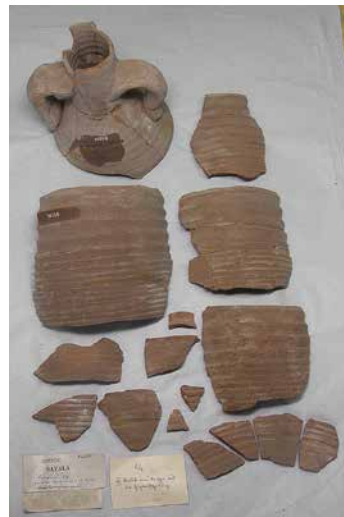
Fig. 8: Amphora, exterior with shallow ribs, in fragments.

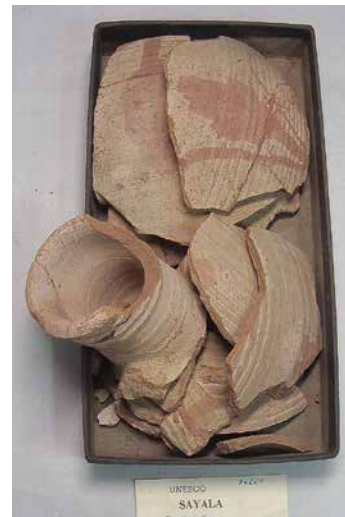
Fig. 9 a: Ribbed vessel fragments with mathe beige slip, painted pale red (photograph of the initial state).

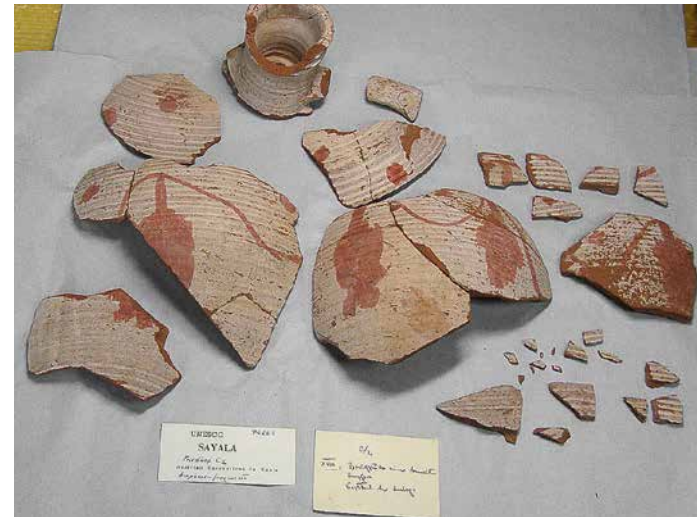
Fig. 9 b: Cleaned shards with pale red vine pattern; they are laid out to give an impression of the complete vessel.

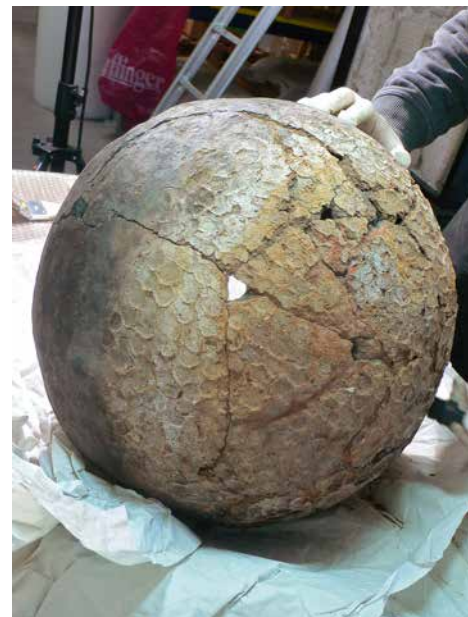
Fig. 11: A very large, ball-shaped vessel, the lower half of the exterior is textured.

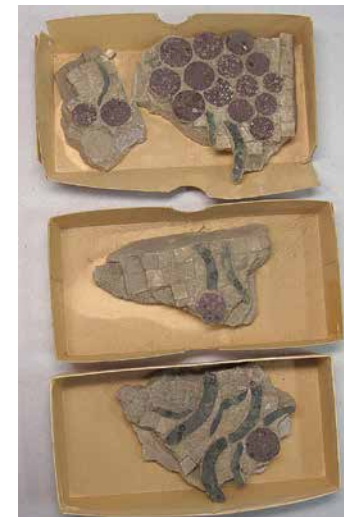
Fig. 15: Mosaic made of white, green and red stone, in mortar bed, 4 pieces (photograph of the initial state) (see fig. 64).

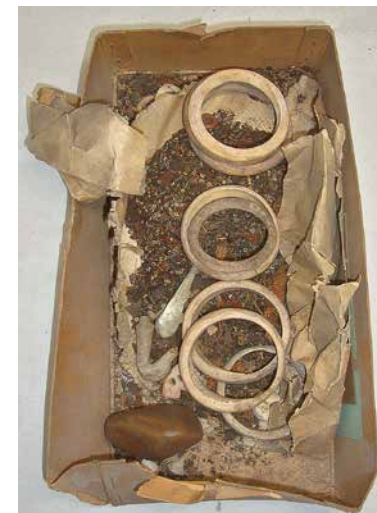
Fig. 16: Group of objects, box with bracelets made from snail shells, hair rings, colourful circular beads, small mother-of-pearl and stone amulets, small fragments of cloth and yarn, muller (photograph of the initial state).

- fragments of wall paintings – loose;
- jewellery (bracelets, hair rings, pendants, hair pins) – made from various crustaceans, shells, mother of pearl, bone (fig. 16);

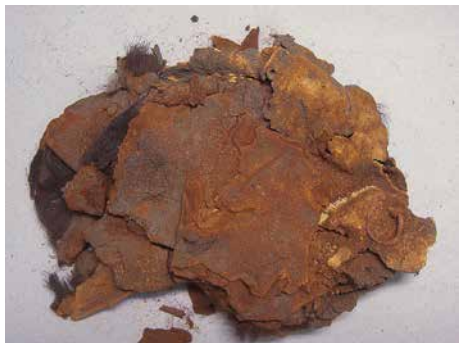
Fig. 17: Fragment(s) of fur: folded together, broken; with twisted leather thread and grommets (photograph of the initial state).

- Asian coins (2 objects);
- leather, fur – fragments of bags (?), partially coloured red (painted?), clothing (fig. 17); shoes (pairs); with seams, decorative seams, knots, strings; leather fringe bracelets with fastener (2 objects) (fig. 18);

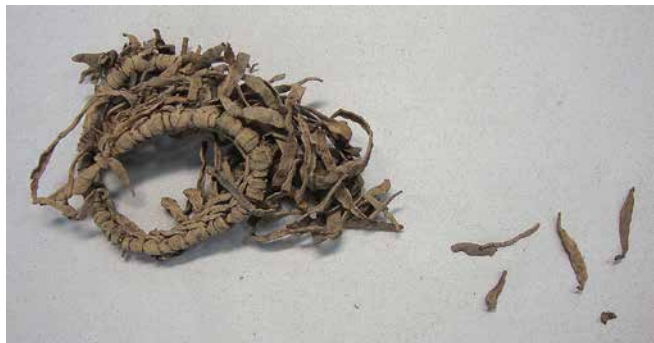
Fig. 18: Open leather bracelet with fringe; for tying together.

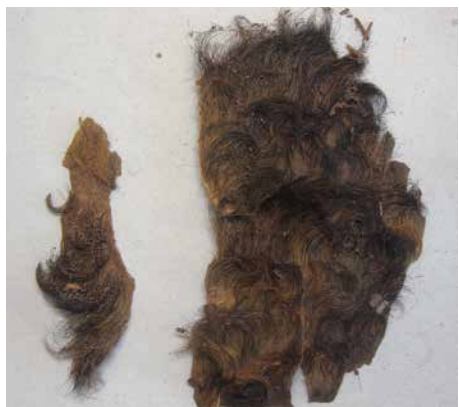
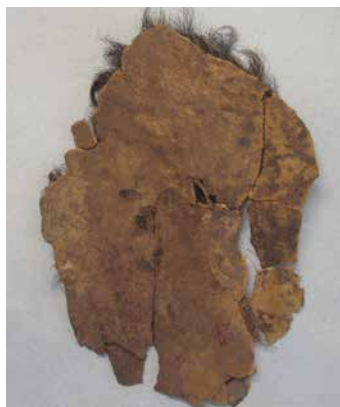
Fig. 19 a
Cranial skin with short, curly hair (front and back views, photograph of the initial state).

- single animal hairs;
- animal bones; small devices made out of bone;
- human bones, fragments of cranial skin sometimes with hair (short hair, curly hair, braids, loose), remains of skin and/or sinew, finger nails (often attached to textile fragments) (fig. 19);

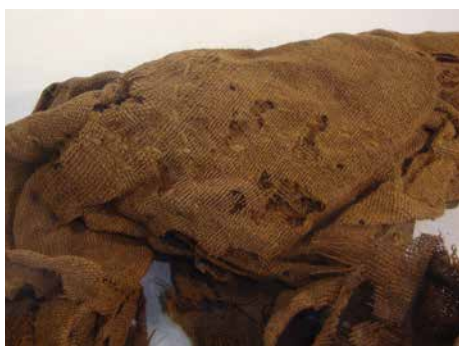
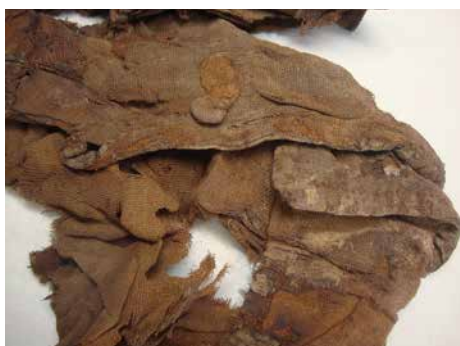
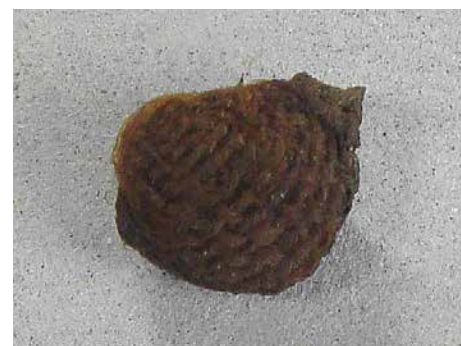
Fig. 20 a: Fragment of pants with button, partially decorated with an embroidered design (diamond pattern); cleaned.

Fig. 20 b: View of the fastener.

Fig. 20 c: Detail, pearl-shaped button, formed from linen fabric.

- textiles – linen fabric with various weaving techniques and densities, in various colours, with patterns, markings, fringe, strings, knots (figs. 20 and 21);
- fabric – macramé-like technique (from black yarn?) (fig. 22);
- wood – fragments of coffins, containers, or furnishings, small utensils, statues (sometimes with a layer of wax [paraffin] as stabiliser) (fig. 23);
- papyrus – small individual fragments with writing;
- braided objects (from plant materials) – fragments of mats; burial basket (fig. 24, see fig. 78), sandal soles (fig. 25), excavation worker's basket (2 objects); remains of straps (e.g., on clay seals, ceramic vessels) (fig. 26);
- plant parts – dried leaves, blossoms (1 object); fruit, seeds, pits, skins (fig. 27);
- resin, wax;
- excrement, animal, human (?), dried;
- forgeries – various.

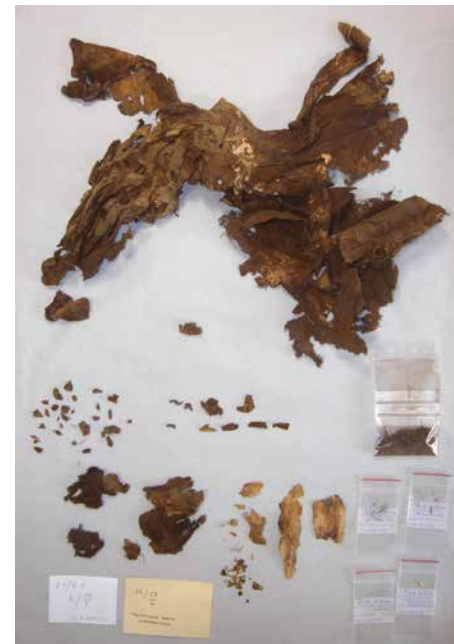
Fig. 21: Pieces of a loin cloth patterned with light and dark brown yarn, cord sewed onto the edges; remnants of human remains present (light, on the right side); cleaned.

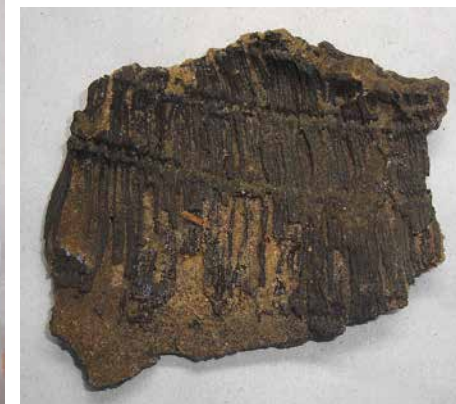
Fig. 22: "Macramé"-like knotted textile; cleaned.

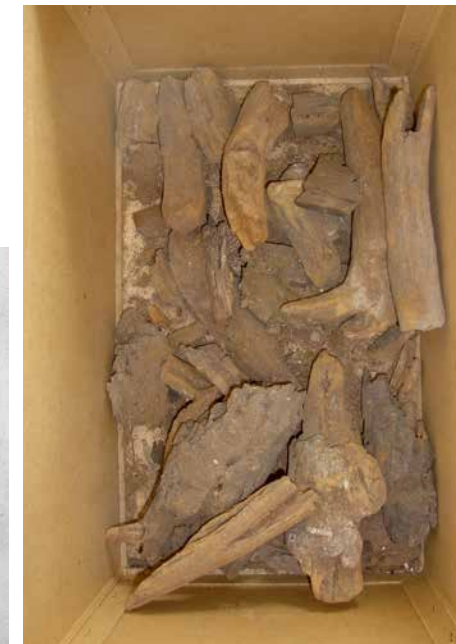
Fig. 23: Brown cardboard box with various wood fragments, some bent (angular forms) or with long slits.

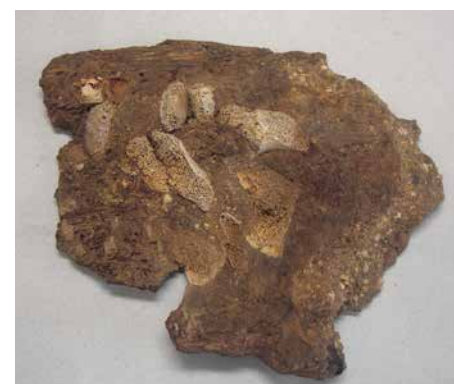
Fig. 24: Bottom of a basket-like object with bone fragments, one of countless fragments belonging to this object number; cleaned.

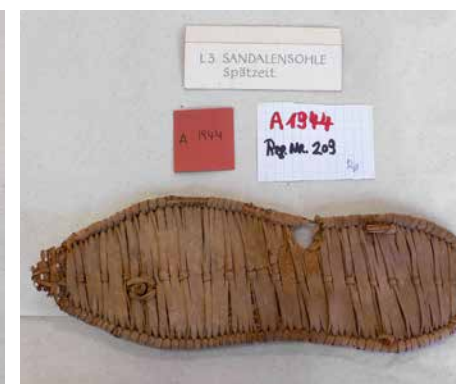
Fig. 25: Sole of a sandal made from plant material, straps are missing (photograph of the initial state).

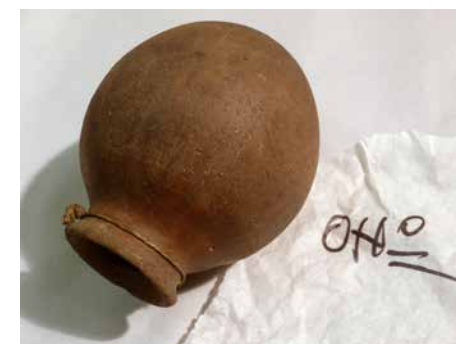
Fig. 26: Small, round clay vessel with knotted string under the mouth; cleaned.

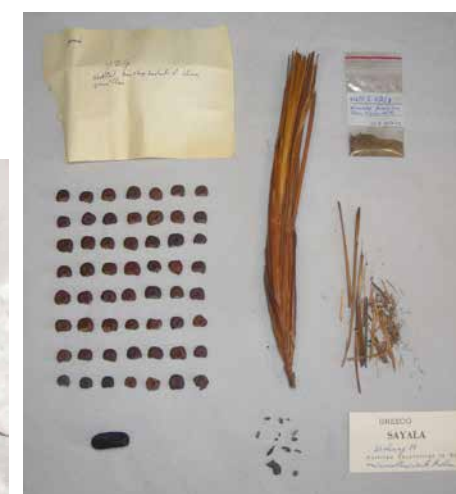
Fig. 27: Plant sections, seeds, dates, palm fronds, various broken fragments; cleaned.

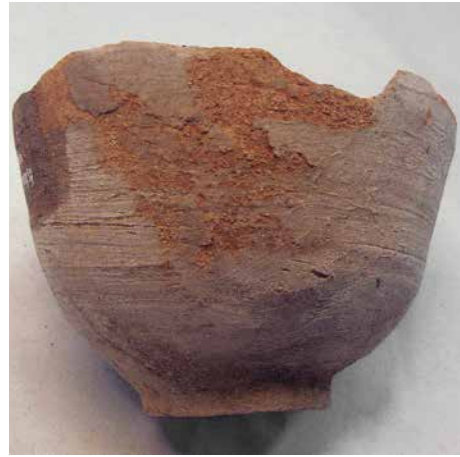
Fig. 28: Flaking clay surface, caused by moisture and salt (photograph of the initial state).

Along with the mould infestation already mentioned, various kinds of damage and old restorations were found. The objects had either already been glued together or discovered in fragments, sometimes with unstable or freshly broken previously repaired joints (particularly among the stone and ceramic vessels), sometimes with inpainted plaster fills; the occasional piece of adhesive tape was found still in place; scuff marks; in rare cases advanced salt efflorescence and/or the related flaking and powdering of the material layers (figs. 28 to 32).

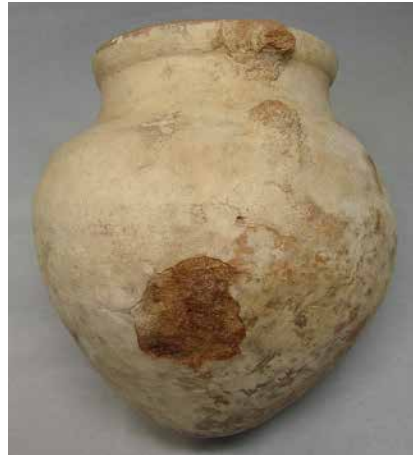
Fig. 29: Large clay vessel with matte, pale yellow slip; large areas of the surface are falling away, handle is missing.

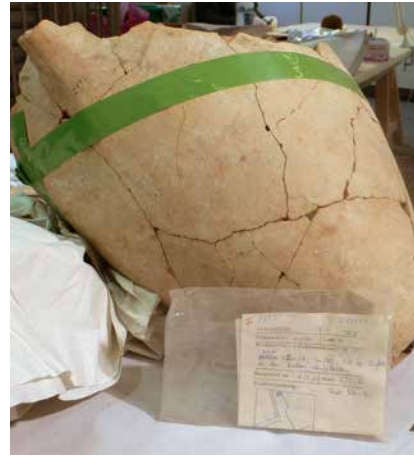
Fig. 30: Vessel shards held together with a green, insulating tape (photograph of the initial state).

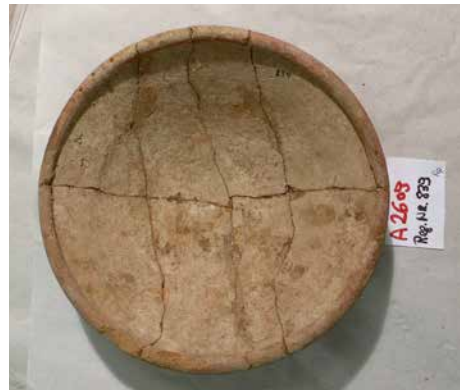
Fig. 31: Large clay plate. Many fragments glued together; cleaned.

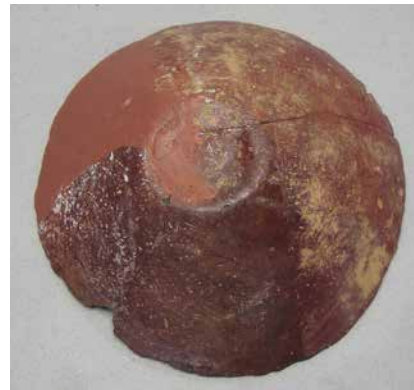
Fig. 32 b

Inpainted plaster fills in a small bowl (top and bottom); cleaned.

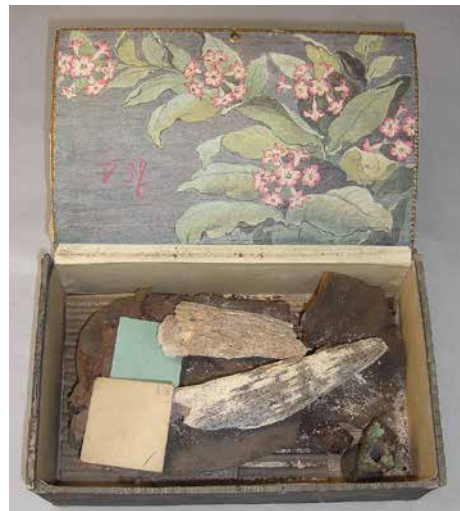
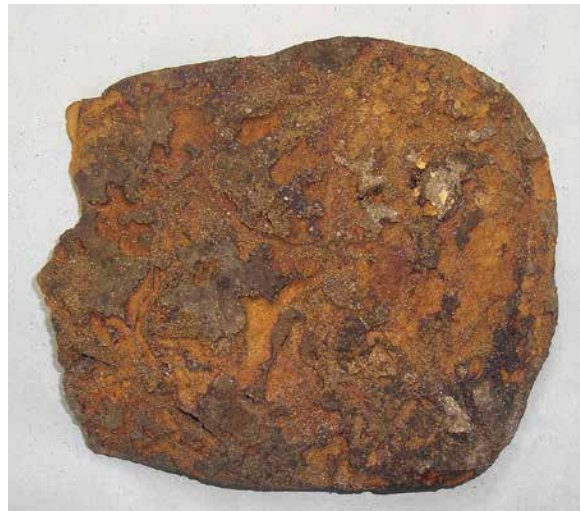
Fig. 33 a: Group of leather fragments and bones in a cigar box (photograph of the initial state).

Fig. 33 b: Leather fragment from the cigar box with traces of frass from an insect pest; cleaned.

In addition, pest infestation on leather and textile fragments occurred: feeding holes, tunnelling (figs. 33 and 34); broken and falling away hairs, fur (short or long-haired); tears, creases (see fig. 17), etc.; damage to crustaceans: cracking; glass: occasional corrosion (fig. 35); metal objects were very fragmented and corroded (fig. 36); mould growth was discovered on inorganic and organic materials (sampling of ceramic objects: fig. 37).

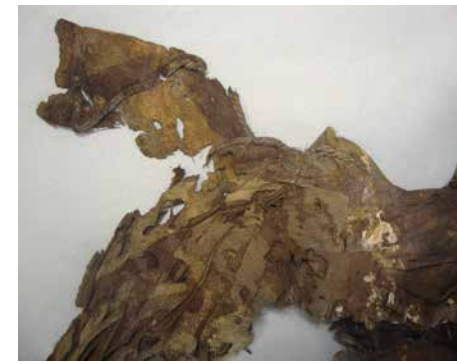
Fig. 34: Detail: loincloth with a pattern formed from light and dark brown yarn, edge with sewed on cord; a few mummified human remains (pale – on the right side), see fig. 21. All fragments have been cleaned; evidence of damage: eaten away by insect pests, holes.

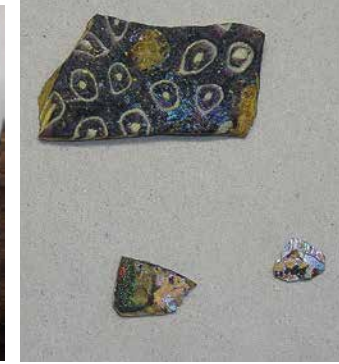
Fig. 35: Millefiori glass fragments, broken, glass corrosion (iridescent).

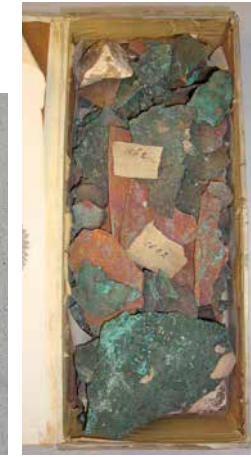
Fig. 36: Fragments of a metal plate and limestone fragments in a cigar box (photograph of the initial state).

Naked eye observation could clearly identify a mould infestation comprised of white, spot- or cross-shaped colonies with a granular to powdery surface. The mould had not only formed cell threads (hyphae) and groups of cell threads (mycelium), but also the spores that form a layer of mould on the mycelium were also observed. Sampling of the surface proved that the mould possessed a limited capacity for germination, and in the majority of cases, was no longer capable of germination, eliminating the need for treatment with a biocide. The allergenic potential of the mould, however, had to be considered, as it can be stimulated by dead spores as well. It is caused by protein in and on the cells (see fig. 36 and figs. 38 to 43; also see figs. 48, 50, and 51).

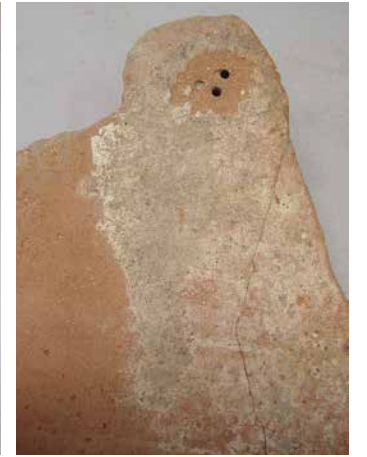
Fig. 37: Vessel shards, an example of taking samples of ceramics by drilling.

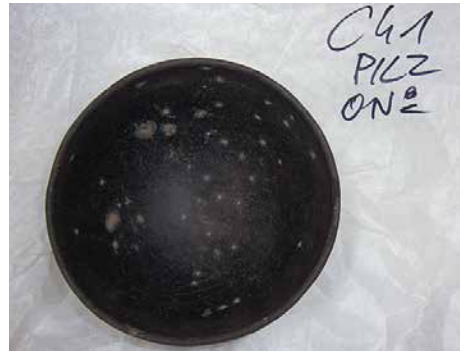
Fig. 38: Small, round clay bowl, inside black, polished – light spots of mould throughout.

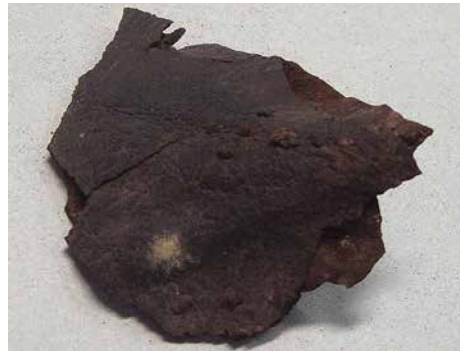
Fig. 39: Leather fragment from a shoe – light, furry mould spots on the exterior.

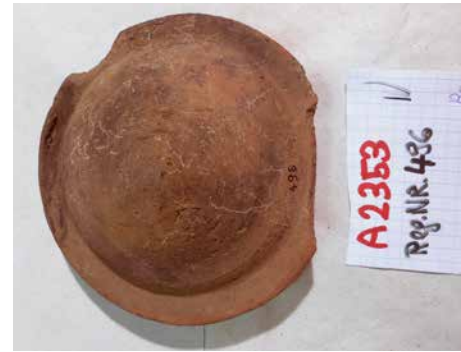
Fig. 40: Large vessel with light, linear mould growth pattern.

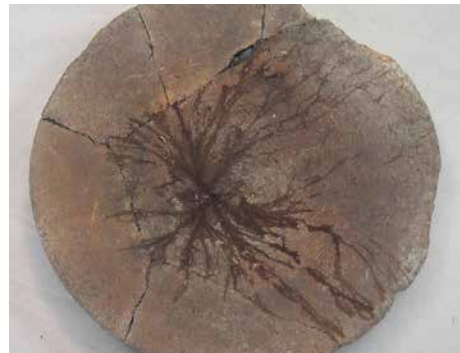
Fig. 41: Large clay dish with stain-like growth.

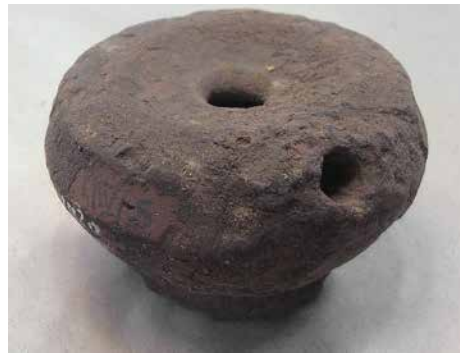
Fig. 42: Oil lamp with spots of light, furry, mould growth.

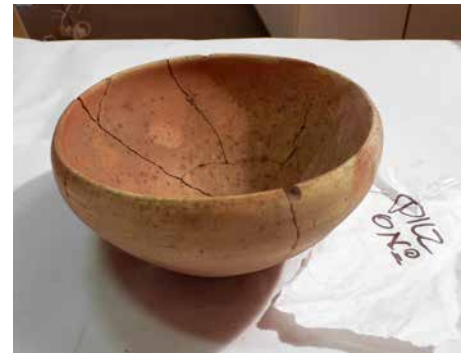
Fig. 43: Large bowl with scattered, dark areas of mould growth.

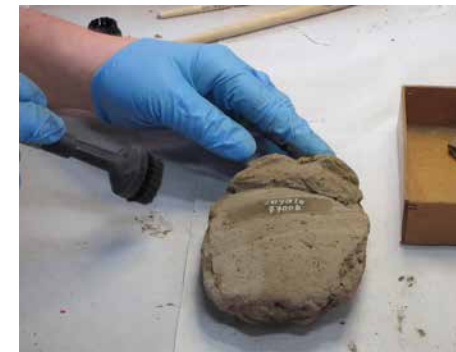
Fig. 44: Cleaning a fragile fragment of mud jar stopper with pale mould growth: vacuuming with a small brush nozzle (pale left corner not yet cleaned).

- primary cleaning with specialised vacuum cleaners (vacuum level control, mini-brush attachments, adapter hoses, diverse bristle brushes; tulle net nozzle protection) (fig. 44);

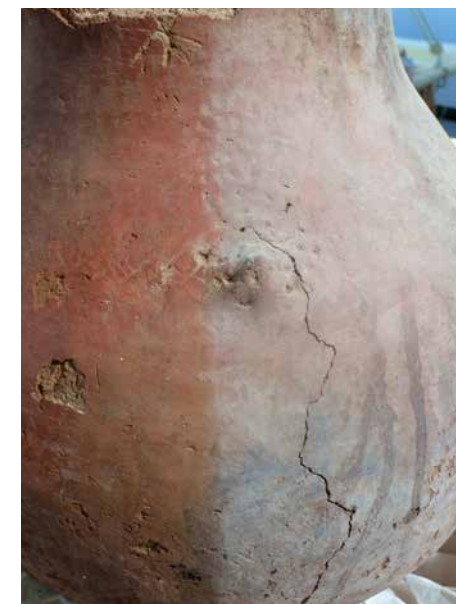
Fig. 45: Cleaning test on a large clay vessel with incised star-shaped forms; the left side has been cleaned (vacuumed) (see fig. 44), followed by cleaning with Wishab sponges and a TeraTex cloth.

- secondary cleaning with Wishab® sponges (hard), Wallmaster sponges, TeraTex cleaning cloths (figs. 45 to 50 and fig. 52) and soft erasers (for writing on paper);

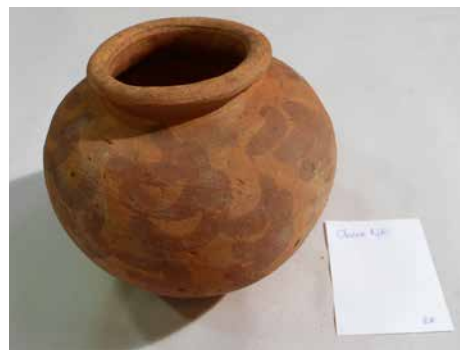
Fig. 46 a
Small, bulbous vessel with dark red, freely painted decoration; left: before cleaning (photograph of the initial state); right: after cleaning.

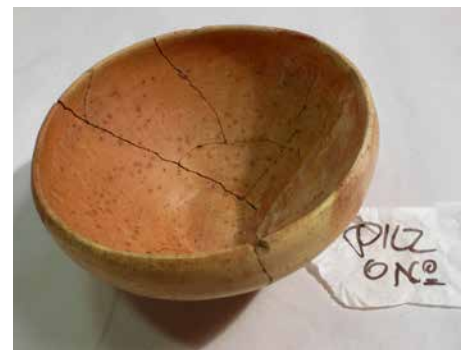
Fig. 47: Large bowl with dark mould growth after cleaning (see fig. 43).

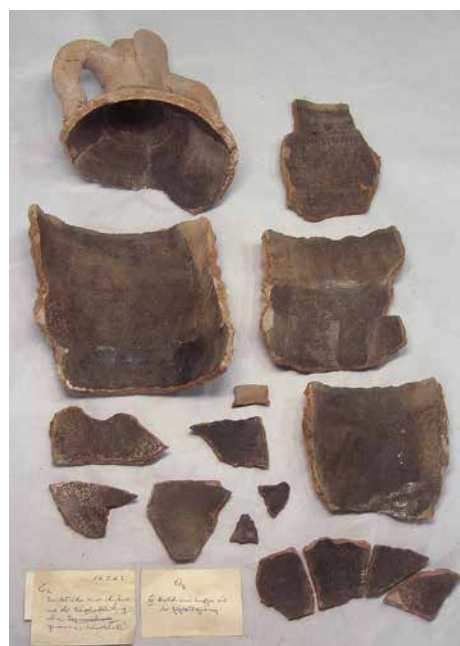
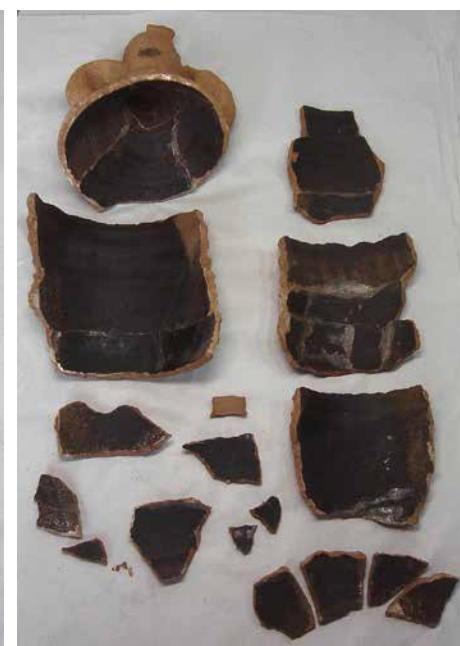
Fig. 48 a
Amphora fragments containing dark, resin-like deposits, ribbed exterior (see fig. 8); left: exterior/interior before cleaning; right: interior after cleaning.

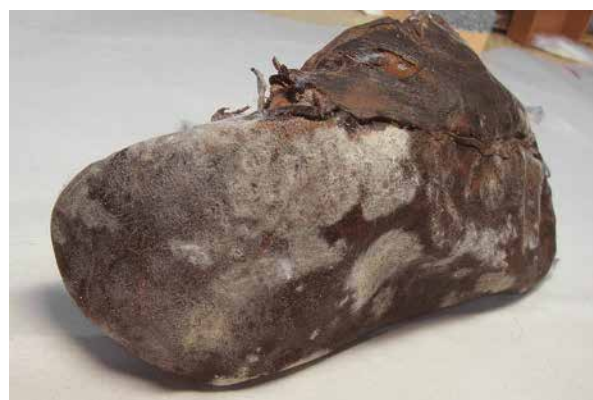
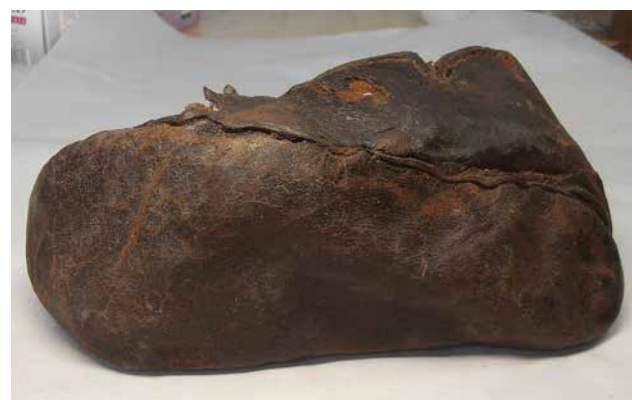
Fig. 49 a
Leather shoe with mould growth overall: left before, and right after, vacuum cleaning with a small brush nozzle and a soft brush, followed by cleaning with a Wallmaster sponge.

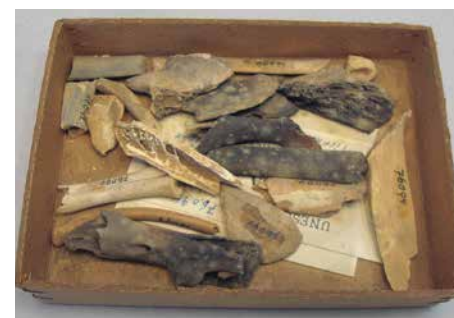
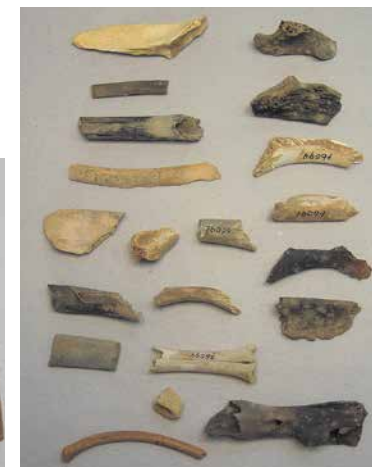
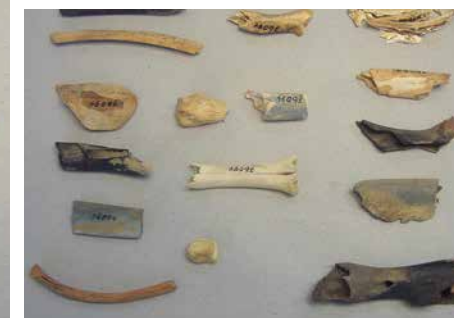
Fig. 50 a
Diverse bone fragments with pale mould infestation. Fig. 50 a: Photograph of the initial state. Fig. 50 b: Individual bone fragments before cleaning. Fig. 50 c: A few bones after removal of mould.

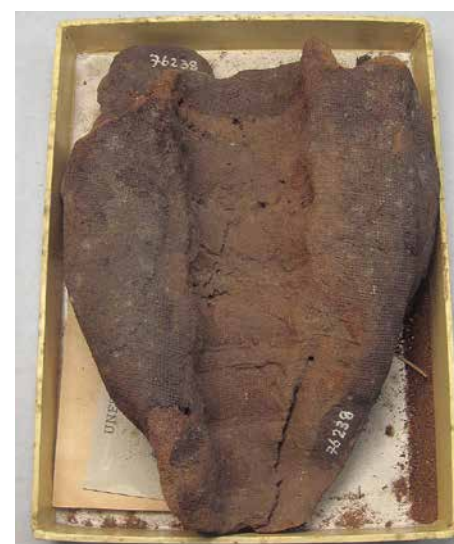
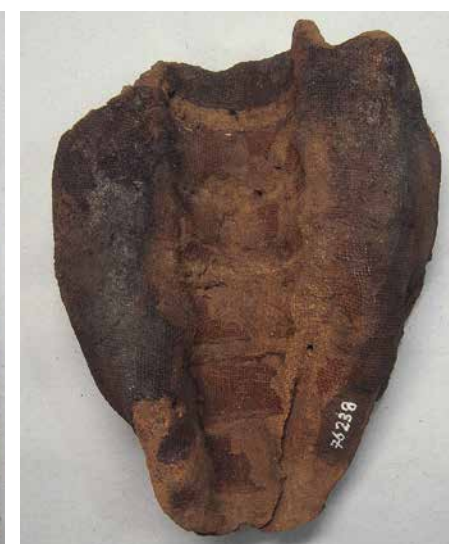
Fig. 51 a
Compact, mould infested textile with negative imprint resembling a spinal column, encased in linen fabric; soiled and infested with pale mould growth. Fig. 51 a: Photograph of the initial state. Fig. 51 b: After cleaning.

- textile fragments were vacuumed through three layers of tulle netting, smaller fragments of various materials were vacuumed (depending on fragility) in two-layer tulle pouches or sandwiched between layers of tulle netting (fig. 51). Remains of mixed materials found in the containers were sifted through fabric, sorted, and placed in labelled PE zipper lock bags;

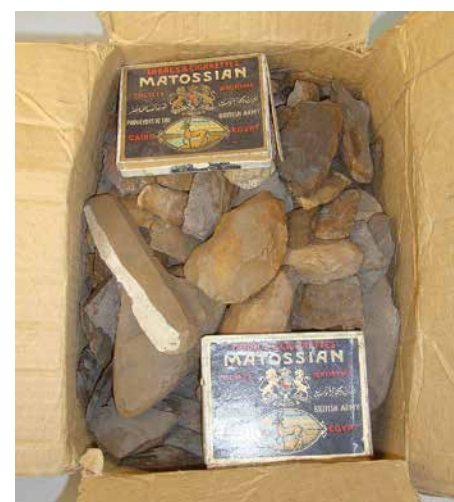
Fig. 52: Flint fragments (photograph of the initial state) and two cigarette boxes with small slivers. All were cleaned with TeraTex cloths (microfiber cloth, see fig. 14: Flints after cleaning.)

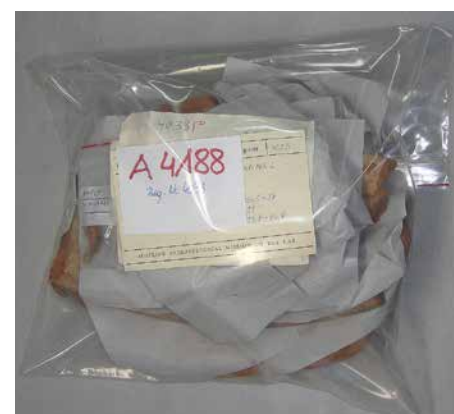
Fig. 60: Fragment of a vessel wrapped protectively in tissue paper (to prevent abrasion); then placed in a PE zipper lock bag.

When many shards belonging to one object number were stored together, strips of paper were placed between the individual pieces lying next to each other in order to prevent further abrasion (fig. 60). Shards that obviously belonged together were photographed together and packed separately within the larger group of objects. Collections of mixed materials were sorted in this way and separately packed (fig. 61). If fragments of an object whose number had already been assigned were discovered in containers with different object numbers (for unknown reasons), a reference to the situation was provided in a short condition report whenever possible (figs. 62 to 72). Fragile, flat objects were laid between pieces of tissue paper and then (if the object allowed) stabilised in a sandwich of acid-free cardboard (figs. 73 and 74).
