Technological Studies

Kunsthistorisches Museum Vienna

Special volume: Storage
Vienna, 2015

Technologische Studien Kunsthistorisches Museum.
Konservierung – Restaurierung – Forschung – Technologie,
Sonderband Depot, Band 9/10, Wien 2012/13

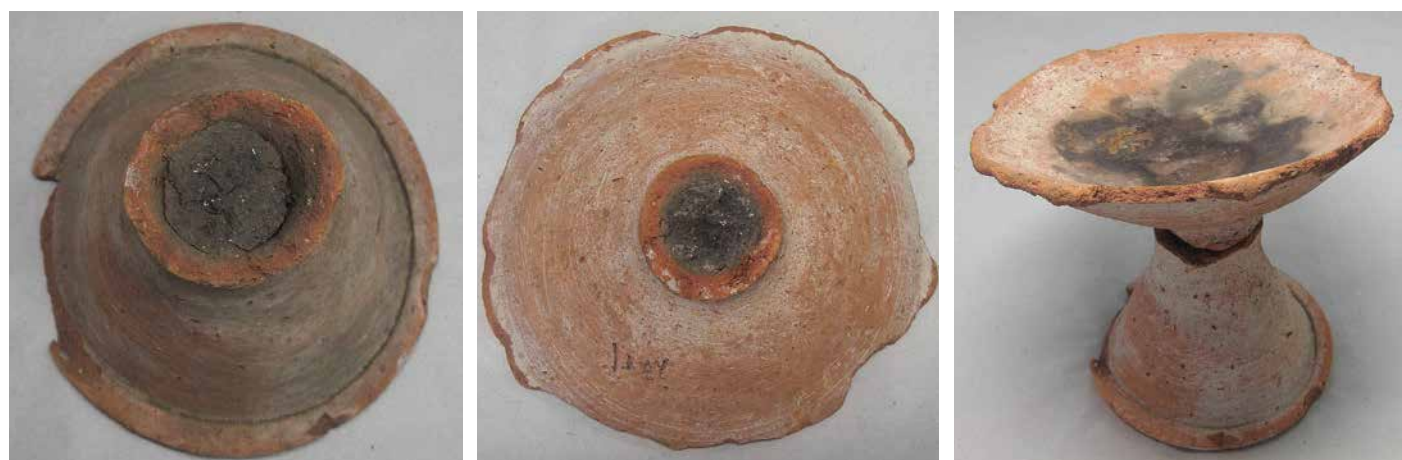
Fig. 63 a Fig. 63 b Fig. 63 c
A complete incense burner, assembled from pieces found on many different shelves, which had previously already been assembled with adhesive. The thick piece of broken-off glue fits in the broken join. Fig. 63 a: Bottom piece. Fig. 63 b: Upper piece. Fig. 63 c: Both pieces complete each other, except for a few small losses, forming the complete incense burner.

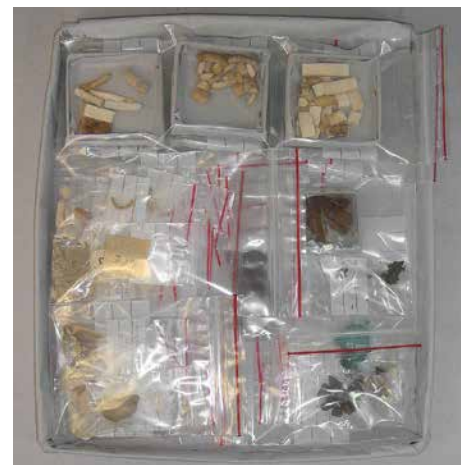
Fig. 72: Storage of all fragments found in the drawer in *fig. 65* in bags in a cardboard tray, which in turn was enclosed in a large PE zip lock bag.

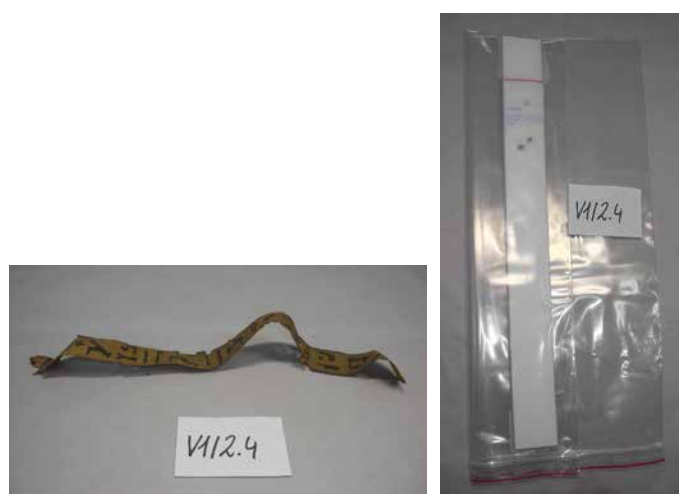
Fig. 73 a Fig. 73 b
Cardboard strips, cut out, painted, with writing. Fig. 73 a: Before treatment.
Fig. 73 b: Packed.

When many shards belonging to one object number were stored together, strips of paper were placed between the individual pieces lying next to each other in order to prevent further abrasion (fig. 60). Shards that obviously belonged together were photographed together and packed separately within the larger group of objects. Collections of mixed materials were sorted in this way and separately packed (fig. 61). If fragments of an object whose number had already been assigned were discovered in containers with different object numbers (for unknown reasons), a reference to the situation was provided in a short condition report whenever possible (figs. 62 to 72). Fragile, flat objects were laid between pieces of tissue paper and then (if the object allowed) stabilised in a sandwich of acid-free cardboard (figs. 73 and 74).

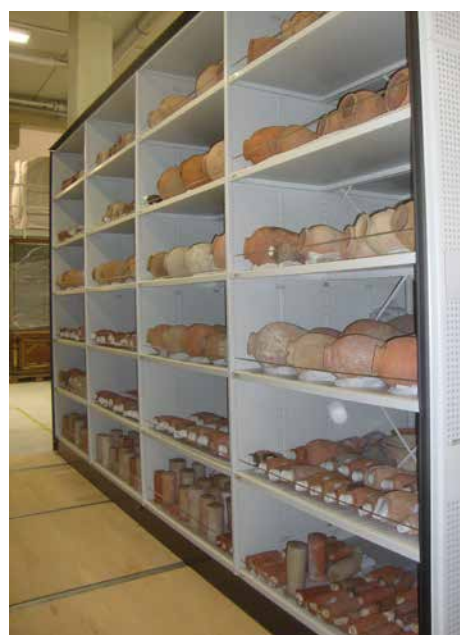
Fig. 75: Small vessels and other diverse objects closely packed in many rows.

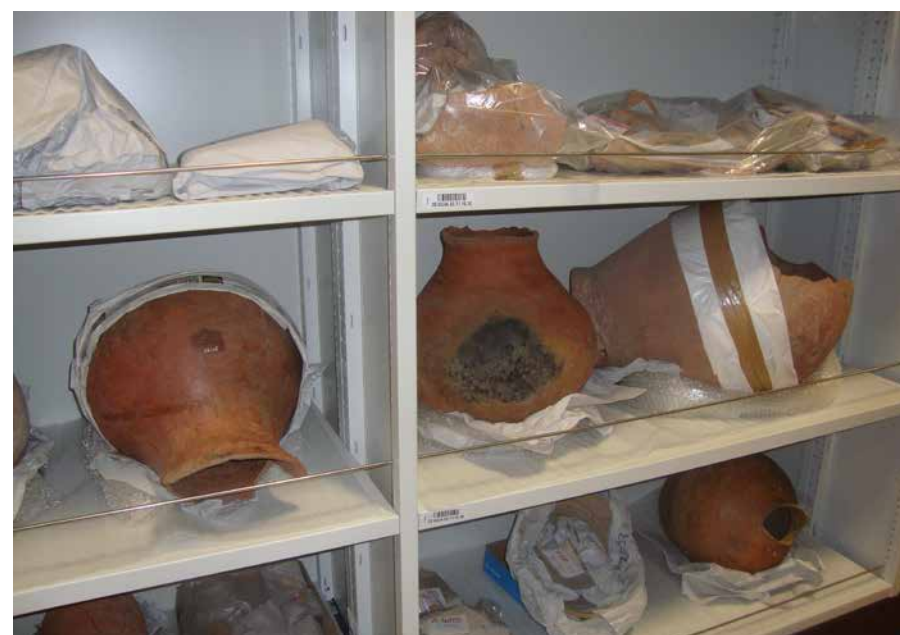
Fig. 76: Temporary circular supports made of bubble wrap for large vessels; stabilisation of loose or not completely broken off fragments and glued joints with a band made from tissue paper folded several times and packing tape; the dark remains of the adhesive tape can be seen on the vessel in the middle, left.

Small vessels with round bottoms and very convex shards were placed in paper bundles or on rotated circular stands made of tissue paper; larger, heavier vessels were placed on a circular stand made of diagonally rolled bubble wrap, whose ends were held together with packing tape, with tissue paper placed between it and the object (fig. 75). This is a temporary solution; at that moment the need for and acquisition of pollutant-free materials for long-term storage was delayed (figs. 76 and 77).

Large ceramic vessels, whose instability stems from partial breaks, or fragmented, previously repaired (glued) receptacles, whose adhesive has deteriorated over time, were supported with a band of tissue paper folded several times, which was then wrapped tightly around the vessel and closed with packing tape (one could have also used an adhesive bandage). They showed damage from previous, temporary stabilisation with adhesive tape used to hold together the shards; examples of these usually low-fired ceramic surfaces demonstrate the resulting tearing away of surface particles and sometimes embedded remains of adhesive (*see fig. 76*).

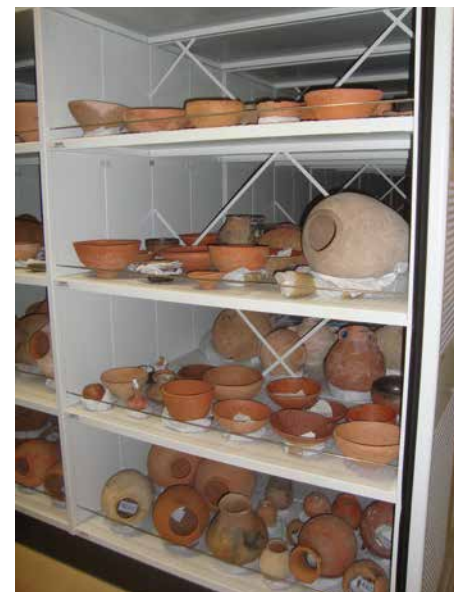
Fig. 77: Temporary circular supports made of packing paper for smaller vessels and for bulbous shards stacked on top of one another.

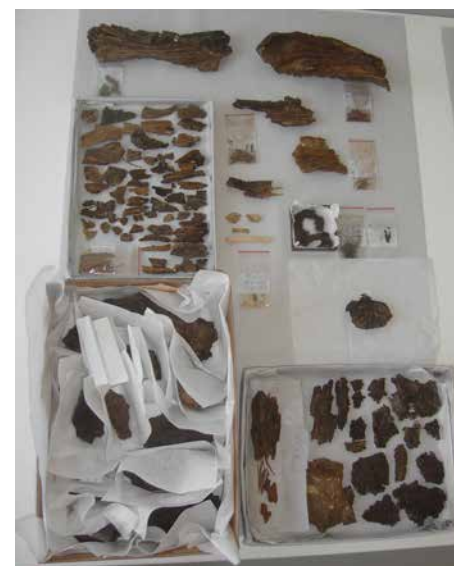
Fig. 78: Photograph during packing (*see fig. 24*), detail: (ca. one third) of the countless braided fragments; after cleaning.

We collected copier-paper boxes (DIN A4, A3; *fig. 78*) because they proved to have an extremely beneficial format for our purposes, as well as large, intact shoe boxes; occasional, unusual object formats required production of customised boxes from acid-free cardboard (*fig. 79*).

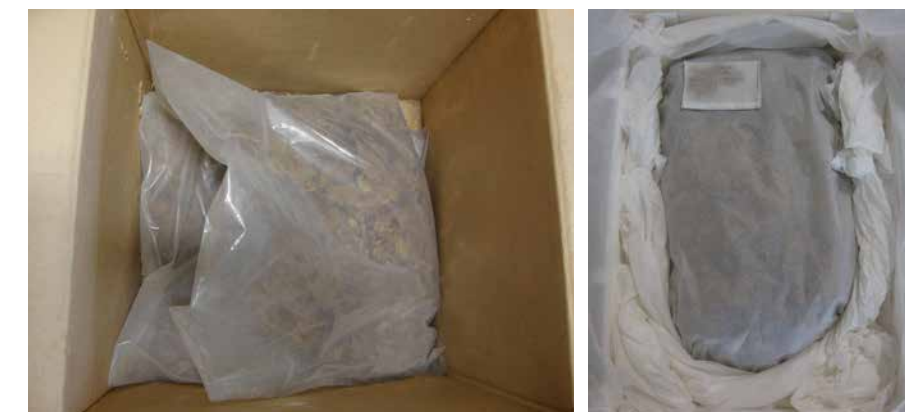
Fig. 79 a: A storage box made on site in the storage facility in Himberg from pollutant-free corrugated cardboard for a combination of fur and textile fragments with coloured, felted, remains and two-colour twine fragments and a bone and hair from a burial. The objects are enclosed in two sealed plastic bags, each with three diagonally cut corners. The bags originate from the excavation site. The three cut corners should prevent the formation of an unfavourable microclimate inside the bag.

cut corners in order to prevent the formation of an unfavourable microclimate) (see fig. 79 a). Occasionally, objects were found in original receptacles – in easy to hold, typical storage containers for everyday use on the excavation site at that time: for example, many different brands of cigarette cartons, wooden cigar boxes, elegant candy boxes, tin cans, canned fish containers, a tin canister without a bottom with Arabic stamps, etc. The excavation number is often handwritten on the containers. A few selected examples of historic excavation receptacles were dry surface cleaned and added separately to the collection inventory (figs. 56 to 59; see also figs. 4, 12, 33 a and 36). The documents and torn slips of paper found with the objects (aged, in some cases already torn or brittle), some of which included sketches, were also treated. These documents, sometimes up to four pieces, were placed into suitable PE zip lock bags and packed with the object.

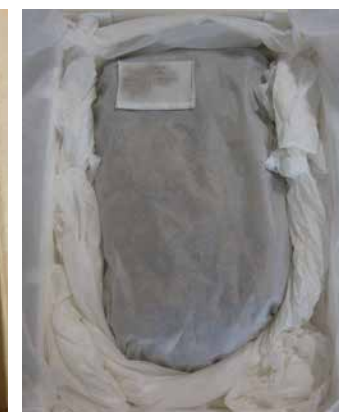
Fig. 79 c: New packing of the contents shown in *fig. 79 b* in acid-free tissue paper and placed on a cardboard support with cotton twill tape to lift the entire assembly.

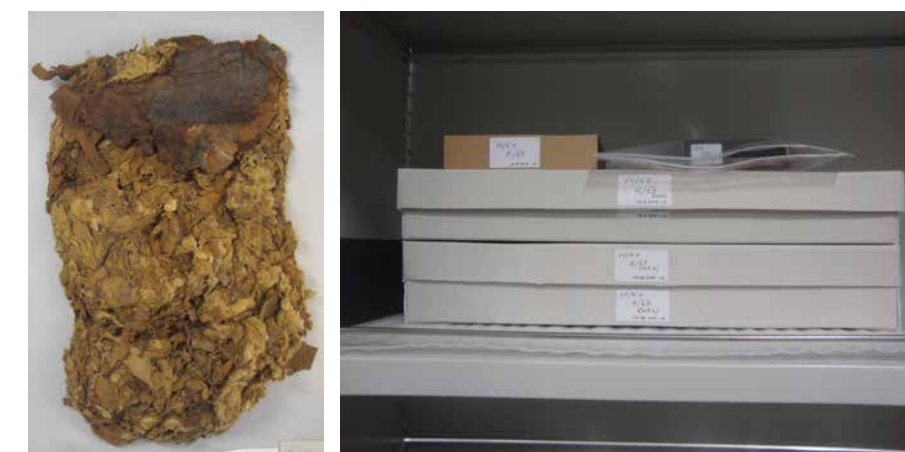
Fig. 79 b: Contents of one of the plastic bags. Fig. 79 d: Completed packing of the objects.

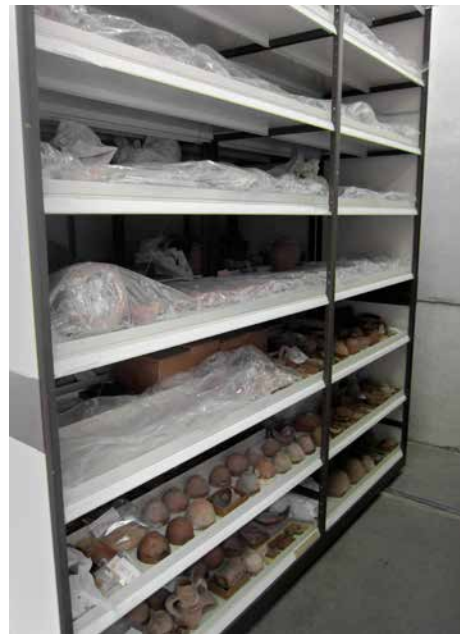
Fig. 80: Inzersdorf storage facility: above: temporary storage of cleaned objects. Some have been placed in PE zip lock bags or without additional packing materials under a thin PE cover sheet folded one time (see fig. 2: storage of cylinders, vessels without additional materials). Below: objects not yet cleaned.

A clean area was established in the rolling shelving units in Inzersdorf for the cleaned objects until they could be moved because there was no other possibility for them: the 30 cm deep shelves were lined with a thin, PE sheeting folded one time (the depth and height was determined by the tallest object on the shelf), so that the objects and fragments in their PE zip lock bags along with their documentation and sketches (and their subgroups) could be placed between the layers of protective PE sheets. Most of the air had been pressed out of the PE bags (fig. 80). Similar objects (e.g., cylindrical glass or stone vessels) were placed standing on the shelves in compact rows (two to three deep) with no additional cover; the protruding material from the zip lock bags would have reduced their standing stability and the available storage space in the shelves. Large vessels were individually wrapped in thin sheeting (see figs. 2, 76, 77, 80 and fig. 81).

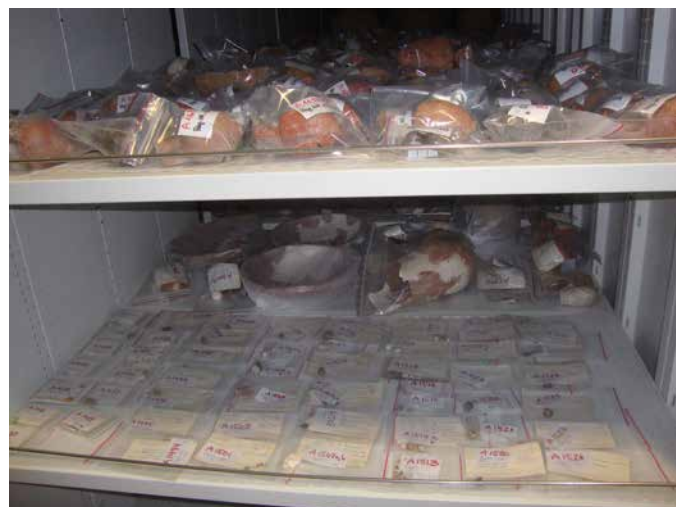
Fig. 81: Small objects remained with their accompanying documentation in PE zip lock bags fitted to the documents.

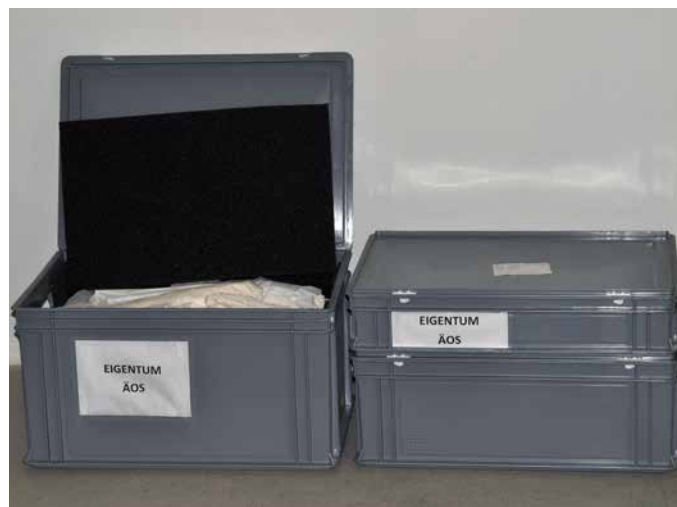
Fig. 82: Grey plastic containers in three sizes with an additional Ethafoam lining and/or cardboard trays were one solution used during the move.

Further packing of the small objects in typical cardboard moving boxes could be quickly accomplished because of the implemented packing methods. Some of the boxes originating from the move of the Collection of Greek and Roman Antiquities were already lined with foam rubber, or were outfitted with tissue paper bundles air cushions, and/or Ethafoam sheets serving as stabilising packing materials. Grey plastic containers in three different sizes (14/24/34 cm high, 60 × 39.5 cm square), used for transport of objects within the collection, were also used (fig. 82). Several very large vessels were packed in a large wooden

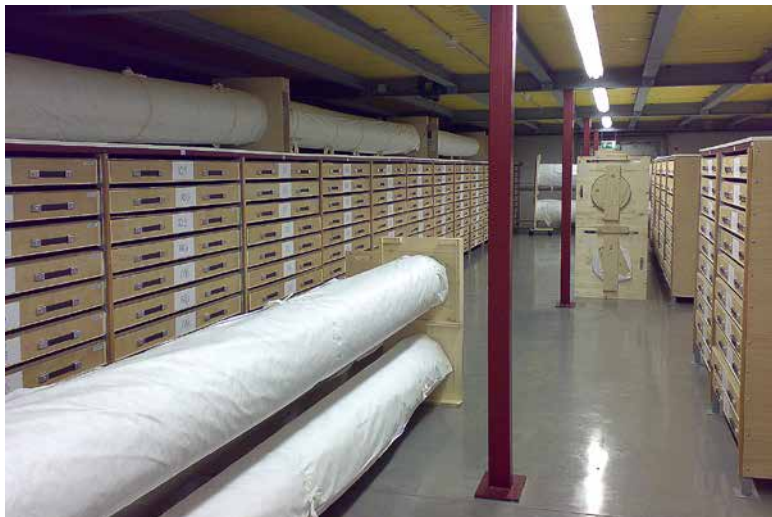
Fig. 3: The first rolled-up tapestries in the repository in the 23rd district (after 2003).

By the time the tapestry collection was moved to the newly built repository in September 2011, 65 of the tapestries were already put on rolls (*fig. 3*). The stated objective, long before the construction of the new storage facility, was the future storage of all tapestries on rolls, each on its own roll and with a specific location in the shelving system. For small-scale objects such as seat covers, flat storage solutions were devised. Enabling easy access to the tapestries, and the development of a system for the gentle and simple handling of the objects was also a priority. The use of archival storage materials was a pre-condition from the conservator’s point of view.

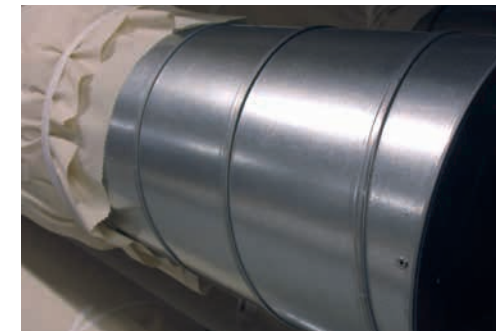
Fig. 5: Handling surface of the folded spiral-seam pipe.

20 cm width were added to these measurements on either side to facilitate handling of the pipes and their resting on the shelf (fig. 5). Following in-depth study of all the tapestries, the holdings could be categorised and distributed onto six lengths of pipes with measurements of 600, 550, 500, 450, 400 and . With regards to the diameter of the rolls, two variants of 25 and 35 cm were chosen, with the addition of c. 5 cm for the build-up and the wrapping elaborated below.

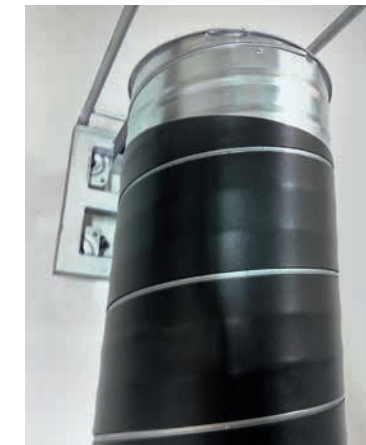
Fig. 6: Wrapping of the folded spiral-seam pipes with Plastazote (PE foam) cut into narrow strips (first step).

Due to the spiral fold of the pipes, it was imperative that they should be adapted to their new use. The stated objective consisted in providing a homogenous surface suitable to accommodating the rolling-up of the tapestries. After a test phase with various materials, Plastazote (PE foam material on reels) was chosen for wrapping around the pipes. The wrapping procedure was divided into three steps. Narrow strips of cut Plastazote with a thickness of 2.5 mm (corresponding to the thickness of the folds on the pipes) were used to fill the space between the folds (fig. 6). The pipe was then wrapped with a second layer of Plastazote of 5 mm thickness to achieve an even surface (fig. 7).

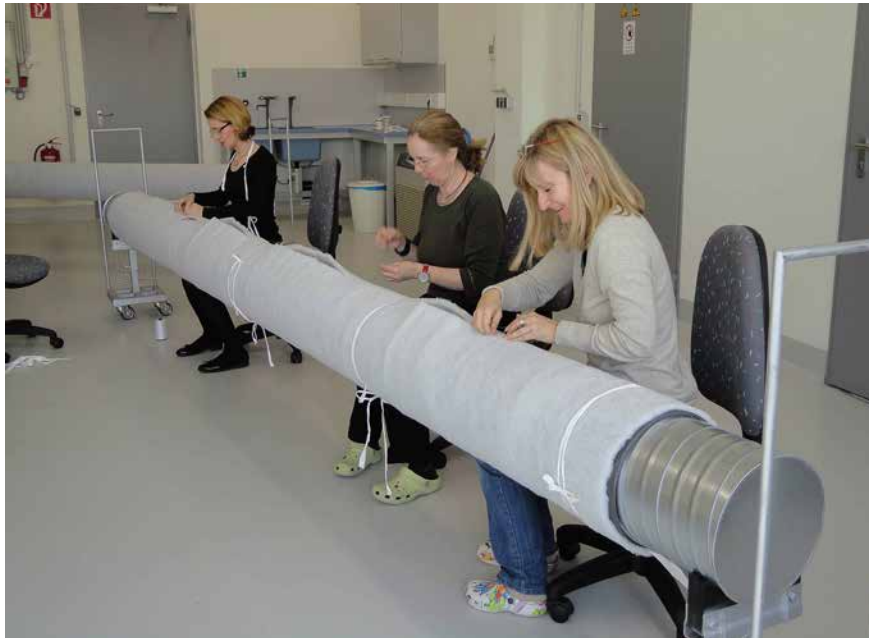
Fig. 8: Wrapping of the folded spiral-seam pipes with polyester fleece (third step).

The fact that the tapestries had been folded up for decades proved to be problematic, as the folds were clearly distinguishable in the fabric. To prevent breaking of the fibres, the rolls were therefore wrapped with polyester fleece in a third step, as it gives way to the tapestry's movements (fig. 8). The three-layered wrapping does not however cover the whole length of the pipes. Areas of 20 cm were left bare on both sides of the pipes, without Plastazote and polyester fleece, to facilitate their handling and resting on the shelf. The visual division of object and handling areas serves, amongst other things, to protect the objects. To secure and simultaneously stabilise the sharp-edged ends of the pipes, they were riveted with lids (fig. 9).

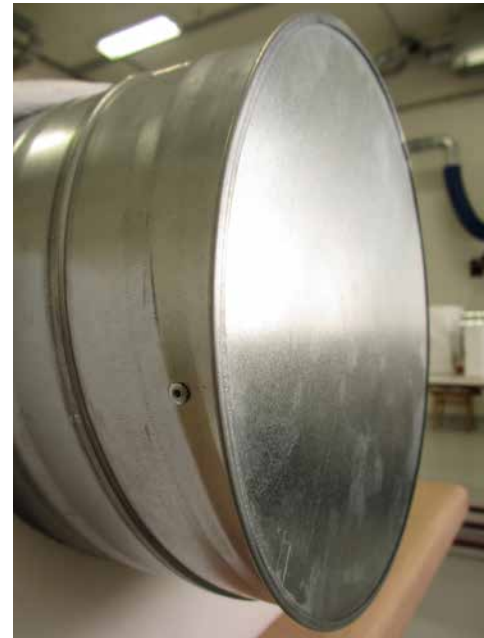
Fig. 9: Riveted lids of the folded spiral-seam pipes.

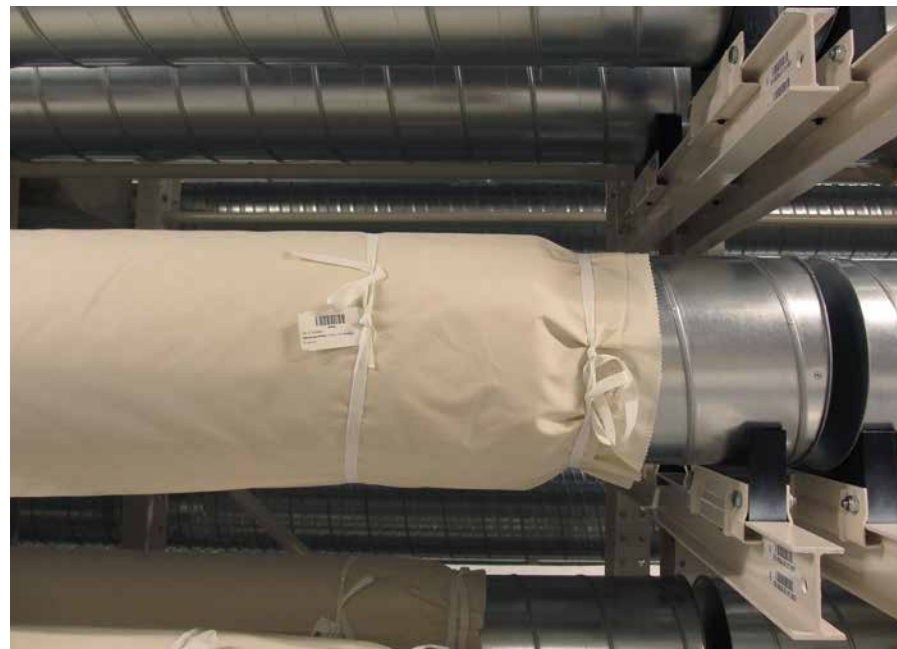
Fig. 10: Dust protection of the rolled-up tapestries by an outer layer of thin cotton fabric.

During the rolling-up process, the surface of the tapestries mounted onto the pipes was protected by Cellplas,⁸ which was rolled on with the tapestries. The same material served as an intermediary layer between the tapestry and the fleece. Externally, the rolled objects are protected from dust by a thin cotton fabric. Loosely knotted cotton ribbons were used to hold the fabric in place (fig. 10).⁹

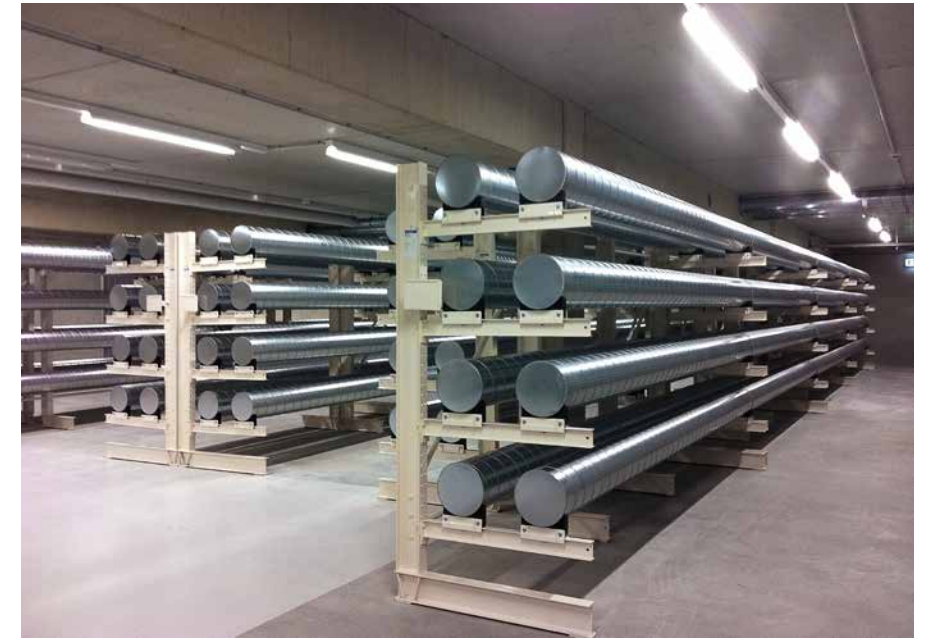
Fig. 11: Shelves for storage of the tapestries rolled onto folded spiral-seam pipes.

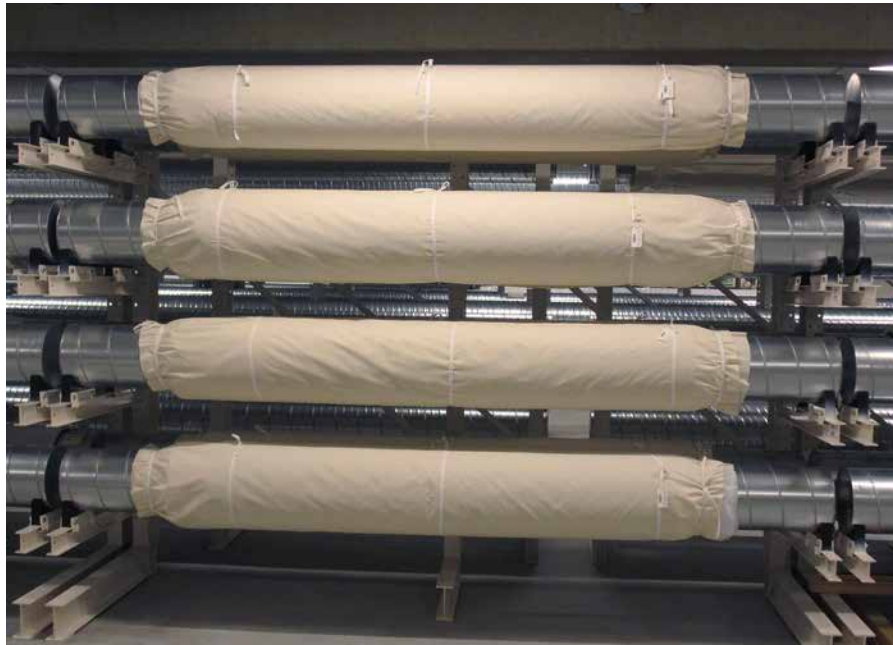
Fig. 13: Shelf with eight folded spiral-seam pipes.

The horizontal pairs of cantilever arms support two tapestry rolls each, one behind the other, in order to make optimum use of the limited space available. Each shelf fits four superimposed pairs of cantilevers, so that one shelf provides space for eight tapestries in total (fig. 13). The distance between the cantilever arms as well as between the half-shells attached to them – thus between the tapestries – is flexible and based upon the size of the rolled objects; the cantilevers are height-adjustable via adjustment steps in units of 50 mm. The half-shells sitting on these arms can be fixed into any desired position with a system of screws.

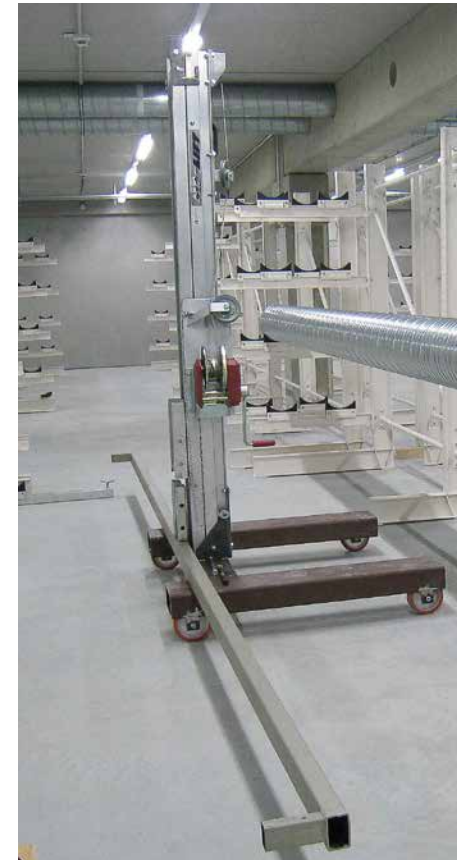
Fig. 14: Lifting apparatus.

A mechanical, mobile lifting apparatus was developed for the handling of the tapestry rolls arranged in four superimposed rows (fig. 14). It has variable lateral extension arms at its disposal, which can be adjusted to the width of the shelf in question, and regulated to any desired height with a crank handle. To each end of the extension arms, one half-shell sitting on a cantilever arm is fixed at a 90 degree angle (with short cantilevers for rolls at the front of the shelf, and longer ones for those in the second row). The extension arms with laterally affixed half-shells on the lifting apparatus standing in front of the shelf, are regulated to such a height that they are positioned between two cantilevers or underneath the lowest cantilever of any shelf respectively; this positioning depends on the tapestry to be displaced. Through targeted movement of the lifting apparatus in the direction of the shelf, the half-shell can be positioned directly below the tapestry roll in the 20 cm wide handling area, and the extension arms lifted by the slow turning of the crank. Through a backwards movement of the apparatus, it is possible to remove the tapestry from the shelf (fig. 15).

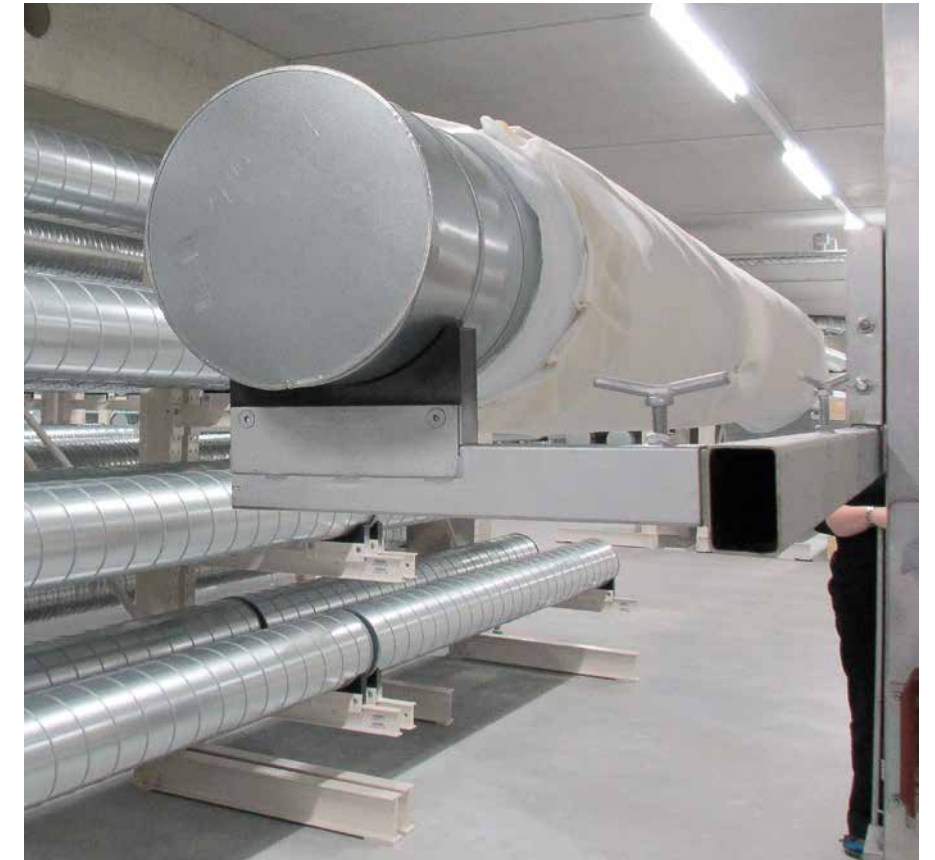
Fig. 15: Lifting apparatus in action.

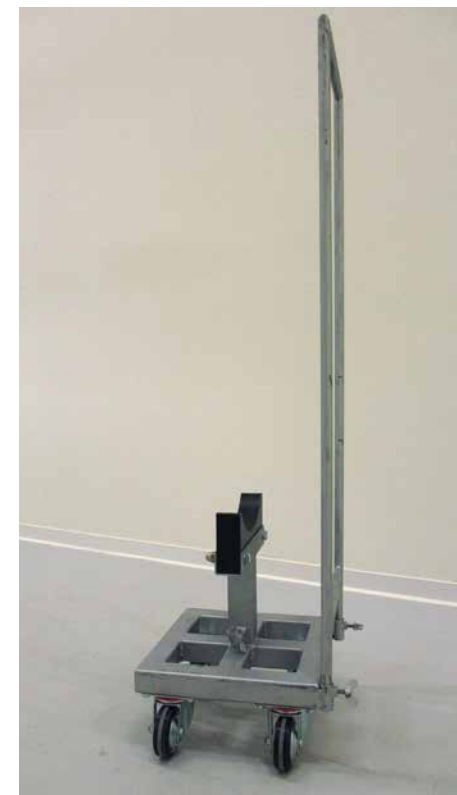
Fig. 16: Dolly with half-shells for handling the tapestries rolled-up onto folded spiral-seam pipes.

The rows of shelves offer sufficient space for this backwards movement of the lifting apparatus. Even in front of the shelf, it is possible to gently lower the tapestry to be manipulated by turning the crank, and rest its ends on the specially designed dolly which has also been equipped with half-shells (fig. 16). On this dolly it is possible to move the tapestry to any given location.

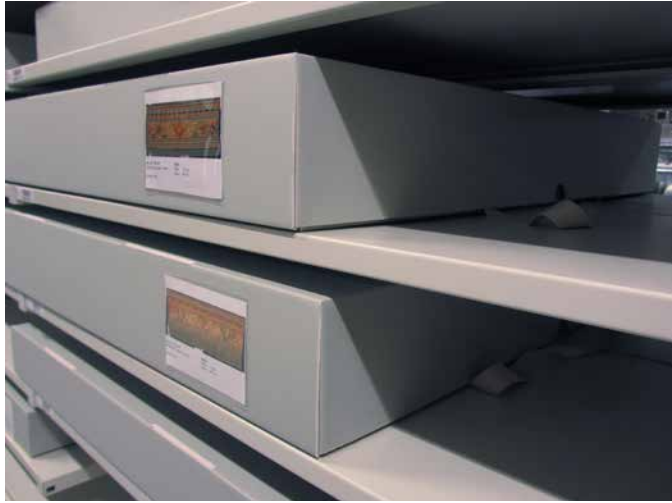
Fig. 17: Support-free shelving with acid-free cardboard boxes.

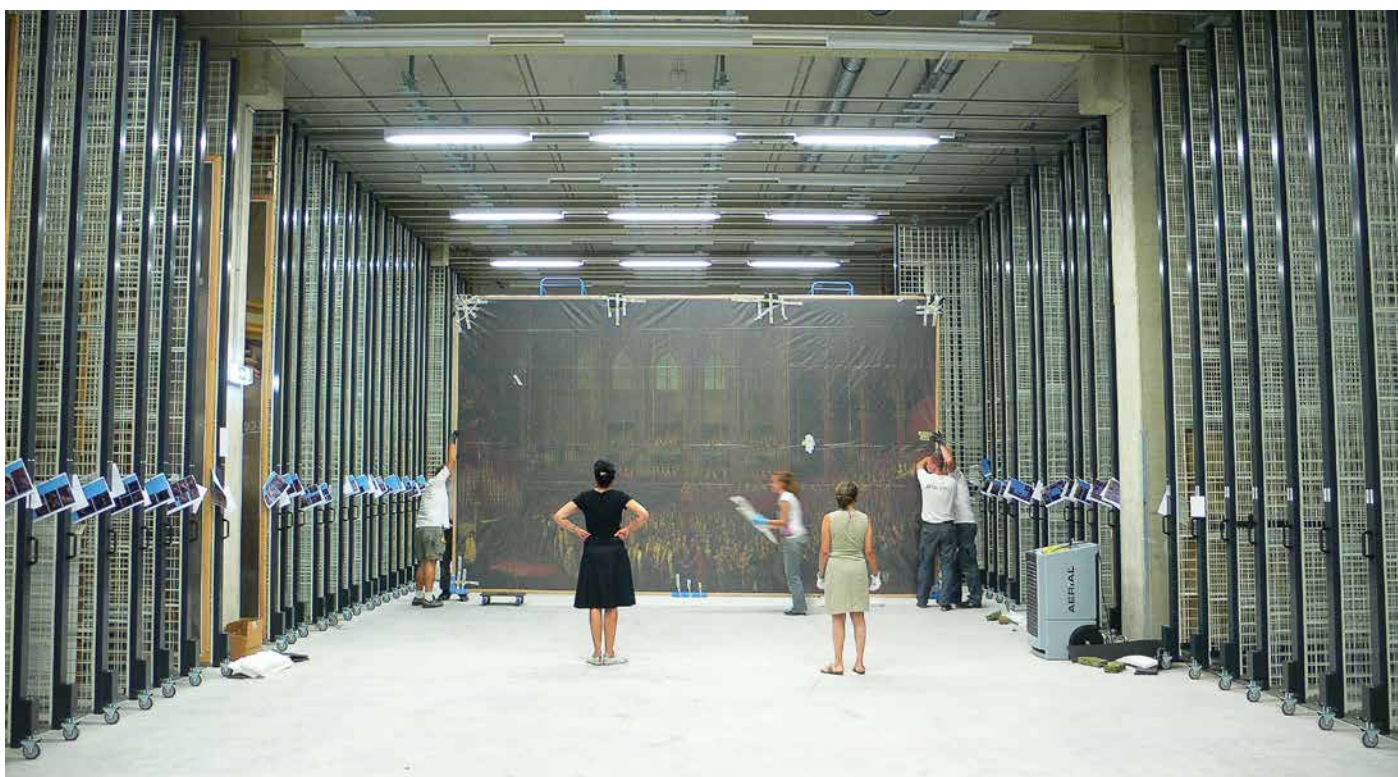
Fig. 1 b: At the new centralised storage facility, there is room even for the largest formats on the wire mesh walls of the pull-out picture racks. Picture of a large format wrapped in PE foil, taken during the relocation campaign.

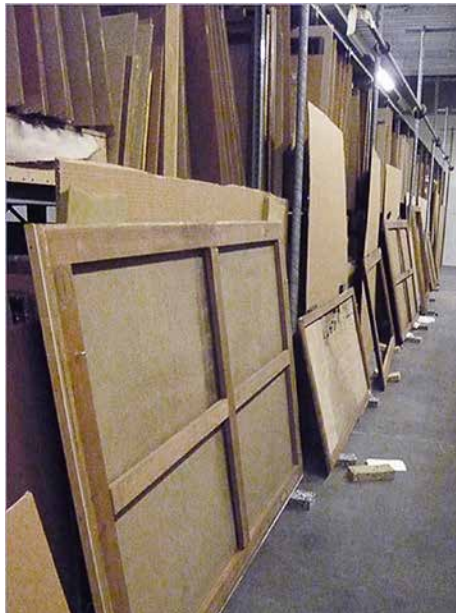
Fig. 2: The frames were for the most part accommodated on shelves, which were similarly difficult to access.

The storage facility in Inzersdorf initially constituted a marked improvement in comparison with the previous storage situation, due to an increase in space and superior control of climatic conditions. However, the building's structural defects, such as the aged flat roof especially, increased over the years and seriously put the paintings at risk, finally leading to the artworks being concentrated in several areas of the repository, making a proper order difficult to maintain (figs. 1 a and 2).

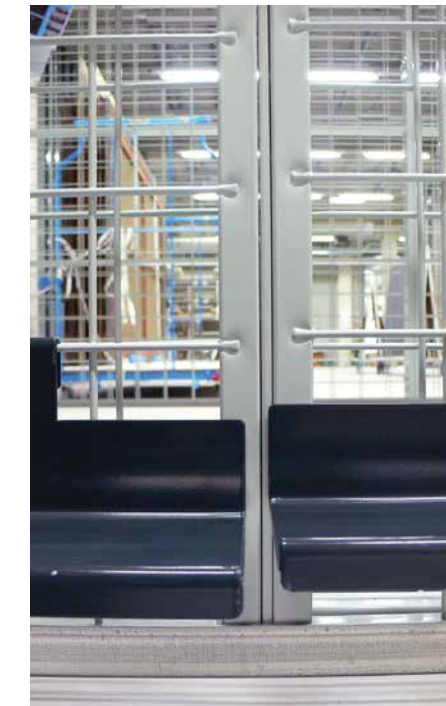
Fig. 4: The installation should be monitored very closely. At the new storage facility, the fact that the wire mesh panels had not been assembled so that they fit perfectly in some places was only noticed relatively late. The resulting slight misalignment is especially bothersome when using the additional support elements to be hooked in individually. Unfortunately this could not be rectified, as a very large number of paintings had already been hung on the racks at that point.

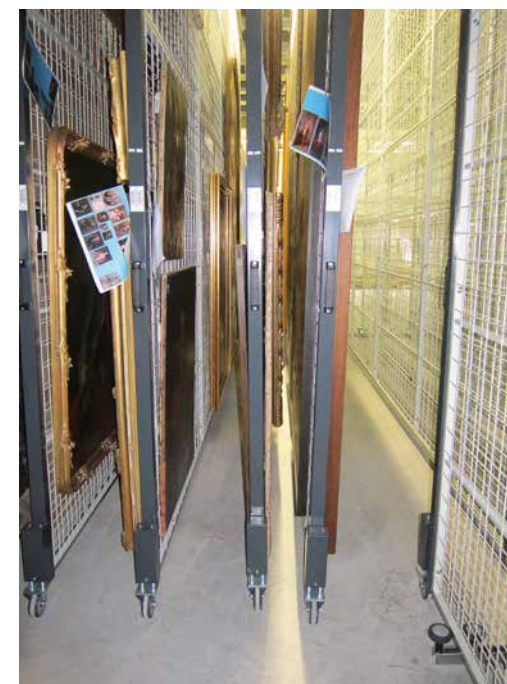
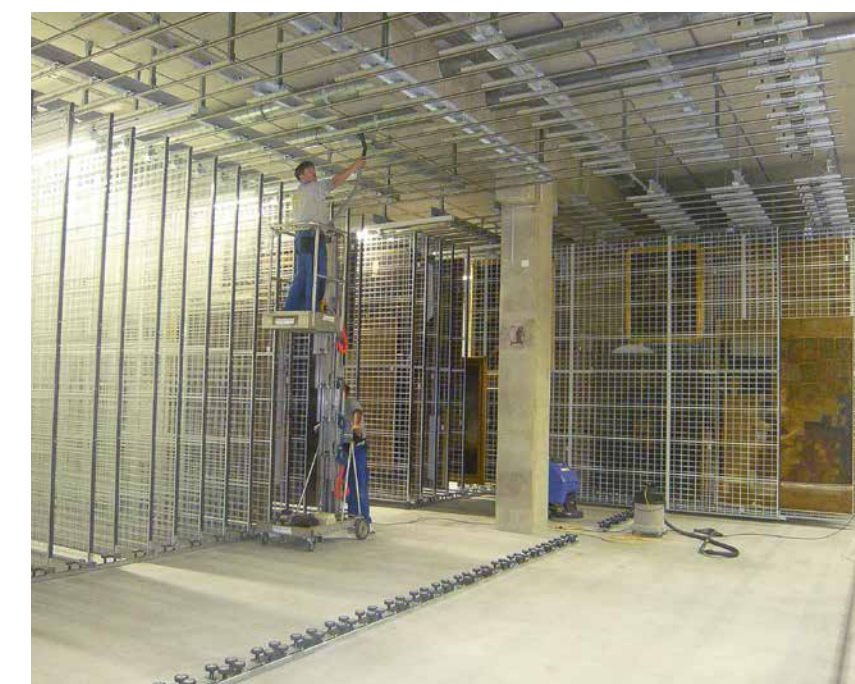
Fig. 5 a

A ceiling-running system with linear guide and an additional floor roller was chosen for the new storage building. The individual wire mesh walls are easy to pull out, with hardly any vibration. Some smaller issues unfortunately only became apparent during use. For example, when pulling out two adjoining wire mesh walls, there is a danger that they run in slightly different directions. This can lead to the distance between the individual walls being significantly reduced, as can be seen in Fig. 5 a. In order to guarantee a fixed trajectory of the wire mesh walls, all the wheels were very precisely adjusted, and a second guide rail subsequently put in place. This can be seen in Fig. 5 b. The picture was taken during the annual general cleaning campaign. Moreover, it was discovered that the floor rollers have a tendency to become flat, so that it is advisable to slightly shift the positions of the walls at regular intervals.

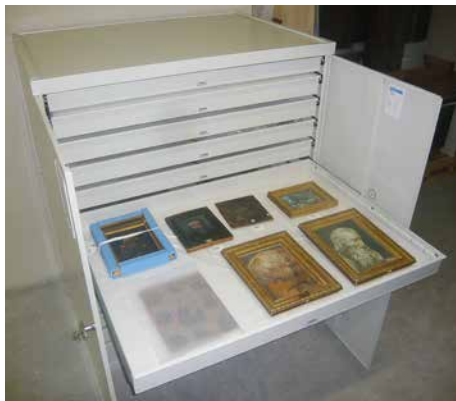
Fig. 6: A number of particularly fragile paintings that require flat storage are housed in a flat file cabinet, such as the two portraits at the bottom right for example, which are “painted” using tree bark and leaves.

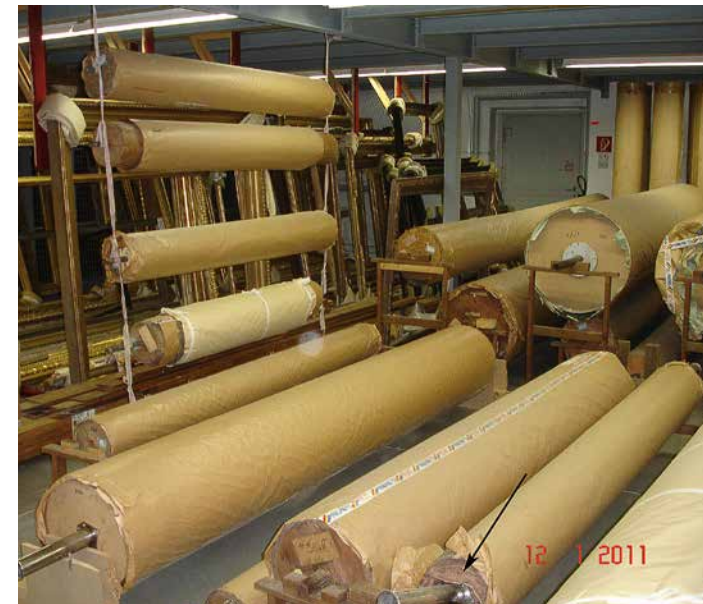
Fig. 7: A total of 78 paintings were stored on 18 rolls, which differed greatly in construction and had become unstable in places. Note the fractured head of one of the rolls at the bottom right (marked by the arrow).

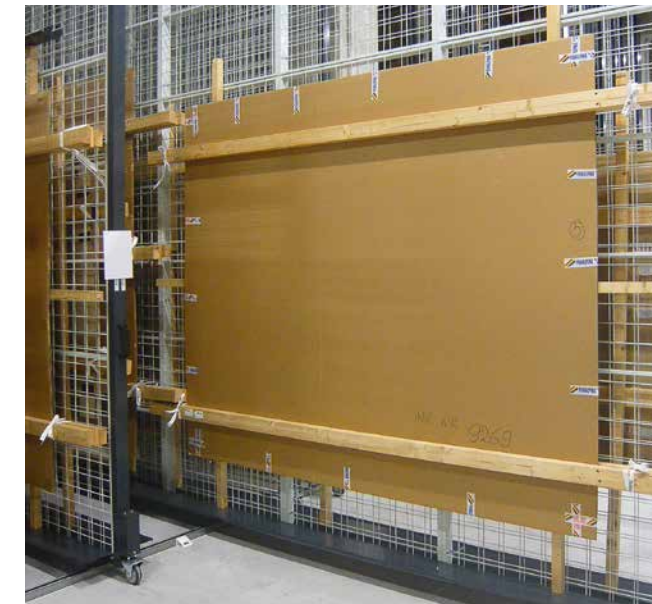
Fig. 8: Some paintings without stretchers had already been stored upright since 2003. The unstretched canvases are pressed between sheets of cardboard and held by wooden braces, which are bolted together. These makeshift structures were left in place for the relocation, however the long-term plan is to consolidate and restretch them. This picture shows the current form of storage at the new central facility, with the paintings tied to the wire mesh wall and resting on individually mounted support elements. The distance between the walls is slightly larger here than in other areas of the building.

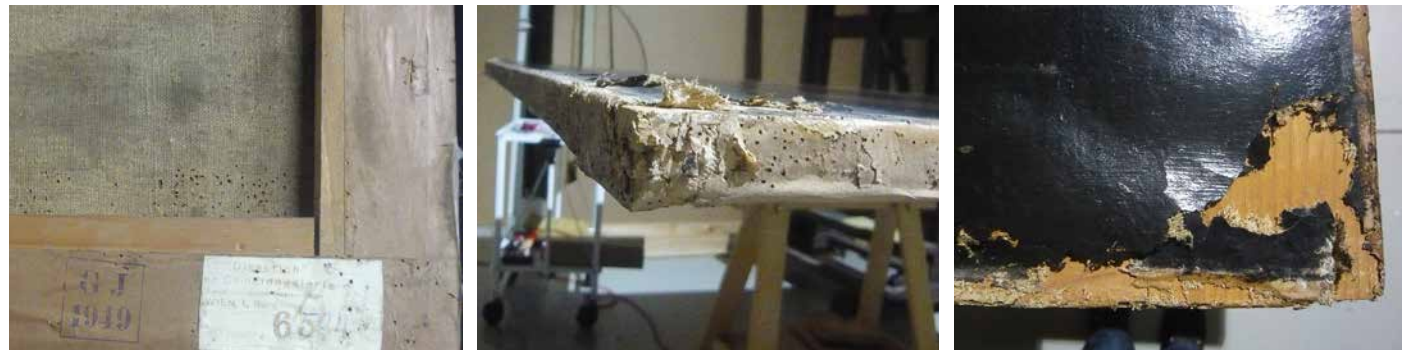
The biscuit beetle favours paintings with starch paste linings as a habitat. A few typical damages are shown here: Fig. 9 a shows the verso of a painting with the typical exit holes. Fig. 9 b and 9 c illustrate the fact that especially areas of the painting which are usually hidden by the frame rebate are often damaged, making an infestation difficult to recognise during the early stages. If it is not noticed in time, the damage to the support can be so significant that large areas of the original may be lost.

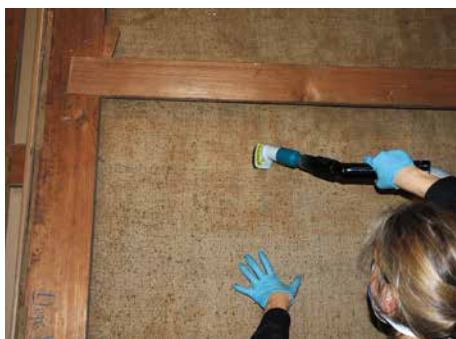
Fig. 12: Old, inactive mould spores were cleaned away using vacuum cleaners equipped with HEPA-filters.

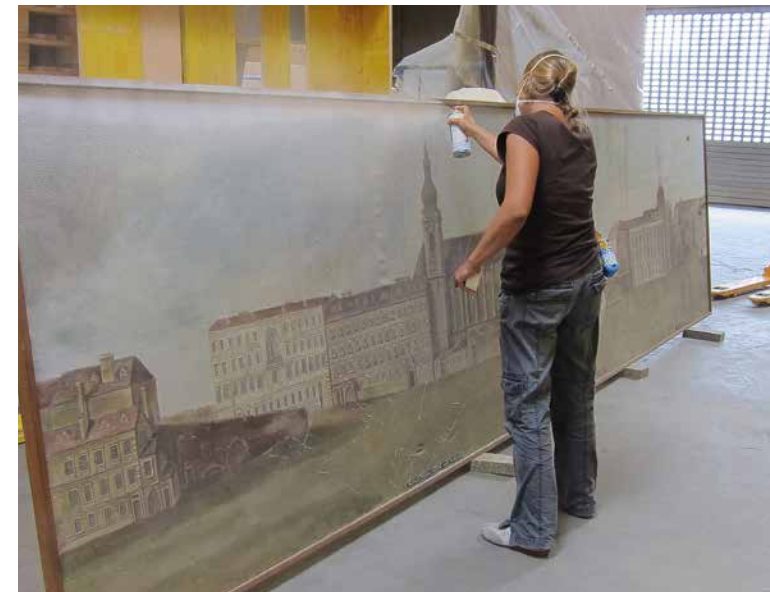
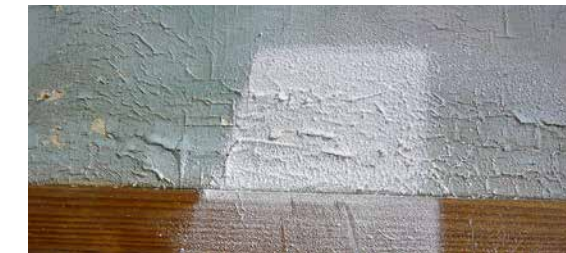
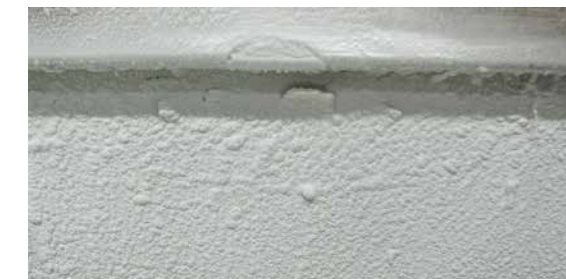
Fig. 13 a

Parts of the very matte, underbound and partly flaking paint layer of this painting were temporarily consolidated for transport using cyclododecane. Fig. 13 b shows a preliminary test, Fig. 13 c a detail with a lifting, but secured flake of paint after transport.

Numerous paintings exhibited areas of flaking paint, which were consolidated using mostly sturgeon glue, and sporadically acrylic dispersions.¹⁷ In one special case, cyclododecane was employed to temporarily stabilise very underbound, matte, flaking paint that had been loosened by an old water damage (fig. 13).

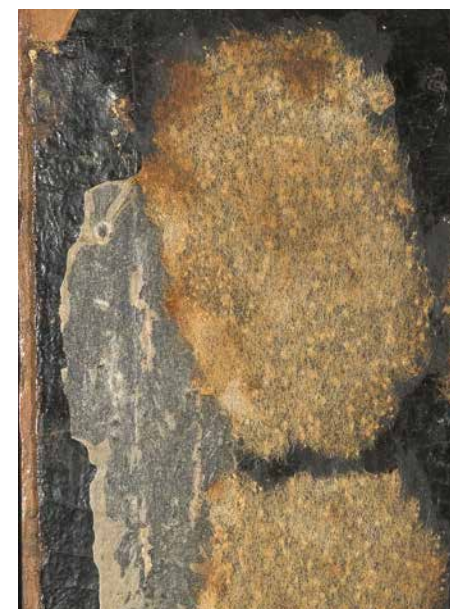
Fig. 14: Several types of paper were used as facing materials over the years. Some of the facings with Japanese tissue paper are noticeably discoloured. Analysis of the binding medium of these protective papers, which had only been applied in the 1980s, has revealed that the browning and crystallisation phenomena stem from the use of honey in the consolidating material.

¹⁸ A diploma thesis examined paper facings from the 1980s found on a painting in the Kunsthistorisches Museum's collection. It established that the browning and crystallisation phenomena could be ascribed to the use of honey in the adhesive. (U. Heinisch, *Aus dem Bestand marouffierter Gemälde des Kunsthistorischen Museums Wien: Restaurierungsgeschichte und Behandlungsmöglichkeiten, exemplarisch anhand des Gemäldes Damenportrait, Leinwand auf Holz, 53 × 44 cm, nach 1600*, diploma thesis, Academy of Fine Arts Vienna, Vienna, 2007.)

Japanese tissue paper. The facings covering the whole surface of paintings were usually executed using newsprint. Mixtures of starch paste and glue as well as methylcellulose were probably used as adhesives, most of the facings are still water soluble even today. Some facings however are very difficult to remove at this point, the adhesion being stronger between facing and paint layer than between support and paint layer in some areas. In addition, the papers exhibit partial, sometimes severe discolouration (fig. 14)¹⁸ or feeding traces from silverfish.

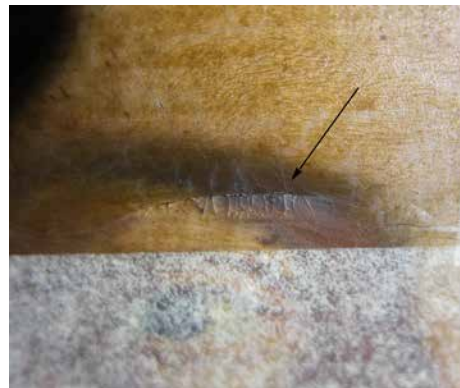
Fig. 15: In some cases, the facings have caused new damages, for example to this painting. Tension in the consolidating adhesive, which has been applied beyond the paper, is pulling up the paint layer and causing cupping (note the arrow).

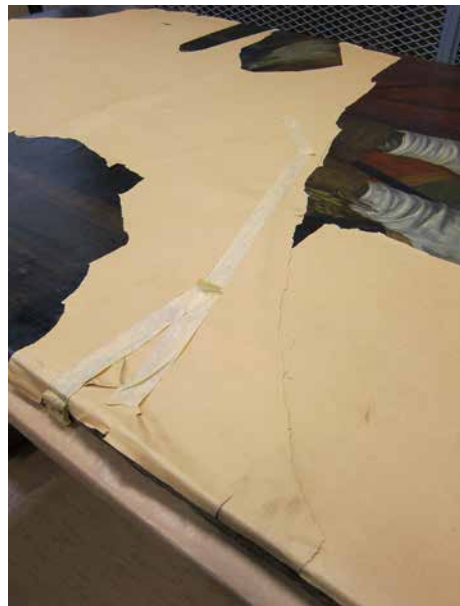
Fig. 16: Some facings had become almost entirely detached over the years. They were removed completely where possible, and the paint layer partly consolidated.

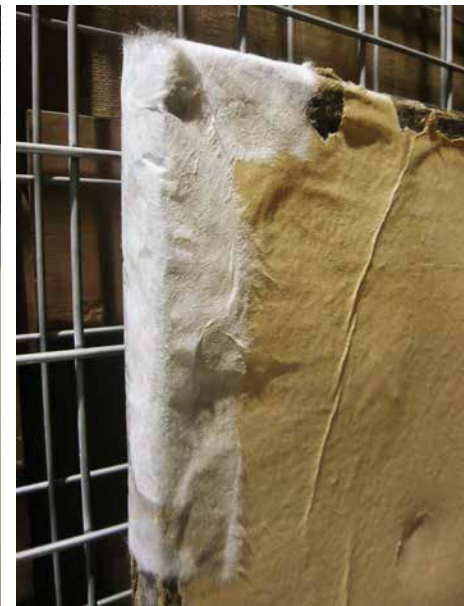
Fig. 17: Old, strongly bonded facings, which, together with parts of the paint layer, had become detached due to mechanical strains, were re-adhered using new Japanese paper facings.

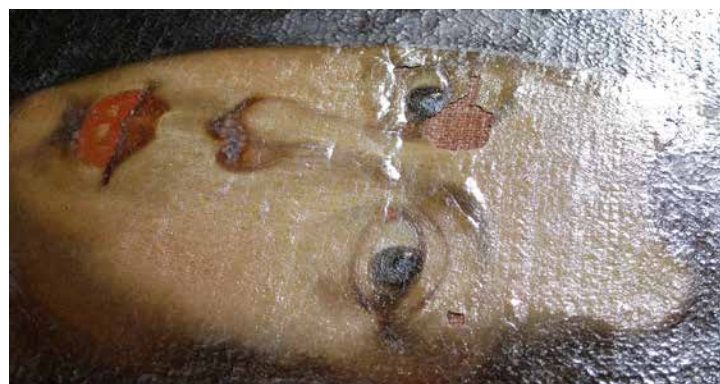
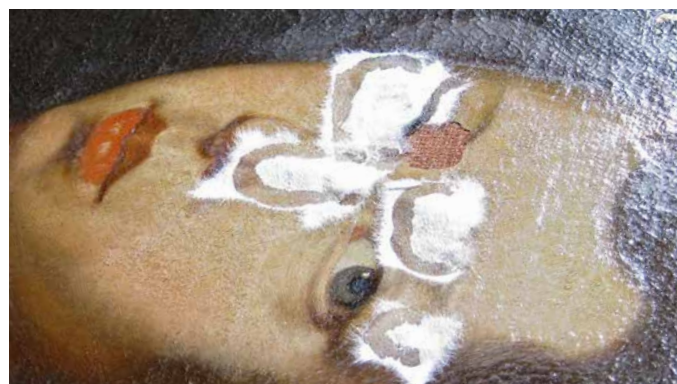
Fig. 18 a

Detail of a newly applied facing. In order to keep the use of temporary facings to a minimum, where possible, it was not the loose paint flakes themselves that were secured, but merely the areas around them, so that the paper could be removed after transport without causing further damage. If worst came to worst, a detached paint flake would not be lost, but would remain in the paper.

New facings were only applied in exceptional cases, where consolidation of the paint was not possible, if for example the support was too badly damaged or the paint layer extremely embrittled. In those cases, Japanese paper was locally affixed with methylcellulose (fig. 18).
