Technological Studies

Kunsthistorisches Museum Vienna

Special volume: Storage
Vienna, 2015

Technologische Studien Kunsthistorisches Museum.
Konservierung – Restaurierung – Forschung – Technologie,
Sonderband Depot, Band 9/10, Wien 2012/13

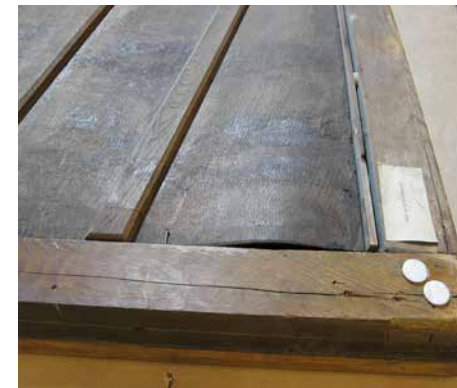
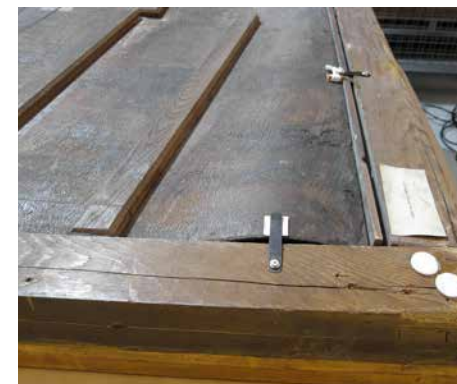
Fig. 19 a

The strongly warped panel was mounted in the frame with nails, a stiff attachment that was replaced with flexible fixing plates.

A stable or stabilised support is a fundamental prerequisite for damage-free transport. With regards to panel paintings, it was primarily their mounting in the frame which was checked and improved where necessary (fig. 19). Occasionally, individual frame rebates were adapted to the warp of the panel using blocks of Ethafoam that were cut to shape in-situ, as a provisional measure (fig. 20). A few of them received new protective wooden frames, custom-made by the Museum's carpenters and frame makers. Seven particularly fragile panels, which were extremely warped, weakened by former pest infestation, or had been thinned significantly, were brought to the Picture Gallery's conservation studio for the time being, to receive conservation framing which would guarantee solid mounting in the long term.

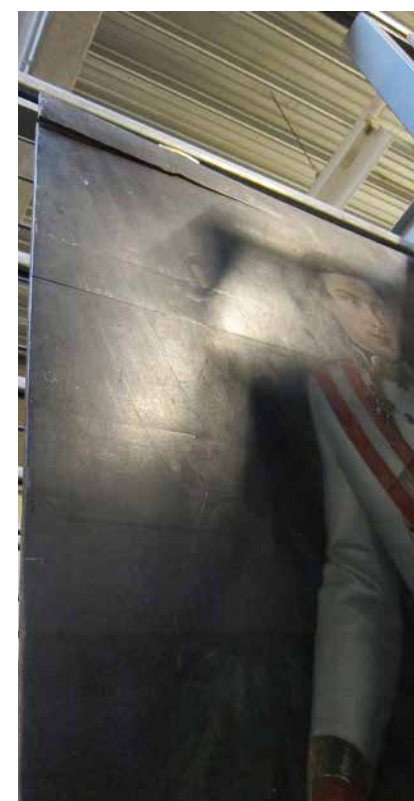
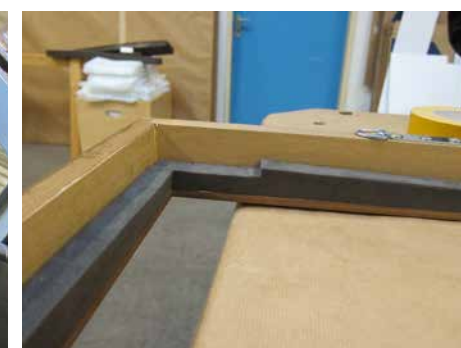
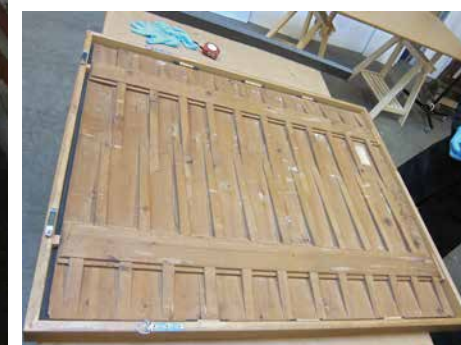
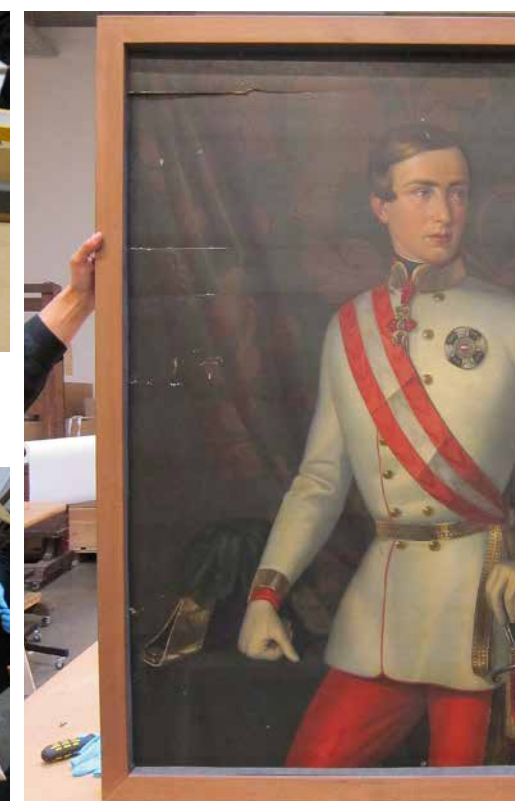
Fig. 20 a

Wooden protective frame with Ethafoam profile that was adapted in situ. The panel has multiple splits, and is under extreme tension from a wooden structure glued to its verso. The eyebolts for hanging were screwed directly into this wooden structure. A wooden protective frame made by the in-house carpenters was fitted with a provisional Ethafoam profile in situ. Following the application of a backing board and flexible mounting with fixing plates, the painting is once again sufficiently stable for transport and storage.

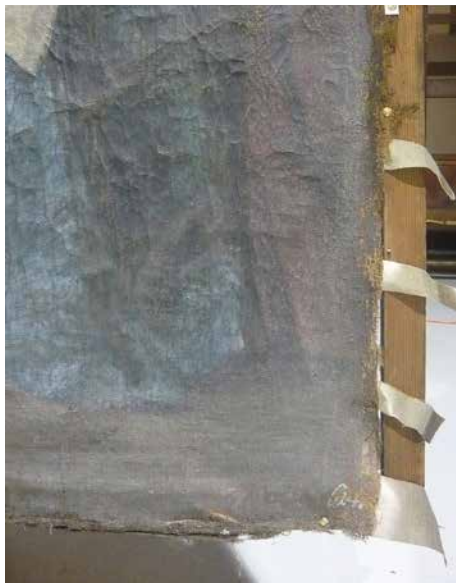
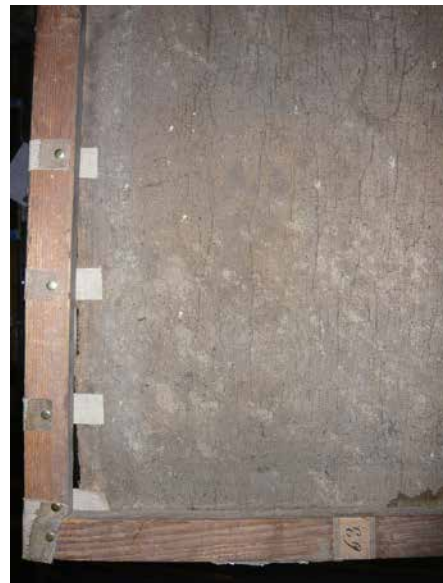
Fig. 21 a

Stabilisation of the painting support using strips of Beva-lined canvas applied to the reverse of a torn area at the edge of the painting, enabling its reattachment using drawing pins.

corners and along the tacking edges – or been eaten away by biscuit beetles. Due to time constraints, it was usually not possible to avoid provisional measures: the loose parts of the canvas were sometimes affixed with drawing pins; occasionally areas with large damages were reinforced with strips of Beva-coated canvas (fig. 21), and tears in the canvas stabilised with Beva-coated strips of Holytex applied to the verso (fig. 22).

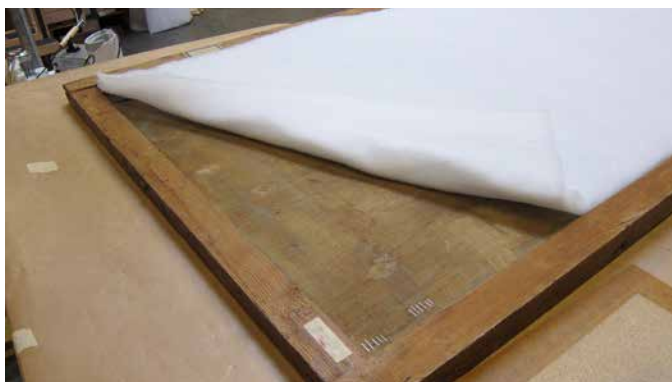
Fig. 22: Example of a provisional tear-mending with Beva-coated strips of Holytex. By inserting fleece material in the thickness of the stretcher, and mounting Kapaplast foamboard to the painting's verso to prevent vibration, the stability of fragile canvas paintings is further improved.

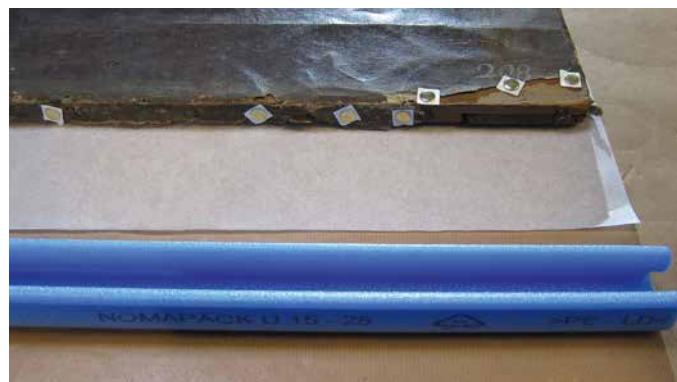
Fig. 23: Fragile edges were enveloped in tissue paper and protected by polyethylene U-profiles.

Particularly fragile painting edges were enveloped in strips of tissue paper for transport, and fitted with polyethylene U-profiles (fig. 23).²⁰ Paintings which exhibited a fragile surface overall were wrapped in full (see fig. 29). The wrapping consisted of an inner layer of tissue paper and an outer layer of non-woven fabric made of polypropylene,²¹ and was removed upon arrival at the central storage facility.

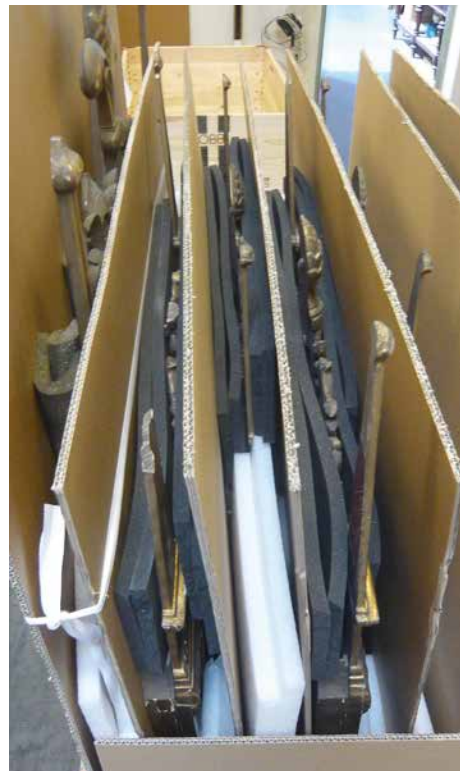
Fig. 24: View of a pallet from above. All intermediate spaces have to be padded, which is very time-consuming, to prevent shifting of the objects during transport.

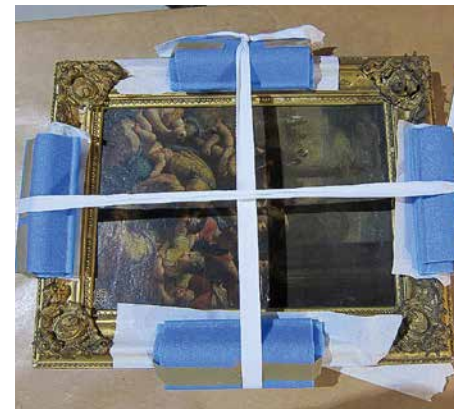
Fig. 25: Frames were padded with U-profiles in such a way that the fragile ornaments at the corners for example would not be under strain during transport.

Polyethylene sheets of 2 cm thickness were used to pad the bottom of the pallets and Corlettes,²⁶ while the metal frames were covered in polyethylene O-profiles.²⁷ This provided sufficient padding for the majority of the paintings. Tulip U-profiles (also made of PE) were put on where necessary during packing (figs. 25 to 27). The side walls of the Corlettes were fitted with corrugated cardboard, and the paintings were likewise divided by sheets of cardboard. Size and quantity were calculated in advance, and the cardboard was ordered cut-to-size.²⁸

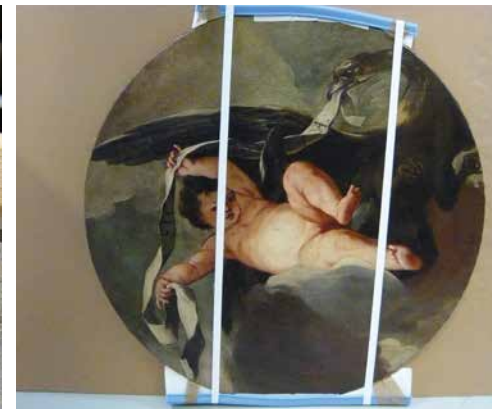
Fig. 27: In the end only 19 paintings required travel frames for relocation; almost all others were fit for transport in "standard" packing following appropriate preparation. For example with the help of PE wedges, U-profiles and cotton ribbons, round or oval formats too could be accommodated in the standard packing units.

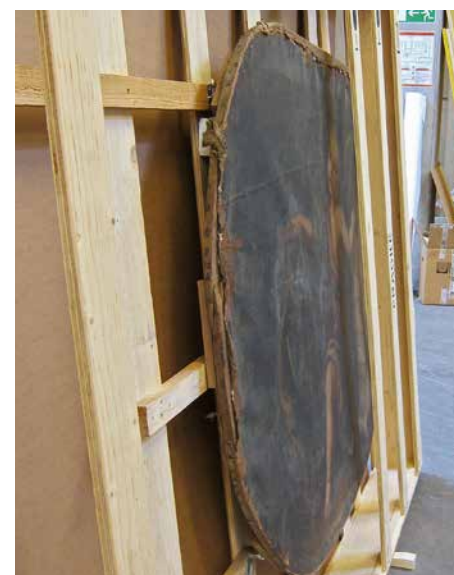
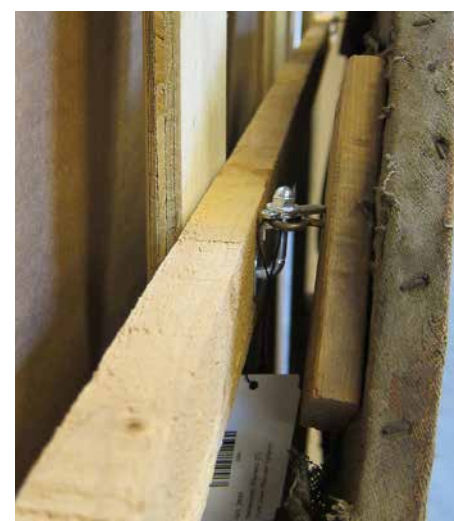
Fig. 28 a

This very warped and unstable painting had to be mounted separately in the travel frame. To this end, Temart T-hooks were screwed into the travel frame, on which the painting was hung by its eyebolts, fixed in place solely with the locknuts, which usually serve as an anti-theft-device. The barcode label affixed to the eyebolt is also visible.

The Picture Gallery was the only collection to already fully implement the newly introduced registration/logging of all objects via barcode labels during the relocation (see fig. 28 b).

Moreover, a few particularly fragile objects were separately mounted into travel frames. This was the case for instance for paintings with very matte, powdery surfaces without frames, or paintings with particularly warped and fragile stretchers or strainers as well as for very elaborately ornamented and delicate frames (see figs. 25 to 27). The manner in which objects were mounted into their travel frames was adapted individually to the work in question. For the most part, Ozclips, Hasenkamp hanging systems, as well as various angle brackets, metal springs and fixing plates, wood and cotton ribbons etc. were used.³⁰ For lightweight paintings with eyebolts, a system with Temart T-hooks was very convincing.³¹ It meant that the painting in question could be hooked into the T-hooks and fixed in place with a locknut, without having to drill any more holes into the object (fig. 28).

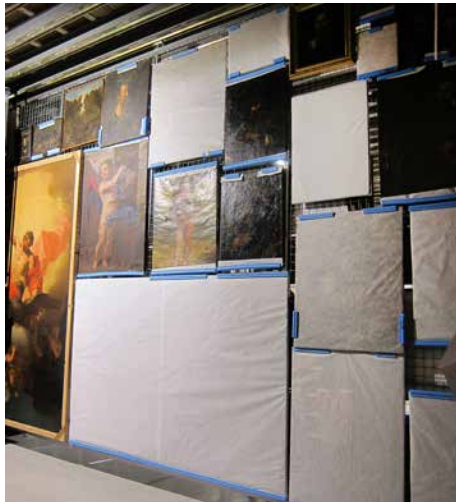
Fig. 29: All paintings hung on the wire mesh walls were prepared and ready for transport.

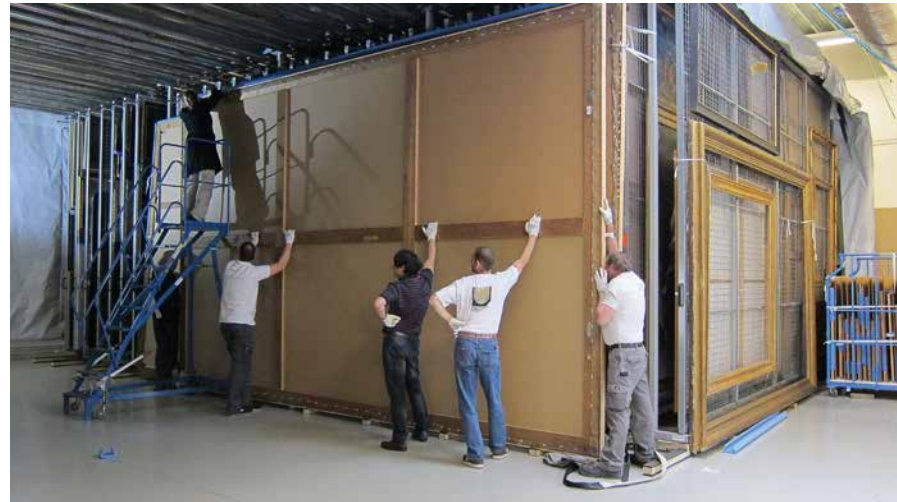
Fig. 30: As the next step, the large formats had to be secured standing nearly vertically to the inner walls of the pull-out picture racks for anoxic nitrogen treatment. The back wall and side walls of the tent had already been closed off.

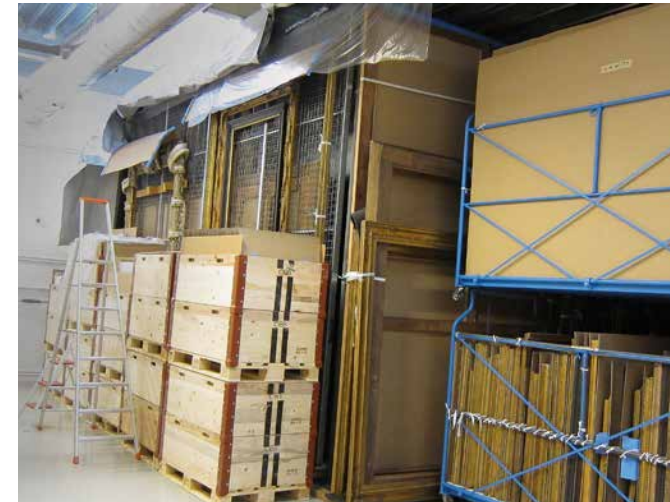
Fig. 31: A view of the fully loaded pull-out picture racks in room 1 of the former storage facility in Inzersdorf prior to anoxic nitrogen treatment. The storage system was filled with paintings ready for transport (see fig. 29). In the middle aisle of the pull-out picture racks, the large formats were tied to the wire mesh walls standing in a nearly vertical position, the space in between was filled with Corlettes stacked one on top of the other. There was also space for a few stacked Euro-pallets with stacking frames in front of the storage racks.

The use of Corlette storage racks²⁴ proved to be much more practical and efficient. Two different sizes were deployed in the relocation: the depth measured 110 cm and the height 160 cm, respectively, and the width – depending on the model – 191 or 261 cm (internal measurements).²⁵ The smooth wooden flooring is stabilised by a metal frame on three sides, the front side is open. Among the Corlettes' advantages are their great stability, the presence of wheels which significantly facilitate handling, and the fact that they are stackable, which proved to be very important for optimum filling of the anoxic nitrogen tent (see fig. 31).

²³ Some pallets were used nonetheless, in order to use the space available in the anoxic nitrogen tent to maximum capacity (see fig. 31).

In order to fit as many paintings as possible into the nitrogen tent and to make sure the relocation that was to follow could be implemented in a time-saving manner, all paintings on the large pull-out picture rack system in room 1 were firstly prepared for transport, including edge protection and wrapping where necessary, and then rehung (fig. 29). The empty spaces between them on the wire mesh walls were also filled and the racks lashed to one another, so that they could no longer be moved. The next step was tying the paintings that were stored between sheets of cardboard and wooden poles, as well as some of the large frames, to the exterior of the rack system, while the large-format paintings were leaned sideways against the wire mesh walls and likewise fixed in place in its middle aisle (fig. 30). The stacked-up Corlettes were then moved into the empty space in between. Finally, pallets with stacking frames were stacked on top of each other in front of the pull-out picture rack system, and the measuring instruments, connected to air humidifier, radiator and ventilator by the Singer company, as well as reference blocks with insects, to verify the anoxic nitrogen treatment's effectiveness, were accommodated in the tent. The tent having been filled to optimum capacity, the special foil, which had already been sealed at the back and the sides, was now adhered together at the front as well (figs. 31 to 33).

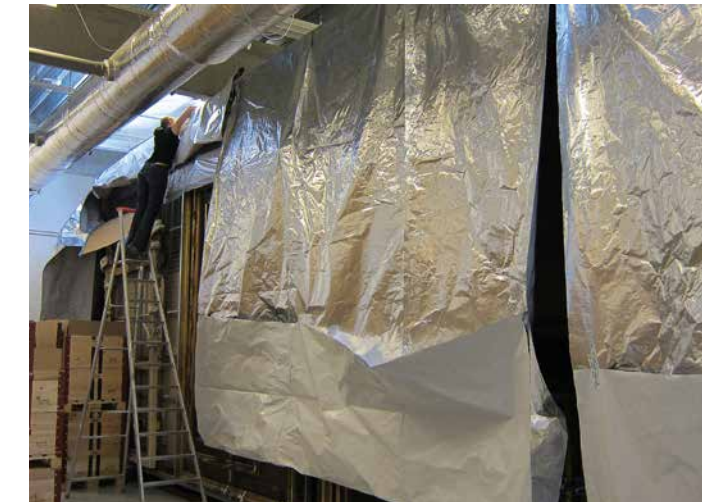
Fig. 32: View of the painting storage 1 at the old Inzersdorf facility shortly before the beginning of anoxic nitrogen treatment. The left hand side of the picture shows how the special foil, which at the back and sides has already been heat-sealed and adhered to the floor, is now being closed at the front as well for anoxic nitrogen treatment.

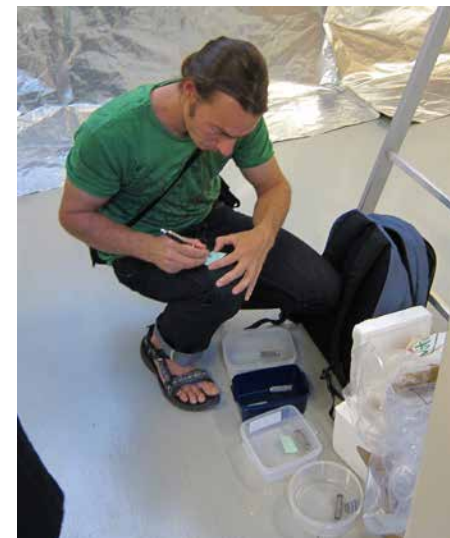
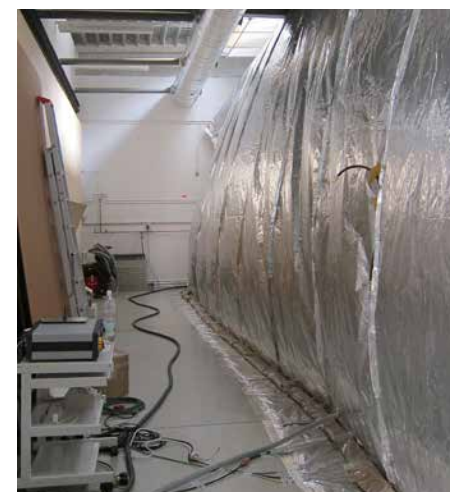
Fig. 33 a

Following the placement by Pascal Querner of test insects inside the tent to verify its effectiveness, the tent was closed off and flooded with nitrogen.

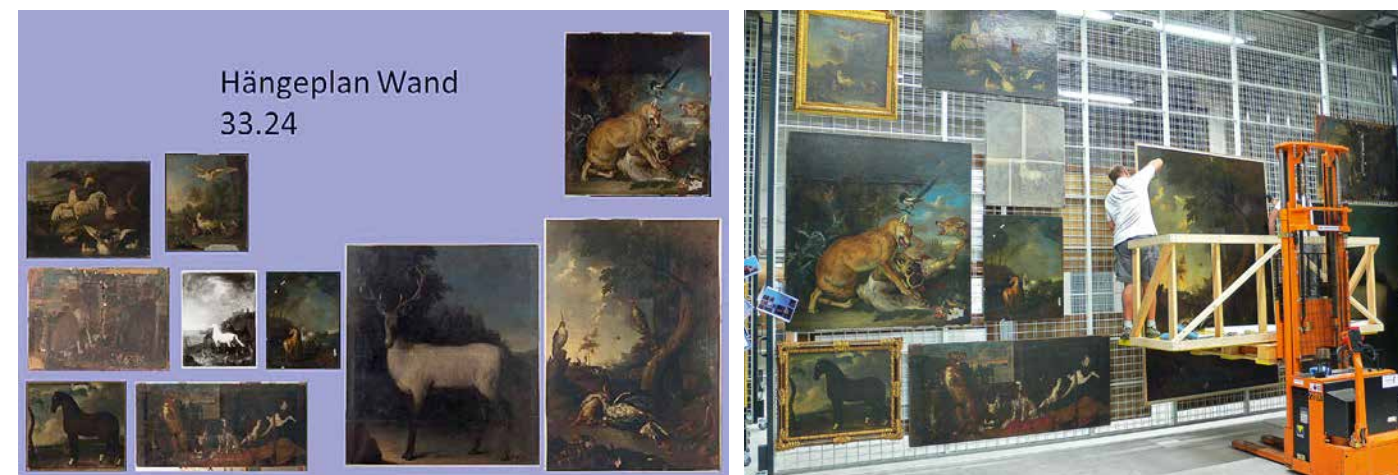
Fig. 36 a: With the help of the *GalleryCreator* programme, each wall was meticulously planned and visualised in its respective wall scheme prior to the relocation.

Fig. 36 b: Implementation of the planned new hanging scheme on the respective wire mesh walls at the central storage facility.

As has been explained before, all wire mesh walls were perfectly prepared before the relocation began, and had been visualised as wall-diagrams with the accompanying lists and location tracking (fig. 36 a).

For the relocation, the paintings were packed in groups according to these new diagrams, and brought to the new storage facility. Having arrived there, it was possible to hang them very rapidly, despite the extraordinarily large size of the pull-out picture racks, measuring 500 × 800 cm (fig. 36 b). In the old as well as in the new storage location, the paintings were moved in cooperation with Kunsttrans company staff under the paintings conservators' guidance.

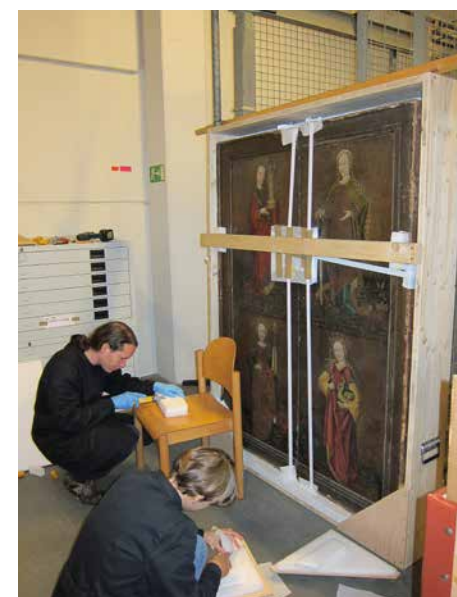
Fig. 37: This very fragile yet heavy winged altarpiece received a custom-made wooden frame structure. The altar was fitted in the case with Ethafoam board, elaborately wrapped in Tyvek and tissue paper.

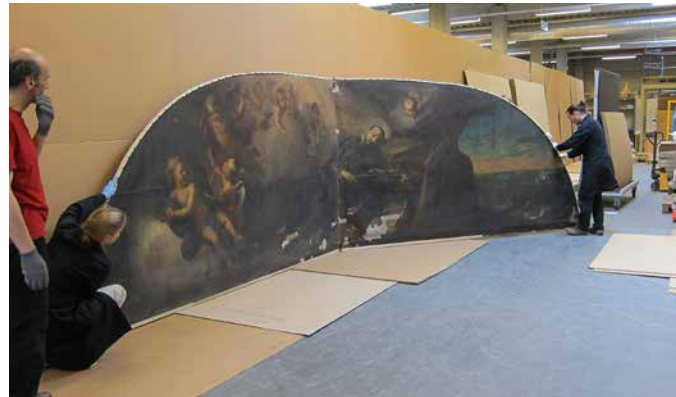
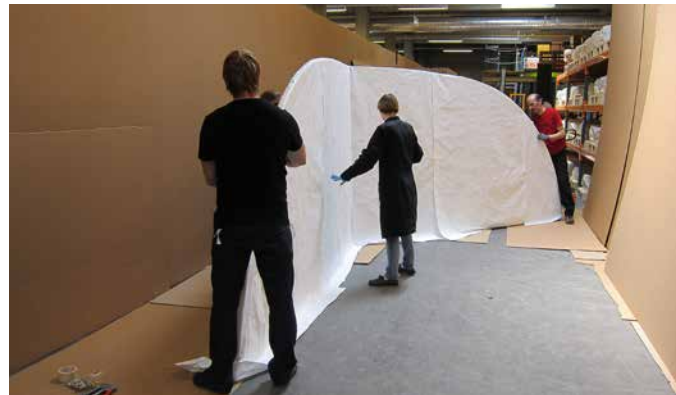
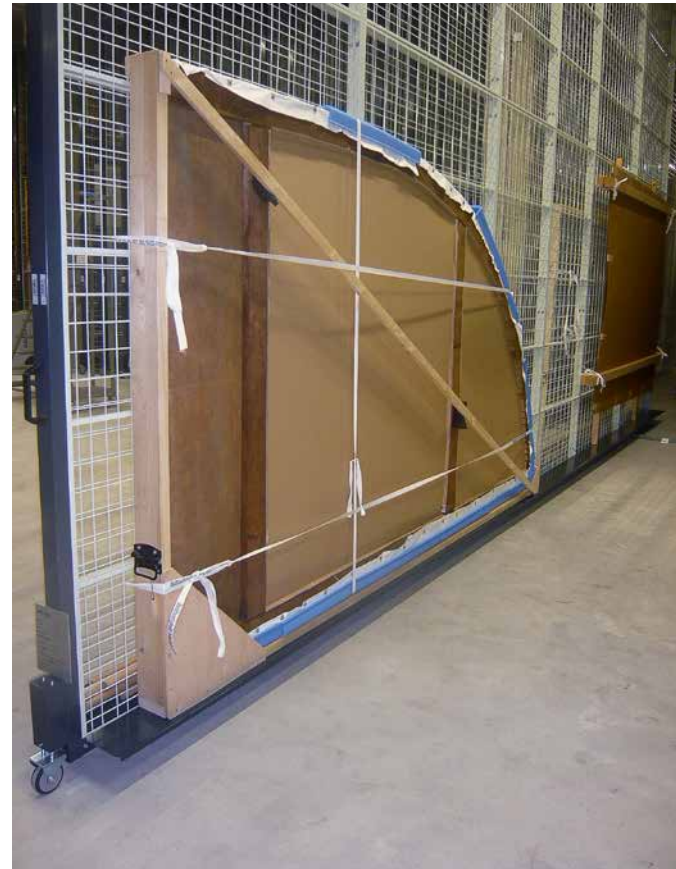
Fig. 38 a

This semi-oval painting with a total length of 665 cm, originally folded in the middle, could no longer be fully unfolded, and was therefore fitted in a custom-made wooden structure for transport and subsequent storage. It was wrapped in Tyvek to protect the paint layer. The vibration protection and backing made from corrugated cardboard fitted in between the stretcher members was left in place.

Many paintings already possessed insert linings and backing boards as protection against vibration, made of corrugated cardboard inserted into the space between the stretcher members (see fig. 38 c).¹⁹ These were usually left in place, for time and cost reasons, and only replaced in a few instances, if they exerted pressure on the canvas for example.

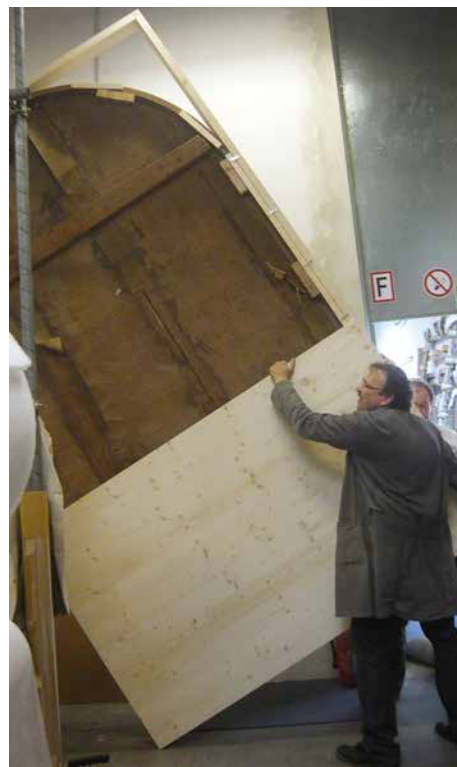
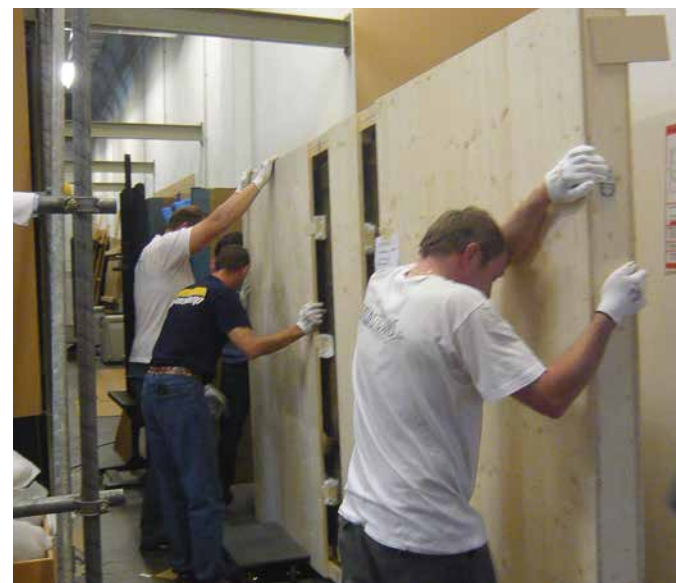
Fig. 39 a

This large and very heavy panel painting by Garofalo also had to be fitted into a frame structure reinforced by wooden boards.

A massive panel painting by Garofalo, measuring 325 × 190 cm, was likewise too unstable for transport. The wooden panel was under strain and weakened by former wood worm infestation. In addition, it had to be tilted onto its long side for transport, which – especially due to its size and weight – would not have been possible without further stabilisation of the existing, rather thin and insufficiently sturdy frame. The panel thus received an additional wooden frame and was fitted with screwed-on wooden panels³⁴ (fig. 39).

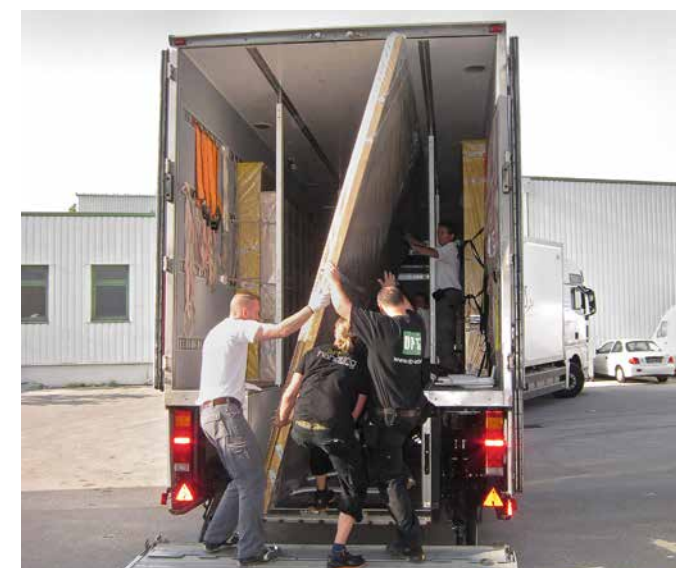
Fig. 41: This special tandem trailer from the Kunsttrans company has a maximum diagonal of 386 cm, due to a lowered loading space inserted between the wheel base.

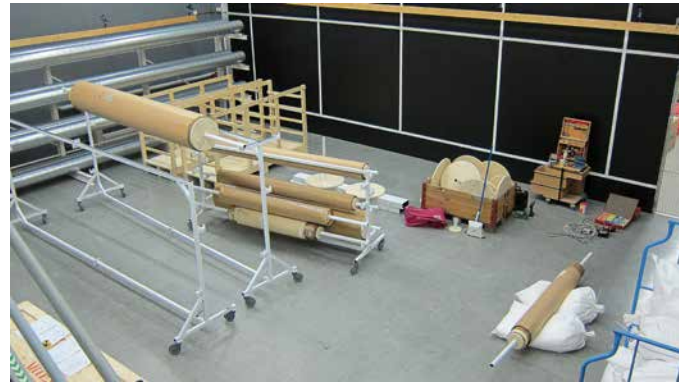
Fig. 43: The heads of all painting rolls were replaced. To this end, the rolls were rested on PP sacks filled with polystyrene granules. Custom-made metal stands were produced for storage at the new facility.

“Unrolling” the 78, mostly large-sized paintings would have entailed elaborate conservation measures. As had been the case during previous relocations, wholesale treatment was unfortunately not possible due to time constraints. A decision was therefore made only to improve the stability of the rolls as well as their future storage at the new centralised facility. To this end, all rolls were inspected by the in-house carpenters and metalworkers, and modified in such a way that could be hooked into three custom-made metal stands at the new storage facility. All the rolls' heads were fitted with stable, newly glued-on and bolted wooden disks with round metal bars. These were selected in such a way that two uniform lengths were achieved (fig. 43). The largest roll with a length of 600 cm was treated separately and now rests on a custom-made wooden structure.

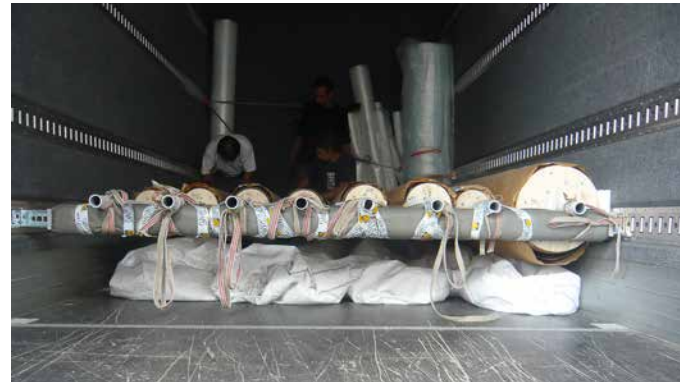
Fig. 44: Crossbars were fitted in the truck for the shipment of the very fragile painting rolls, which were strapped to them individually and at a distance from one another. Polystyrene-filled PP sacks were placed immediately below the rolls for additional protection.

Since only the heads rather than the entire rolls could be renewed however, transporting them directly on their metal rack was deemed too risky. It was feared that the rolls might break in other places. As a compromise, they were fixed separately to crossbars which were secured in the truck for transport. The crossbars were mounted as far down as possible, and the underside of the rolls additionally padded with PP sacks filled with polystyrene granules (fig. 44).

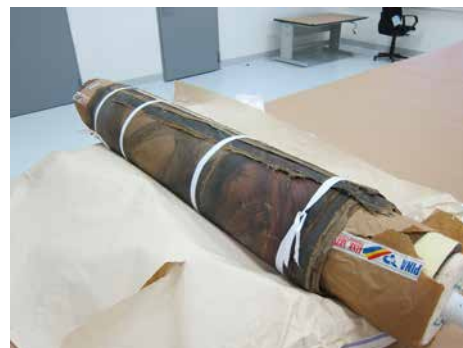
Fig. 45: One of the rolls did in fact break during transport. Thanks to the foresightful manner of transport however no further damage was incurred.

the new central storage facility's workshops (fig. 45). It was revealed that a total of 15 rather small-scale paintings had been rolled up on top of each other. They were temporarily stored flat in a flat file cabinet of the Collection of Historic Musical Instruments (fig. 46). Two paintings from the broken roll were brought to the KHM's painting conservation studio for further treatment.

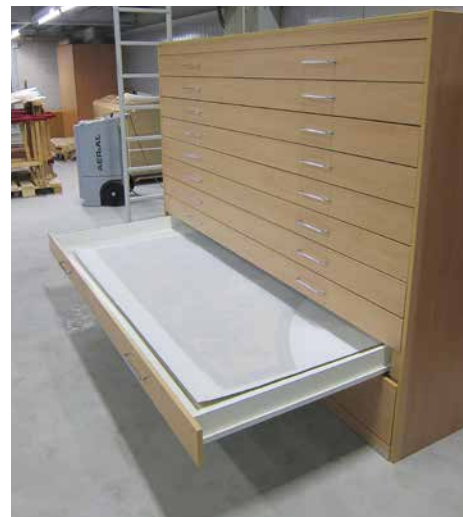
Fig. 46: The painting roll could nonetheless not be repaired and was unrolled at the central storage facility's workshops. A total of 15 mostly small-format paintings was stored on it, which are currently accommodated in their unrolled state in a flat file cabinet of the Collection of Historic Musical Instruments. Two to four paintings respectively are stored on top of one another, protected by sheets of tissue paper.

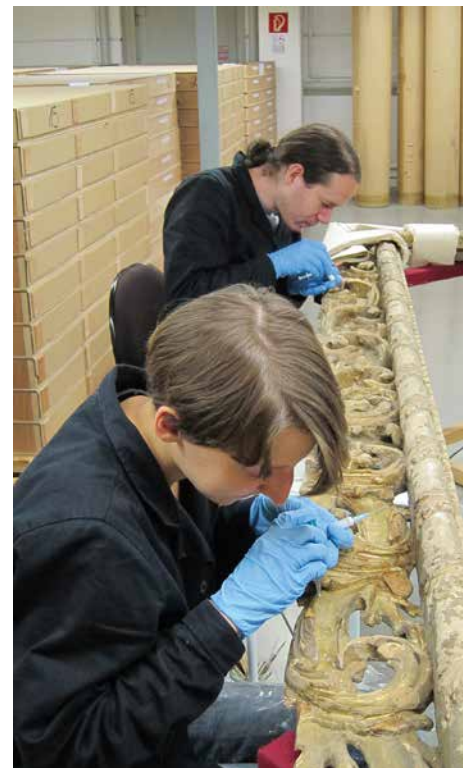
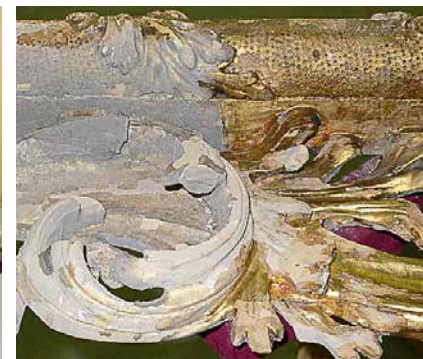
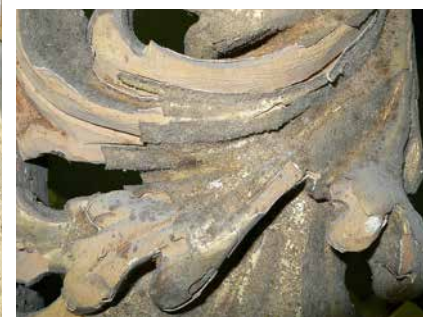
Fig. 50 a

Two large frames had to be extensively consolidated, as large parts of the surface coating were severely loosened and only held together by former mould growth and dirt accretions. Cleaning without prior consolidation was not feasible.

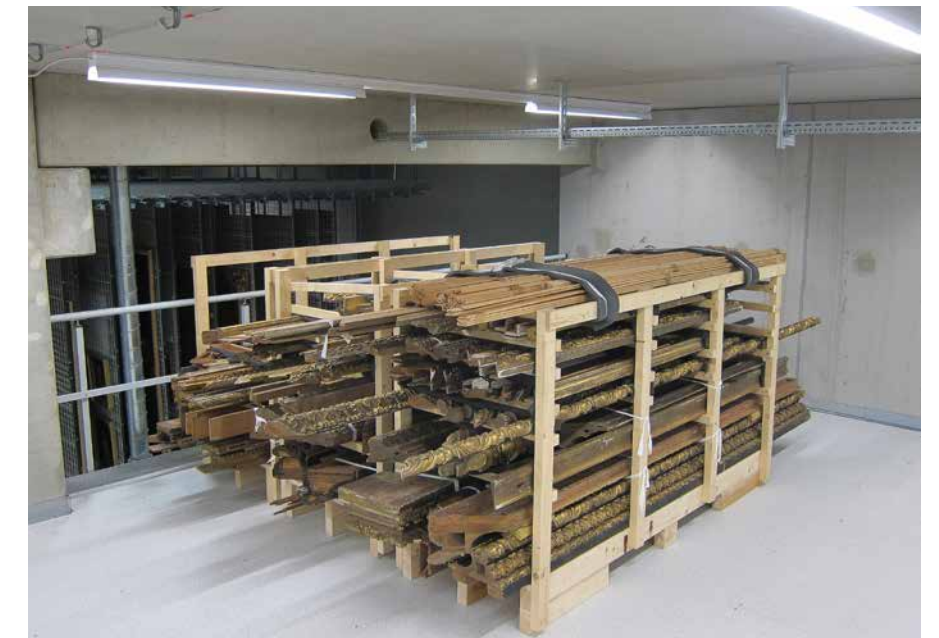
Fig. 51: The individual frame members were sorted and securely fastened onto specially custom-made pallets for transport and subsequent storage.

The individual frame members were sorted into groups and secured in the three respective pallets, custom-made by the in-house carpentry workshop, for transport and storage (fig. 51). The fragments, too, were cleaned and sorted. Related groups were assigned numbers, photographed and wrapped individually, before being accommodated in two pallets with stacking frames, stacked one on top of the other (see fig. 48 b).

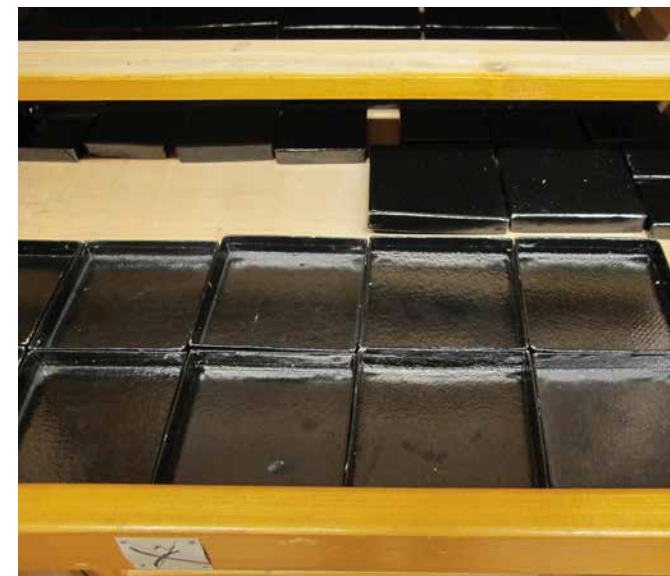
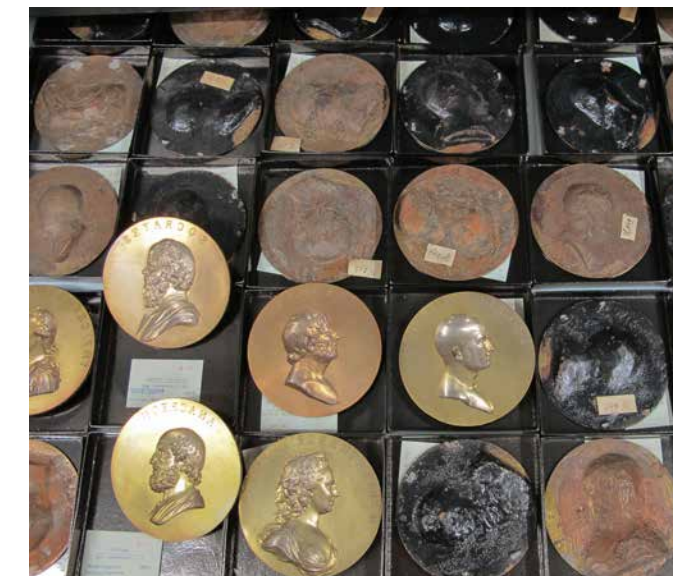
Fig. 2 a: Wooden drawer with black trays.

Fig. 2 b: Modern electrotypes stored in the black trays.

Some of the storage materials and boxes already in use that served as dust protection or for the separation and classification of individual objects had to be tested for their archival suitability. Damaging degradation products can split off of the diverse kinds of paper, cardboard, synthetic packing materials, and various adhesive materials and tapes, which have often already aged, posing a hazard directly on or next to the objects. Cardboard trays lined with shiny black paper in the drawers were of particular concern, in which the majority of delicate objects like orders, medals, seals, electrotypes, and primitive money were stored. Many of these objects were packed individually (*fig. 2*).

The Conservation Science Department subjected the cardboard trays to an Oddy-test to check for the release of degradation products that were incompatible with the objects. The test confirmed the damaging effects of the “black trays”. They had to be removed as quickly as possible from the objects’ surroundings.

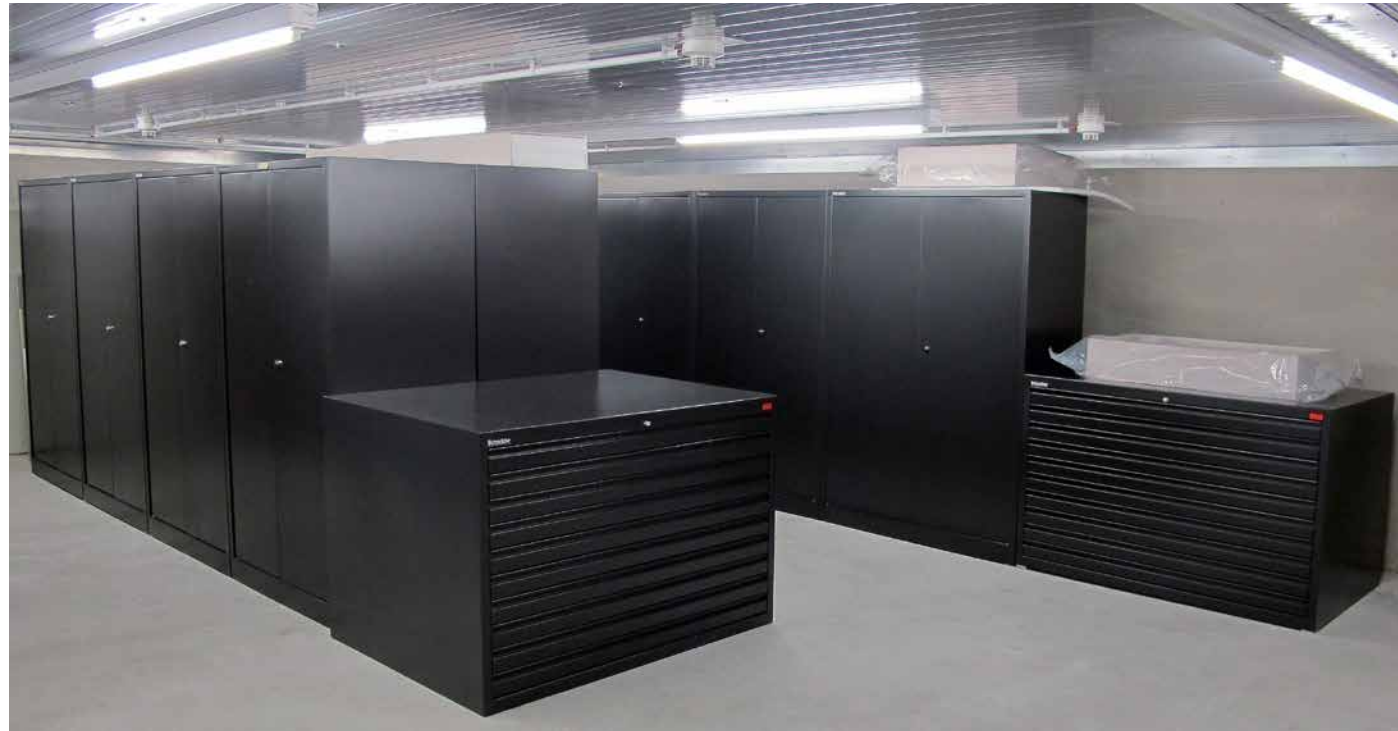
Fig. 3: The new metal cabinets in the Himberg storage facility.

Special archival steel cabinets were made for the housing of the objects. The solid, welded construction from pure stainless steel dispensed with materials that could release degradation products. Neither lubricants nor rubber joints were used. The exterior walls are powder coated in order to avoid the solvent evaporation associated with common paints (fig. 3).

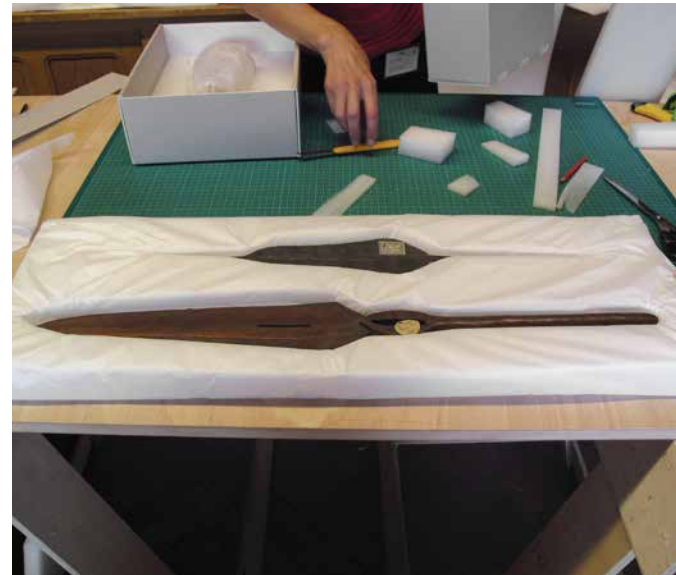
Fig. 5 b

Preparation of the custom-fit blocks of Ethafoam for the packing of two spears, carved to the shape of the objects and lined with tissue paper.

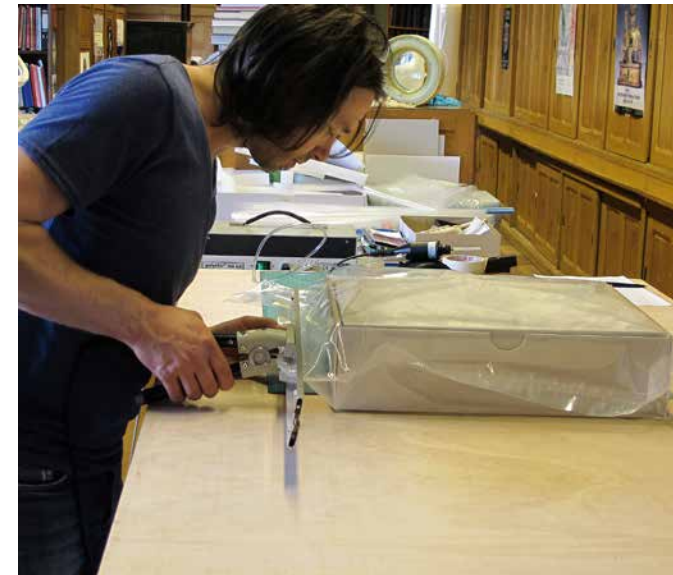
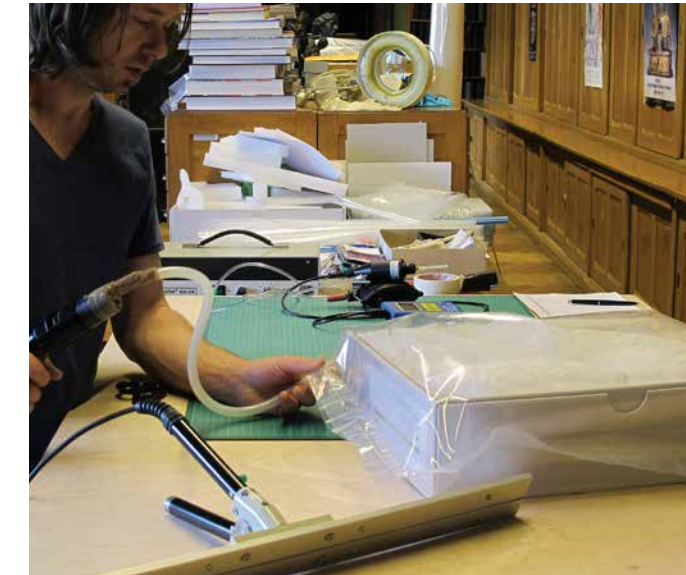
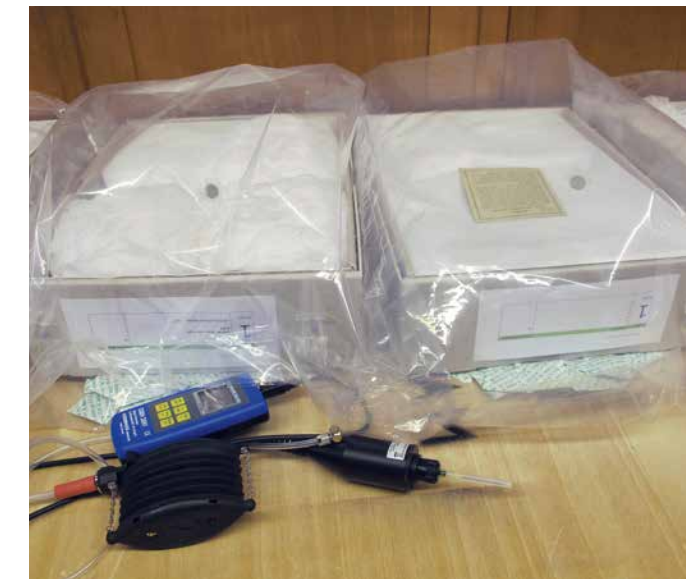
The procedures for sealing storage containers and treating objects with nitrogen gas with the addition of oxygen absorbers and indicators.

deter corrosion processes in iron and to asphyxiate aerobic microorganisms. Inclusion of oxygen indicators enabled quick assessment of the practically oxygen-free environment inside of the boxes (fig. 6). The objects remained enclosed in the plastic wrapping during the move and for at least another 6 months afterwards in order to ensure that all pests had been exterminated. For the long-term preservation of the collection, it is imperative to conduct regular inspections and monitoring for new pest infestations.

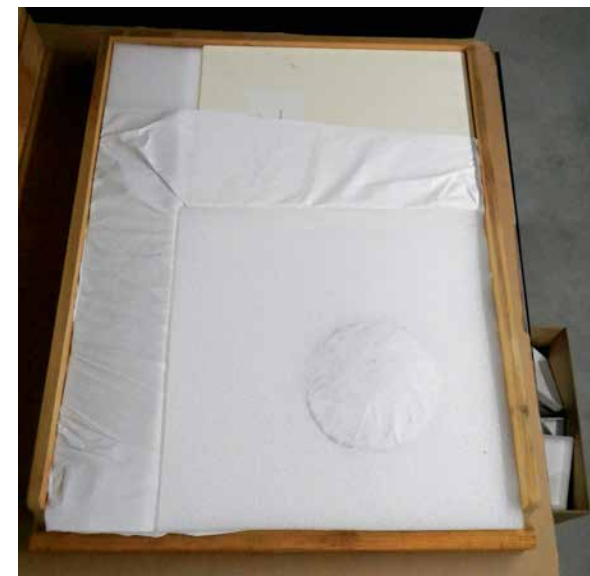
Fig. 7: The drawers were stabilised with Tyvek and Ethafoam padding to prevent sliding of the objects during transport.

For the most part, the individual objects had each been placed in a cardboard tray and identified by an underlying inventory card. Larger sized objects were sometimes in two cardboard trays. These trays were placed next to one another in the drawers in rows. This pre-existing separation of the individual objects saved a substantial amount of time and materials during packing. A piece of Tyvek was used to cover and protect the objects' surfaces in the open drawers. Finally, stabilisation against sliding and impact during transport was secured with air cushions and pieces of Ethafoam cut to fit exactly into the empty spaces in the drawers (fig. 7). Up to 7 drawers could be stacked on a transport pallet (fig. 8).

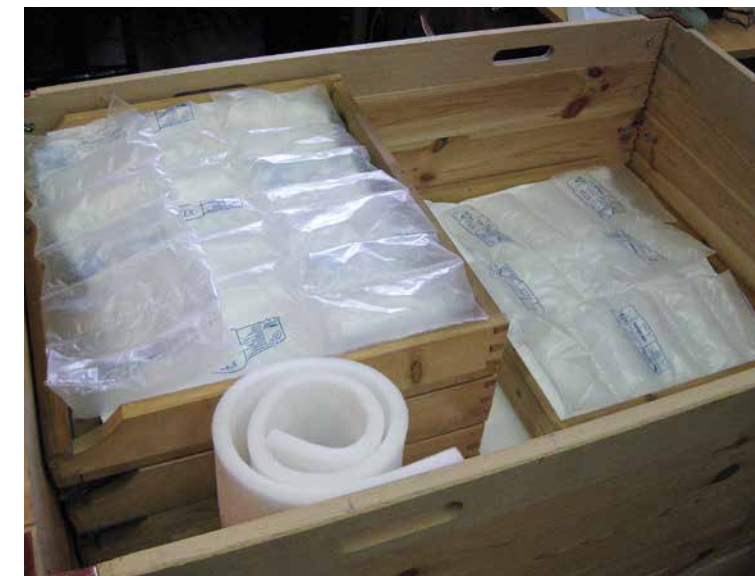
Fig. 8: Packing the drawers for transport on a pallet with stacking frame.

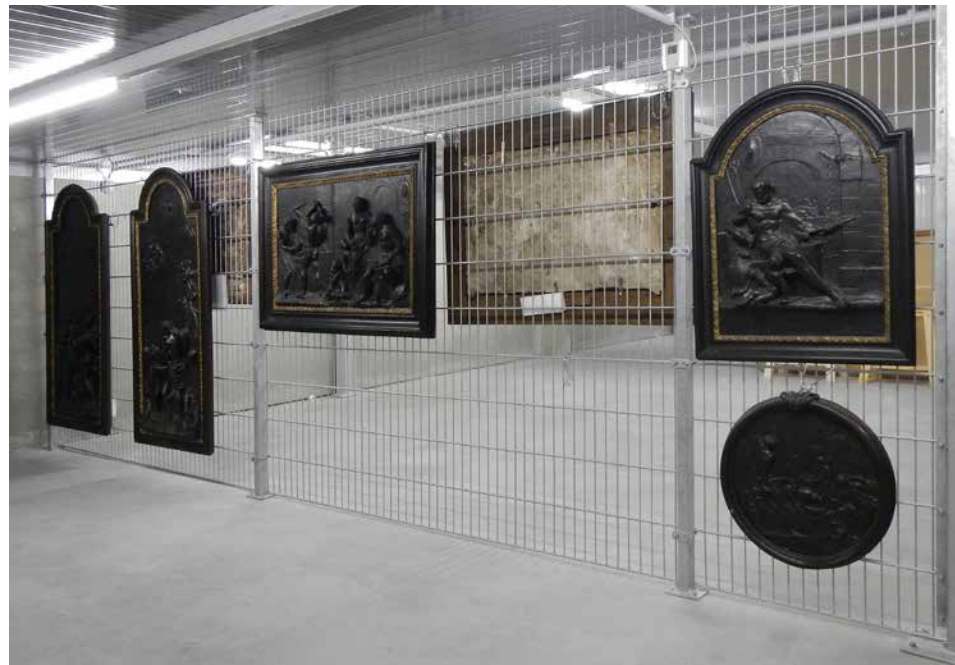
Fig. 9: Wire mesh wall with reliefs.

About 20 large plaster reliefs had been stored hanging on the wall, where they were not protected from mechanical damage or dust. The dust layer was removed with vacuum cleaners and brushes and the reliefs were subsequently hung on the metal mesh wall with S hooks and karabiners. The remaining reliefs, that were not too large for the double door cabinets, were placed horizontally on Ethafoam supports. Around 10 coin vessels and 20 balances with coin weights were first cleaned of dust and then stored in the cabinets with shelves (fig. 10).

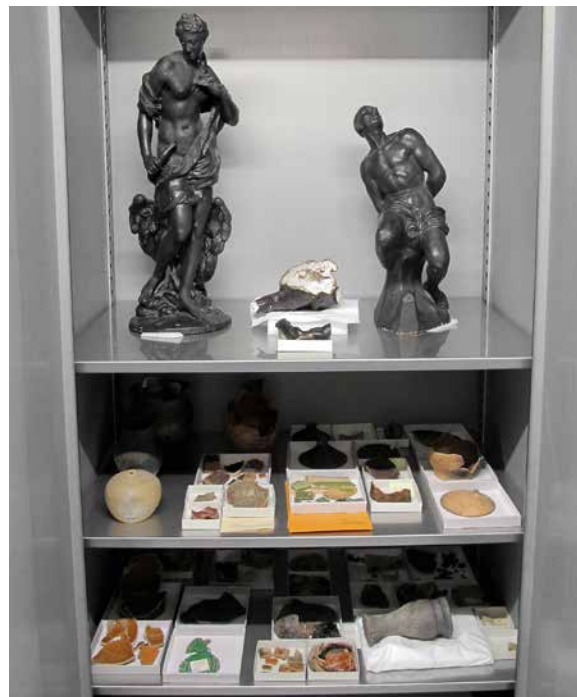
Fig. 10 a
Example of a shelf with figures and coin find containers, and one with balances.
