Technological Studies

Kunsthistorisches Museum Vienna

Special volume: Storage
Vienna, 2015

Technologische Studien Kunsthistorisches Museum.
Konservierung – Restaurierung – Forschung – Technologie,
Sonderband Depot, Band 9/10, Wien 2012/13

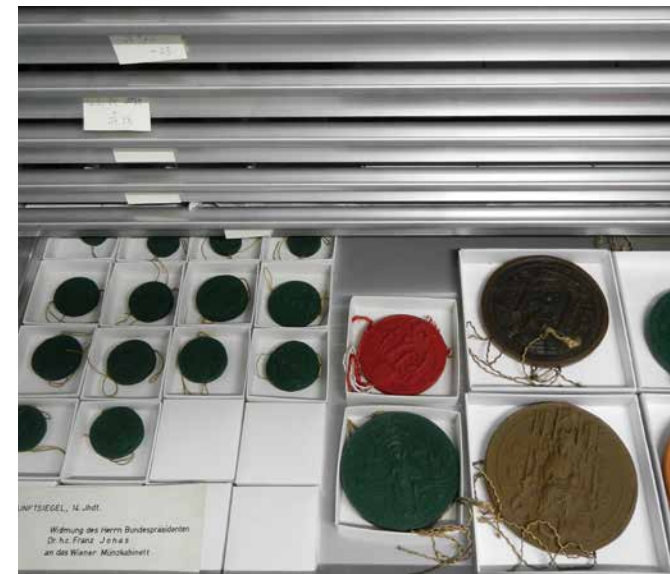
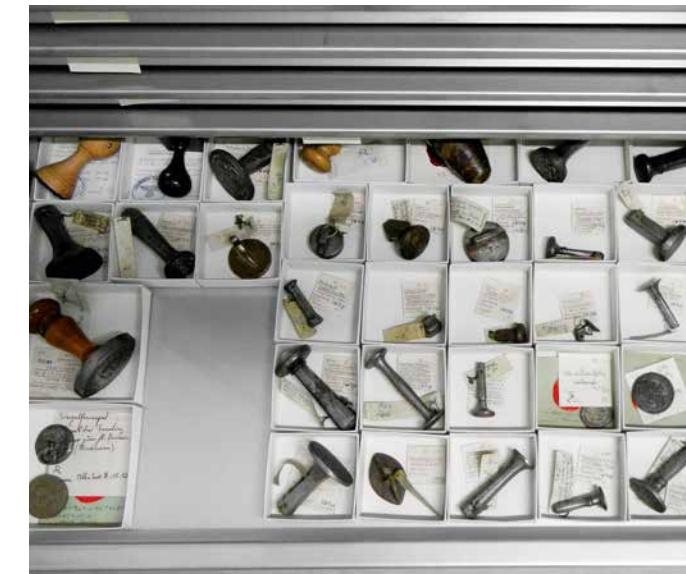
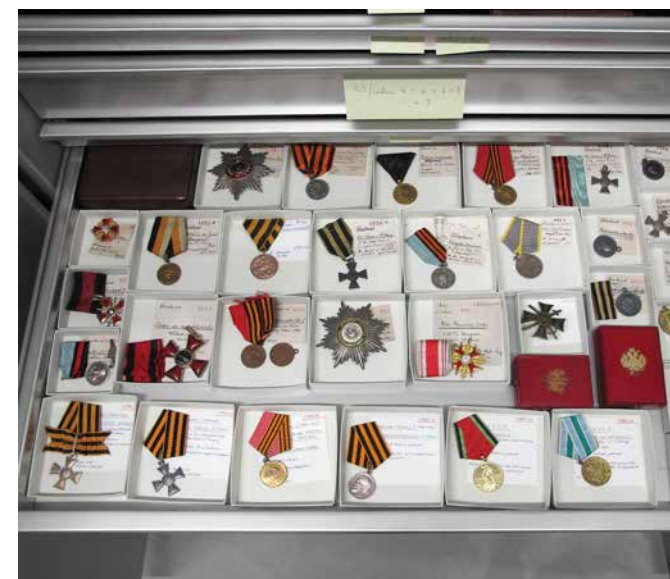
Drawers filled with seals, orders and badges of honour, sorted into archival paper trays.

After removal of the transport packing materials from the drawers, the objects and their inventory cards were cleaned of surface dust with brushes and latex sponges prior to placement in the new storage units. Then they were provided with new, archival, folding paper trays and arranged in the metal drawers (fig. 11).

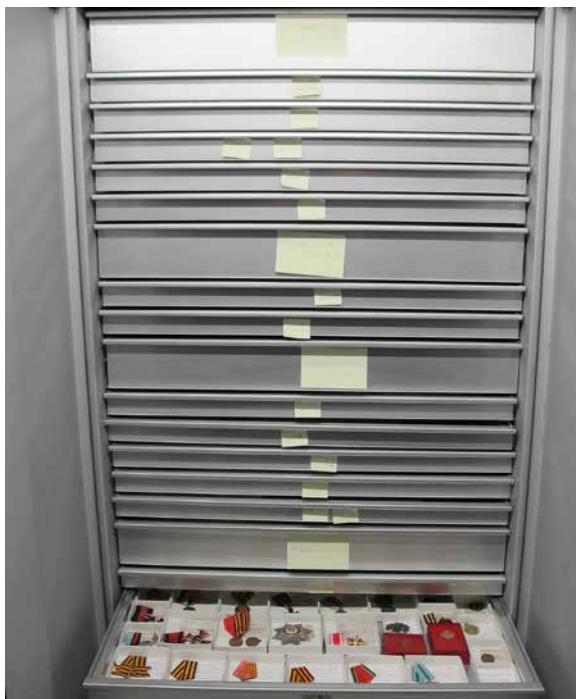
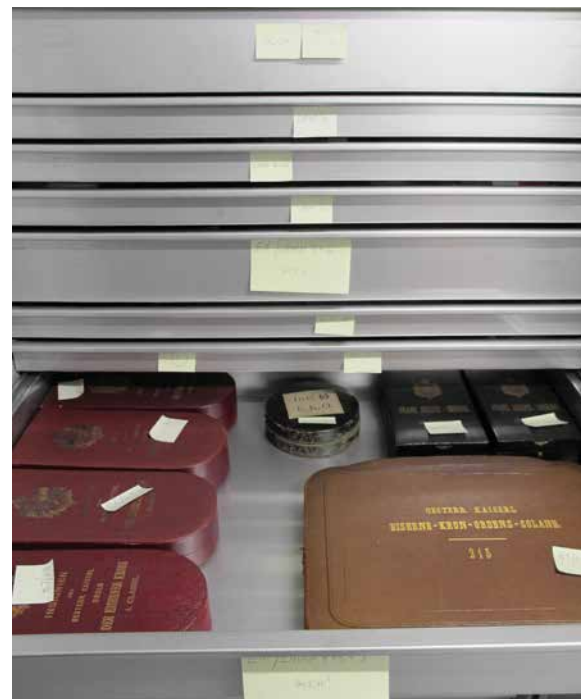
The contents determined the different drawer heights – temporary labelling with post-it notes provides an overview of the object locations.

Around 1,700 orders and badges of honour were placed in individual folded paper trays and stored in the shallow metal drawers planned for this purpose. Some cases and *etuis* that were taller than the 5 cm high drawers were carefully labelled and placed in a custom drawer 10 cm high (fig. 12). These higher drawers were filled with objects from consecutive drawers as needed. In order to maintain the chronological organisation system, the occasional higher drawer was also labelled on the outside with the locations of the related object drawers. In this way, use of the available storage space and cabinet height was optimised by inserting as many drawers as possible.

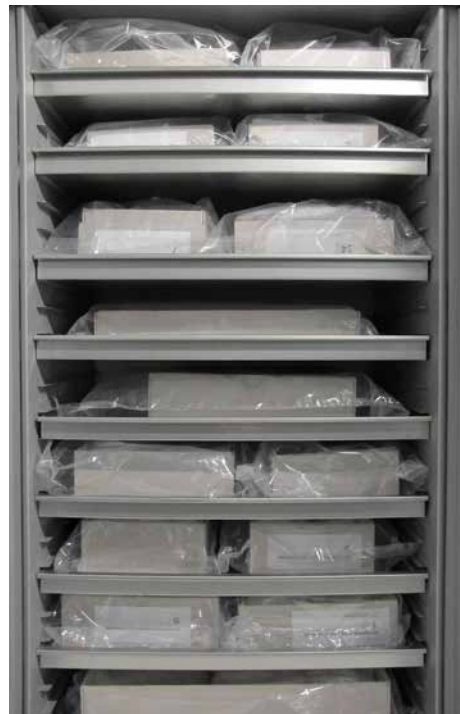
Fig. 13: Archival boxes containing primitive money sealed in plastic wrapping in a metal cabinet.

The collection of primitive money, comprising approximately 425 pieces, had to be handled separately due to a pest infestation and packed appropriately, as already explained above. The continued use of the boxes sealed in plastic wrapping and filled with nitrogen gas for the organic and in some cases infested objects, lead to a reduction in the time, space, and effort required to move them. After placement in the storage facility, the necessary quarantine period of at least 6 months for the extermination of the pests could be fulfilled without a problem (fig. 13). The archival and transport boxes, some of them sealed in plastic, were deposited in the intended metal cabinets; they were unpacked after the quarantine period had ended during a second phase.

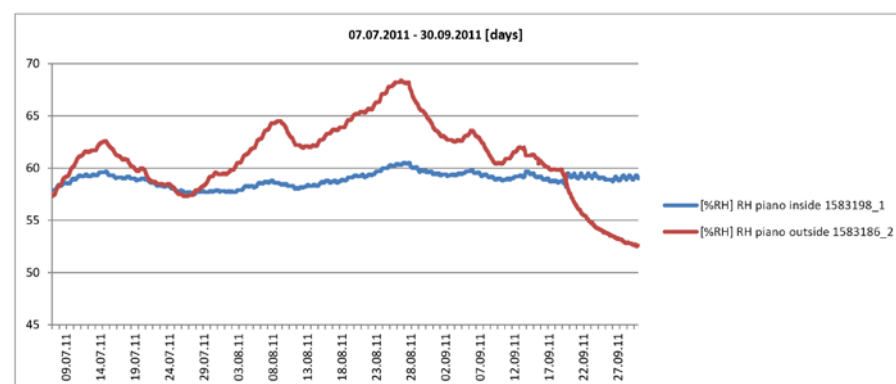
Fig. 1 a: The relative humidity inside the packed instrument is lower than the environmental humidity. (Chart: Angelika Stephanides.)

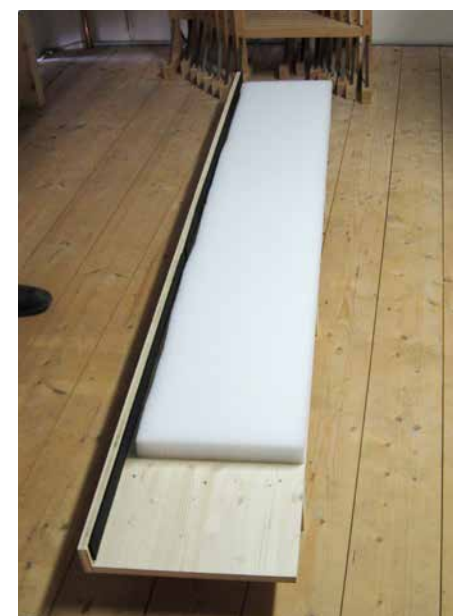
Fig. 2: Custom-made transport board ready for use.

Colleagues from the museum's carpentry workshop made an individual u-shaped transport board for each piano from a 25 mm thick 3-layer wooden panel: the length and width of each board was determined by the length and height of the long back side (including the lid) of each piano. On one long side of the board, a strip projecting 50 mm (for the lid to lean against) was attached with screws; the underside of the board was furnished with three to four wooden blocks (100 × 60 mm), so that it could be easily raised by the forklift. A 40 mm thick Ethafoam panel was attached to the transport board with hot glue, leaving a gap of about 30 mm between it and the wood panel. (The gap is necessary so that in the case of a turned up lid, no pressure is exerted on the protruding lid or its hinges.) To protect the lid, the strip attached to the board was also covered with a thin layer of foamed plastic (*fig. 2*). The instrument was placed on the transport board so that the long back side of the piano rested on the foam while the protruding lid and its hinges fit into the gap.

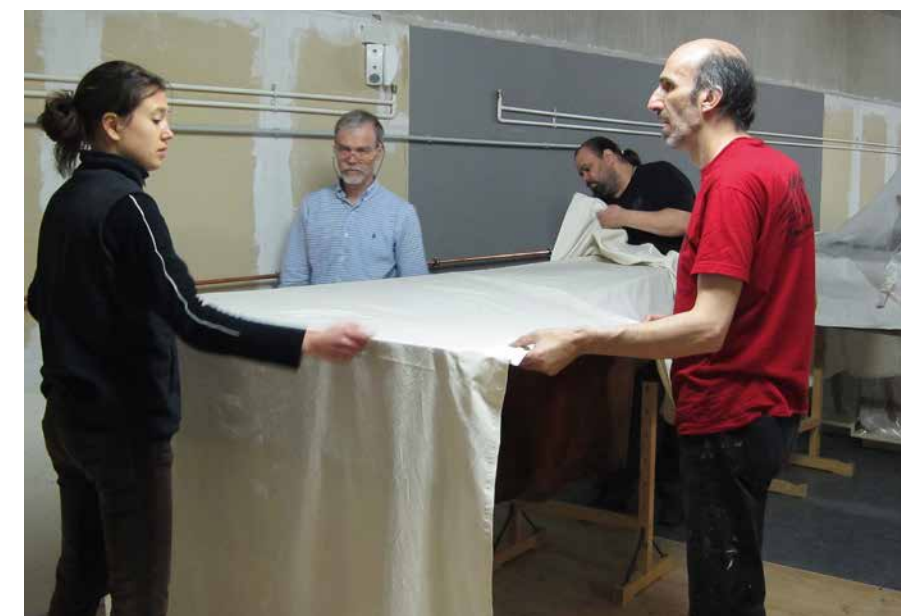
Fig. 3: In order to protect the surface, the pianos were first wrapped in Mollino fabric.

Before the piano was placed on its transport board, its legs were individually packed in tissue paper and bubble wrap and the inventory number was written by hand on the package. The same steps were carried out for the music stand, and when appropriate, for the lyre and pedal rods. The entire piano body was next wrapped in Mollino-Nessel fabric (inexpensive, coarse, unbleached cotton fabric) (*fig. 3*), so that contact between the surface, which was in most cases

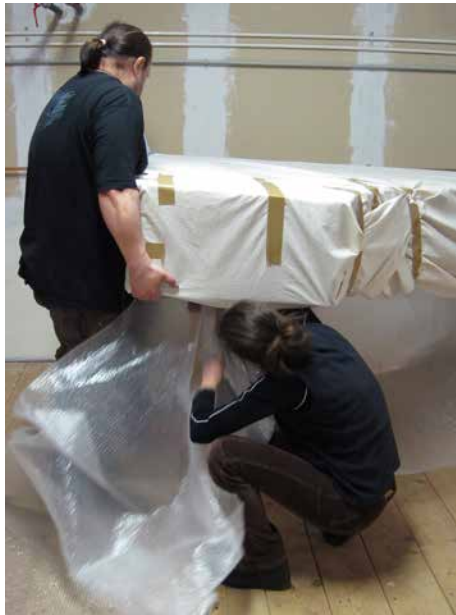
Fig. 4: The second layer of bubble wrap served as protection against mechanical damage and as a climatic buffer.

lacquered, and the different synthetic materials could be avoided. This was followed by a generous envelopment with bubble wrap (fig. 4) that was closed here and there with adhesive tape in order to guarantee a certain degree of air transfer. In this condition, the piano was lifted onto its transport board (fig. 5) and labelled with its name and inventory number.

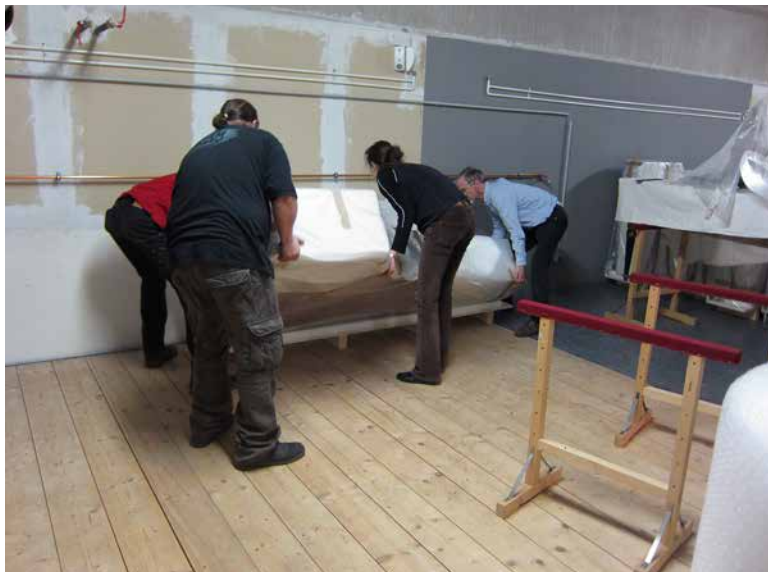
Fig. 5: The encased piano is lifted onto its transport board.

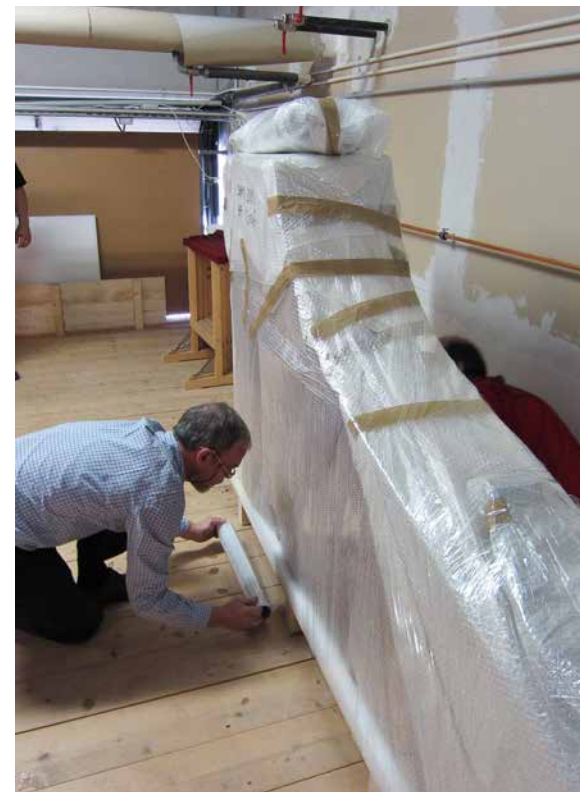
Fig. 6: The encased piano and its transport board are wrapped together in PE sheeting.

For the earlier – and therefore more delicately constructed – keyboard instruments it was possible to place the legs and music stand on the curved side, thereby packing all elements together. The later instruments required stable cardboard boxes for these elements because of their larger volume and weight. In order to ensure that the instrument was securely bound to its transport board, a “final packing” took place: both elements were wrapped together with PE sheeting (fig. 6). The encased objects were stored this way in the old storage area until relocation (fig. 7).

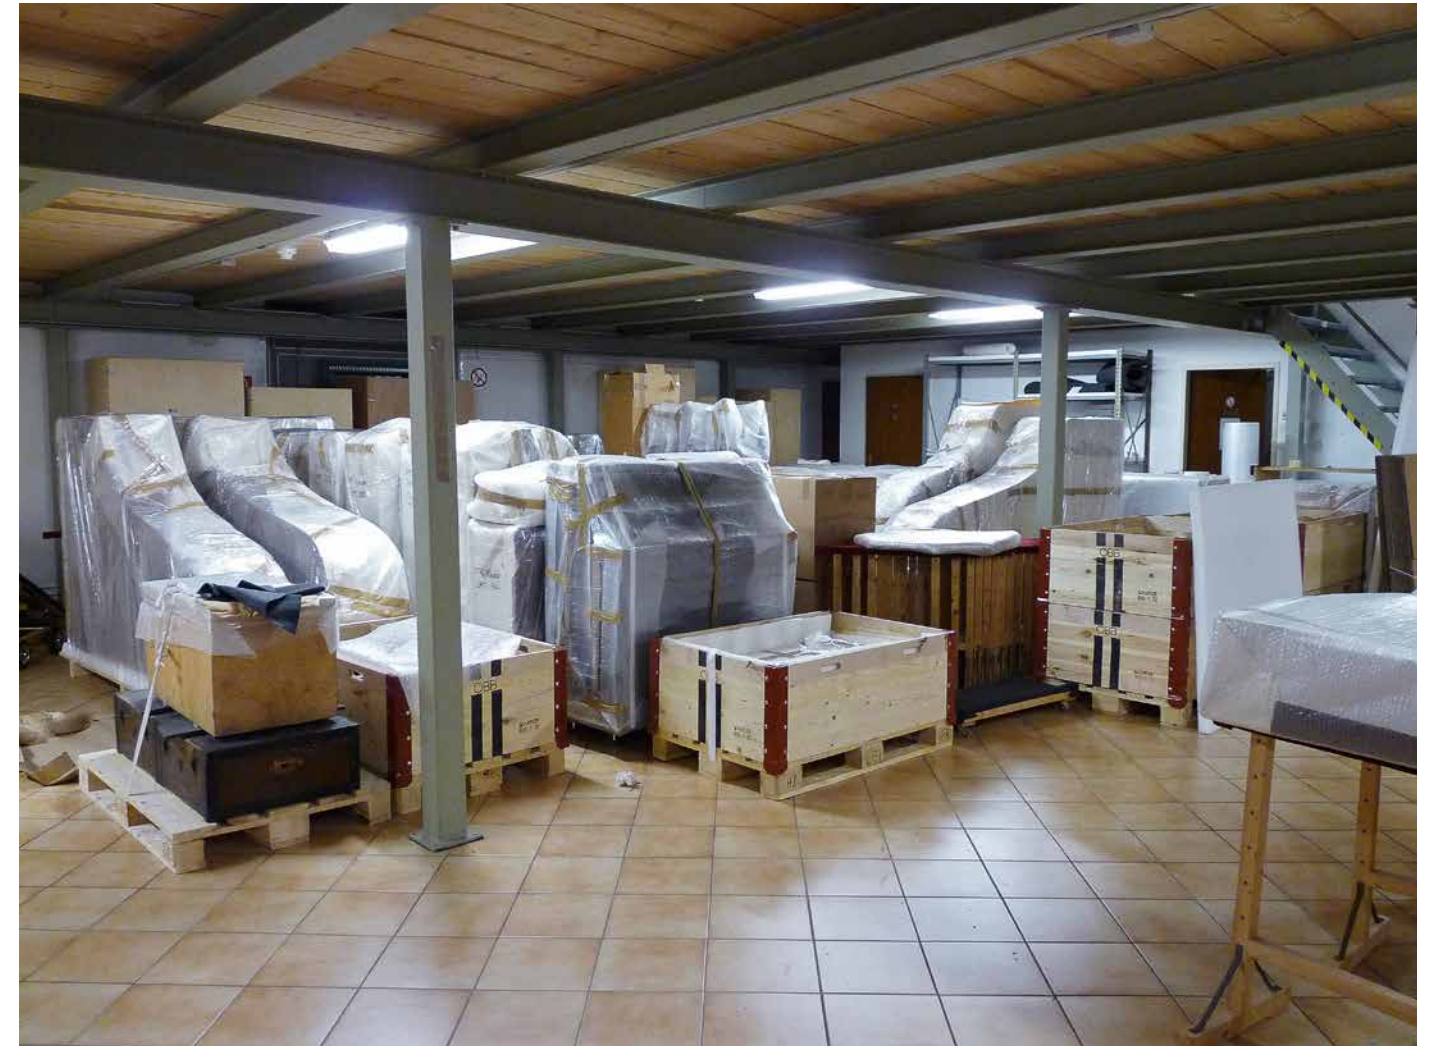
Fig. 7: Completely packed objects before the move.

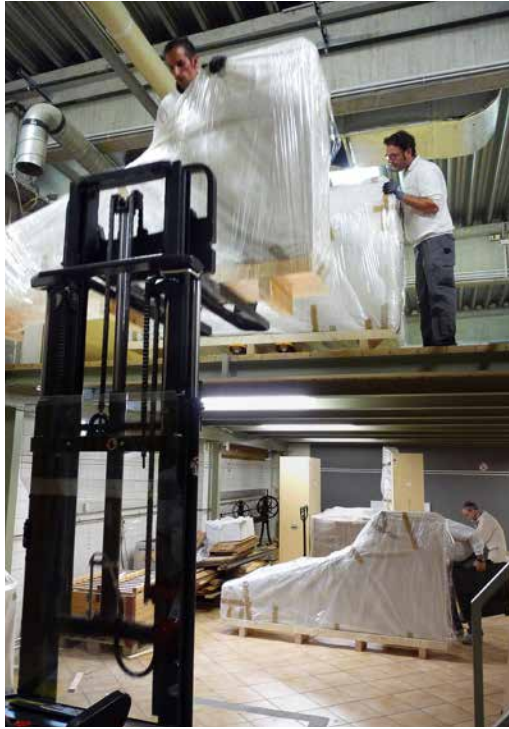
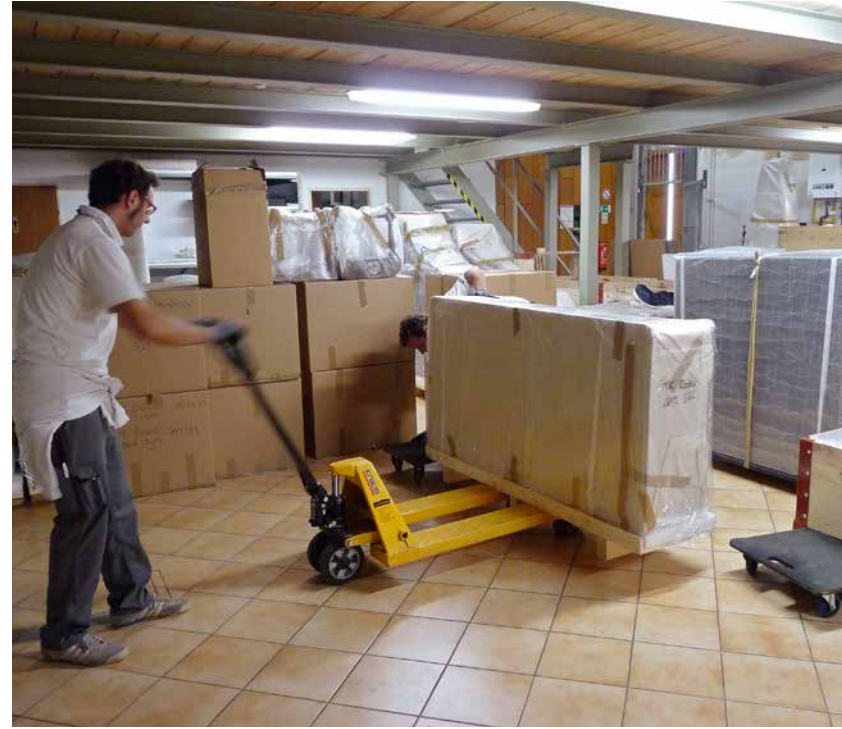
The instruments could be safely moved and loaded into the waiting moving trucks with forklifts or pallet trucks.

The relocation was carried out by the company Kunststrans, who safely moved and loaded the instruments into the waiting moving trucks with forklifts or pallet trucks (fig. 8). Upon arrival at the central storage facility in Himberg, the objects were not immediately unpacked due to climatic considerations and exposure to construction-related dust.

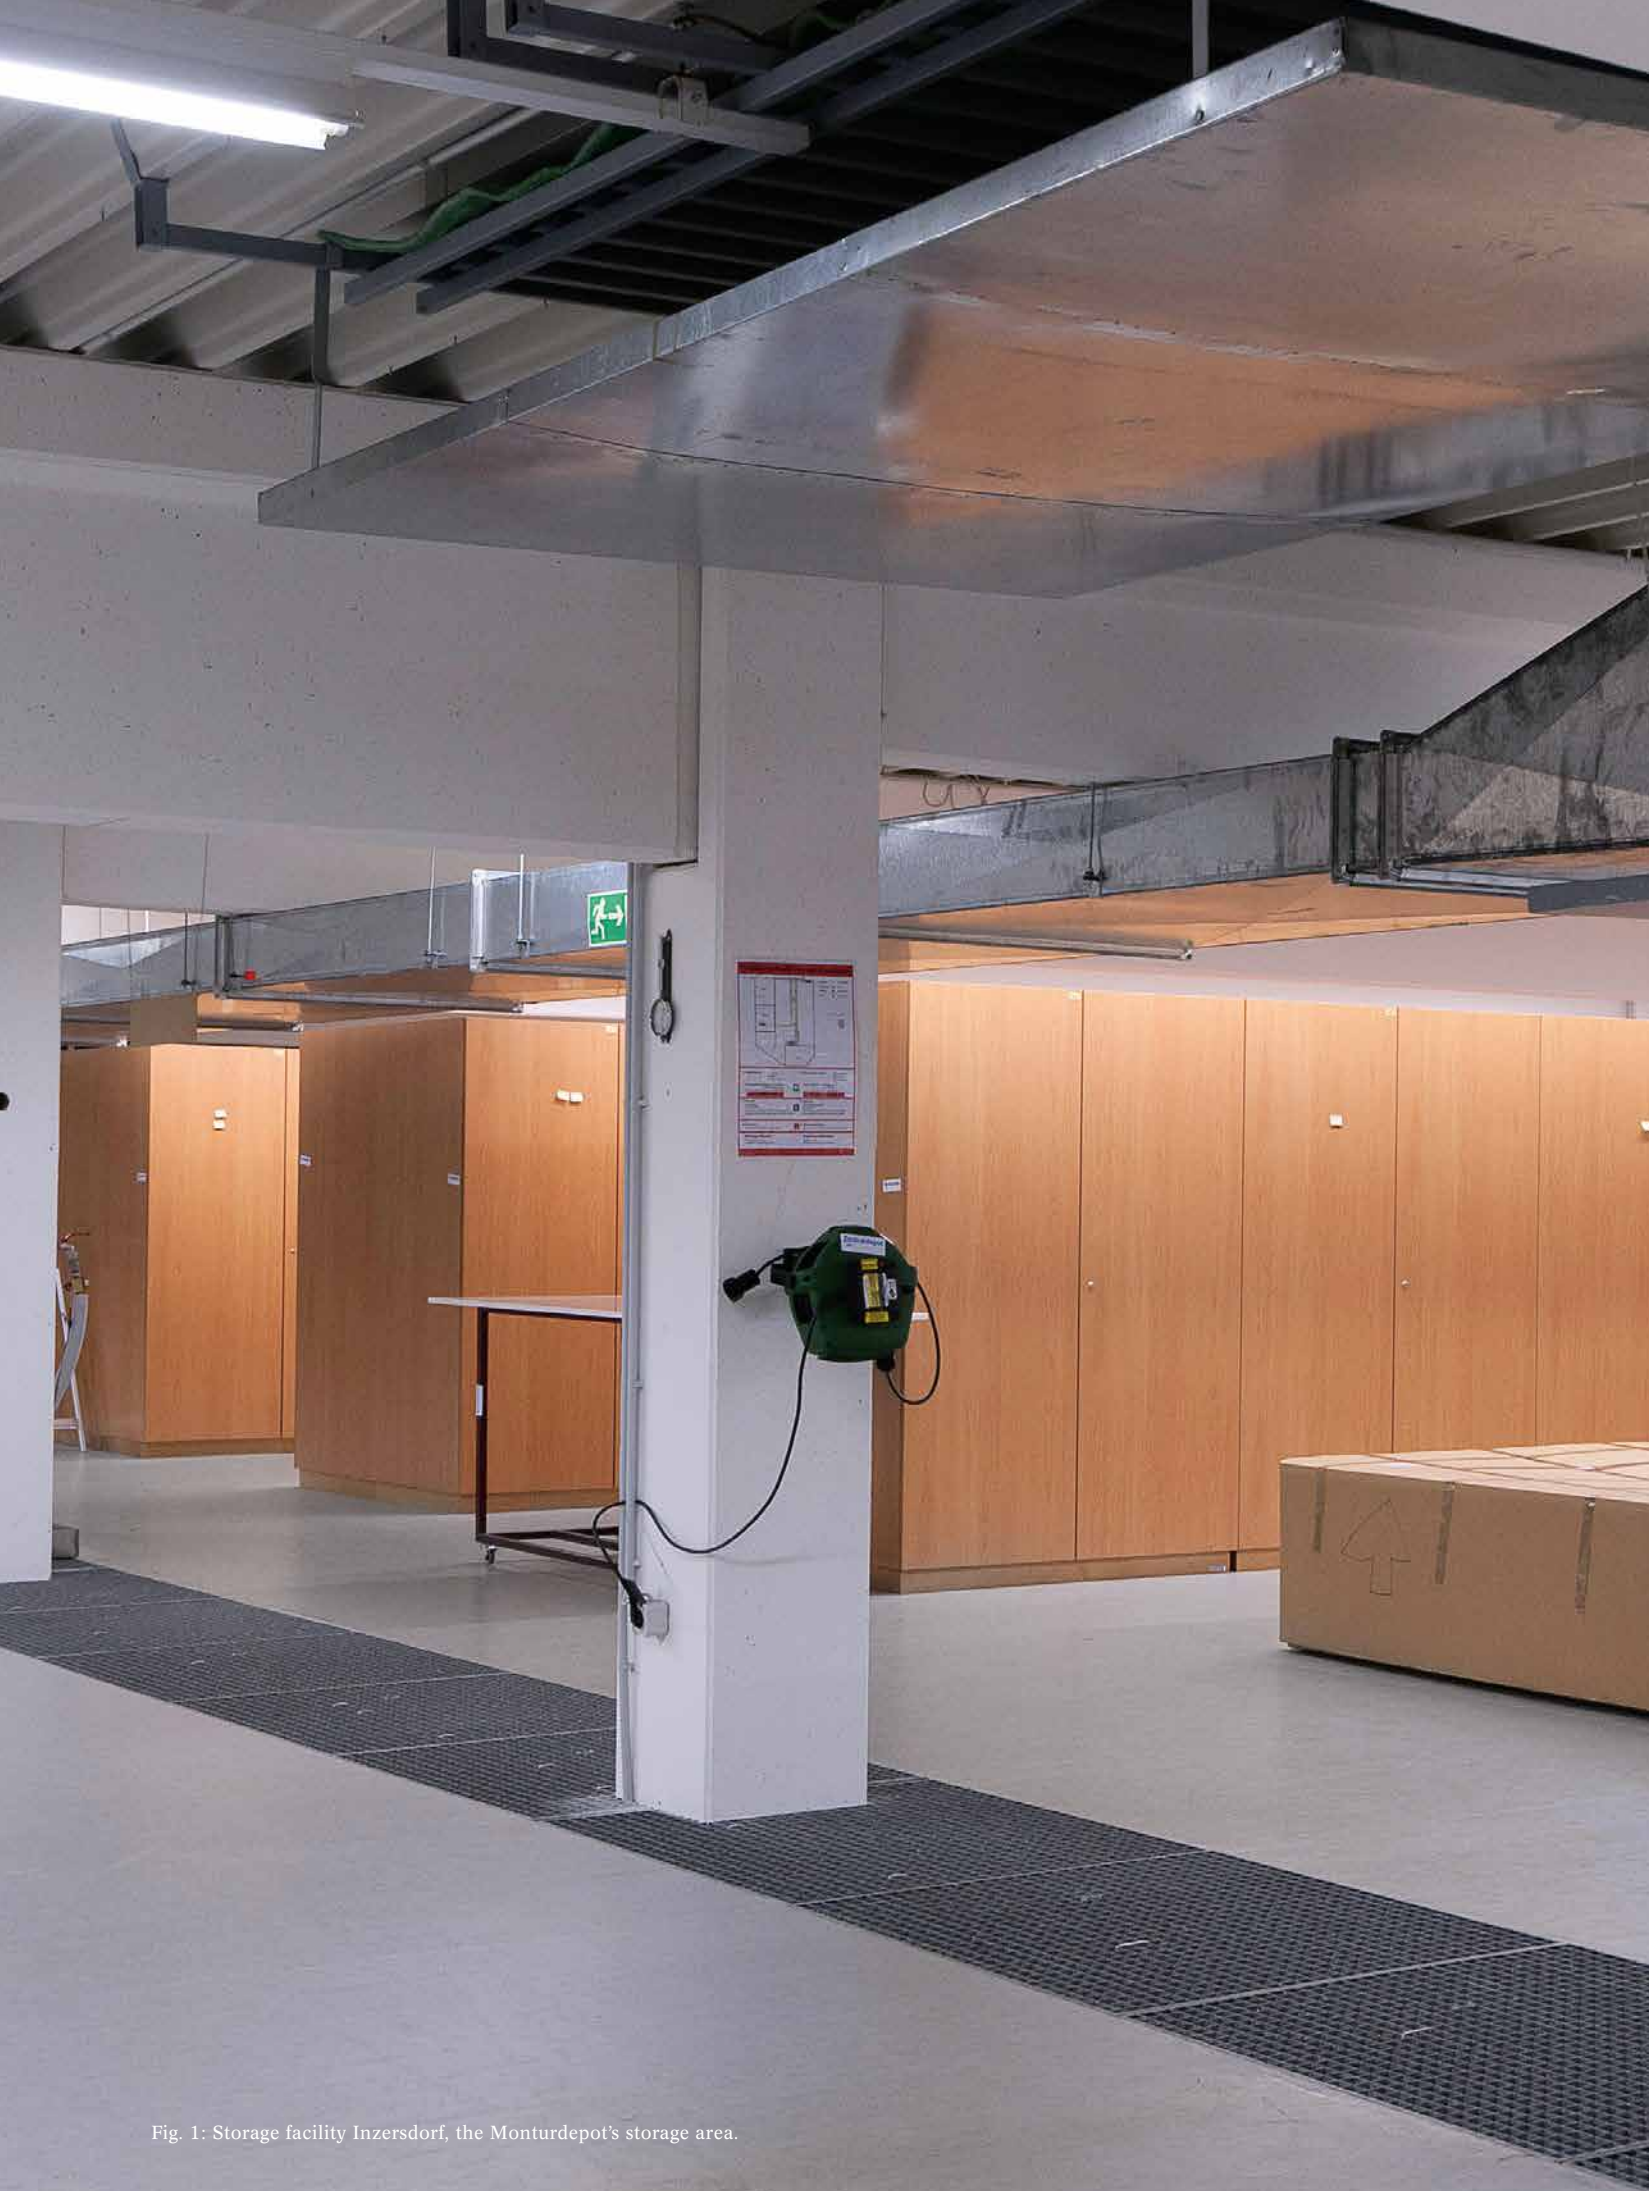
Fig. 1: Storage facility Inzersdorf, the Monturdepot's storage area.

1. in the Kunsthistorisches Museum's storage facility in Inzersdorf (liveries of the Viennese court and historic gowns; *figs. 1 to 4*);
2. in the Monturdepot in Vienna's Hofburg (imperial family household, civilian uniforms, robes of the dynastic orders, liveries of the nobility; *figs. 5 to 8*);

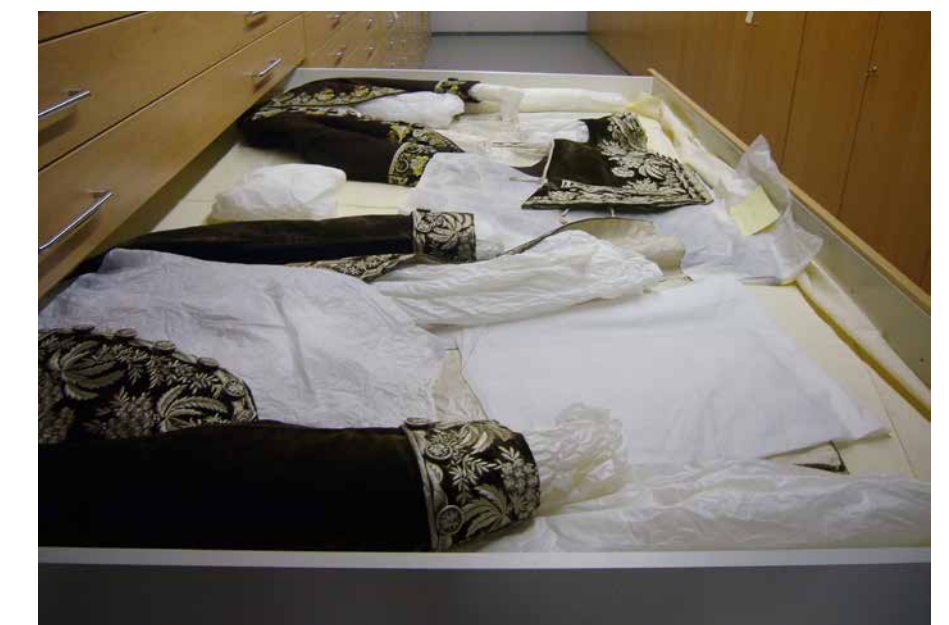
Fig. 2: Storage facility Inzersdorf, storage of rococo tailcoats in oversized drawers.

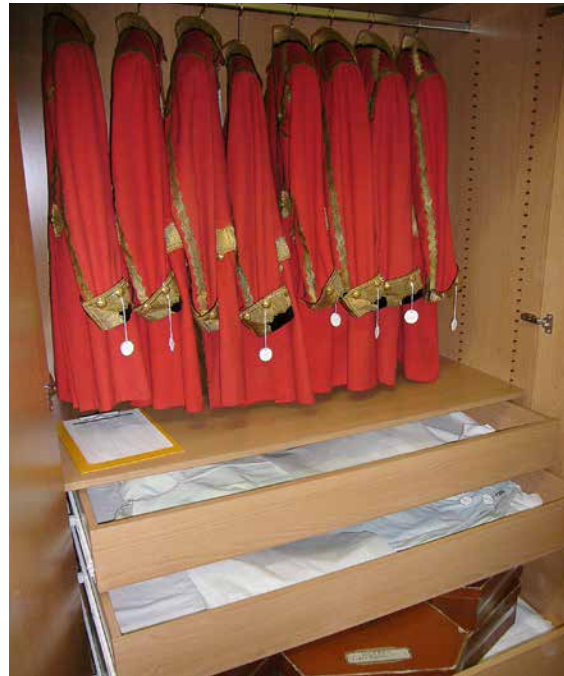
Fig. 3: Storage facility Inzersdorf, storage of court uniforms including accessories in hanging cabinets and drawers.

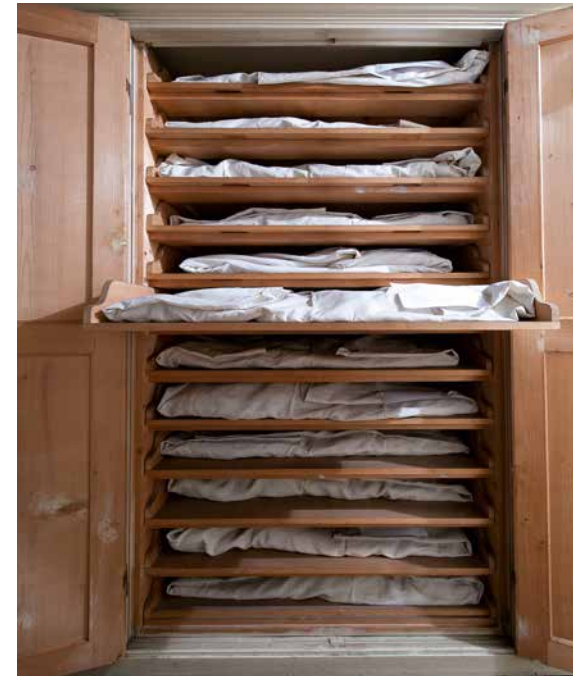
Fig. 7: Storage at the Hofburg, inadequate accommodation of capes and vestments of the dynastic orders. The textiles are folded several times, enveloped in linen cloths and stowed on extensible trays in the cabinet.

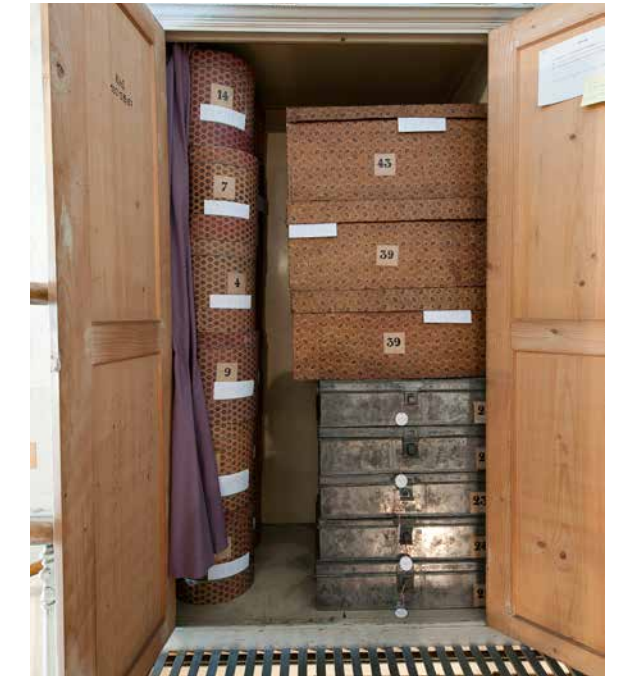
Fig. 8: Storage at the Hofburg, inadequate accommodation of accessories of the robes of the dynastic orders. Original boxes and metal cassettes are piled on top of one another in the cabinet.

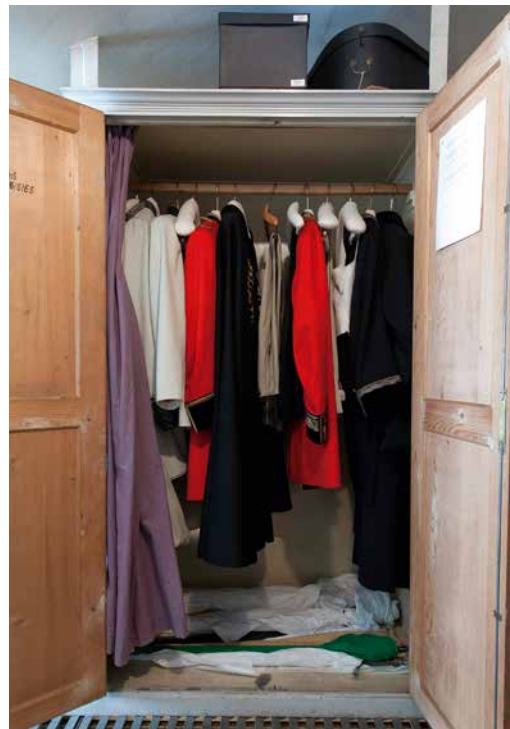
Fig. 5: Storage at the Hofburg, due to lack of space, some of the accessories have to be piled on top of one another and stowed on top of the cabinet.

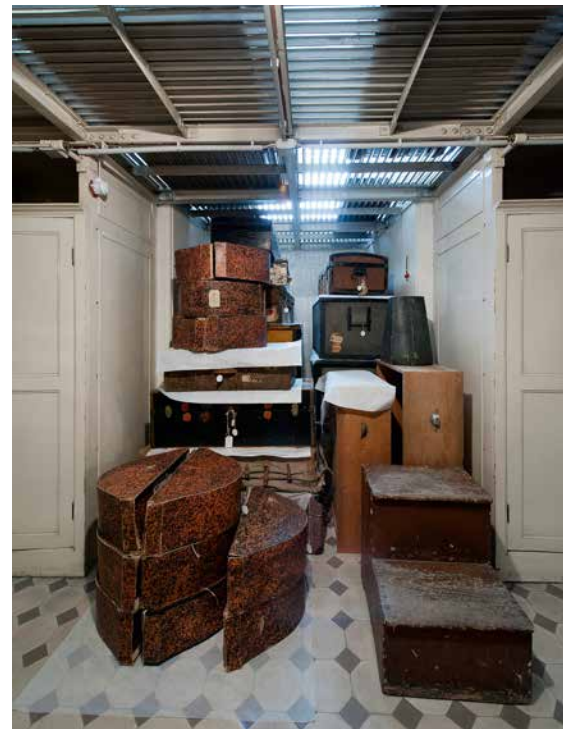
Fig. 6: Storage at the Hofburg, also due to lack of space, miscellaneous historic trunks and chests are piled up in a recess.

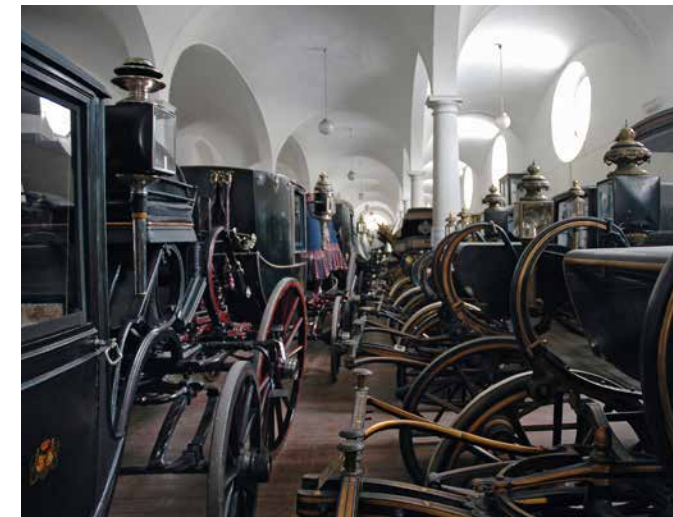
Fig. 9: Storage at the Wagenburg, so-called English Riding Stable, due to lack of space, some of the carriages are parked in the aisle area.

3. in the storage areas of the Wagenburg in Schönbrunn (carriages, harnesses with their different components, collection of paintings and works of art on paper; *figs. 9 and 10*)

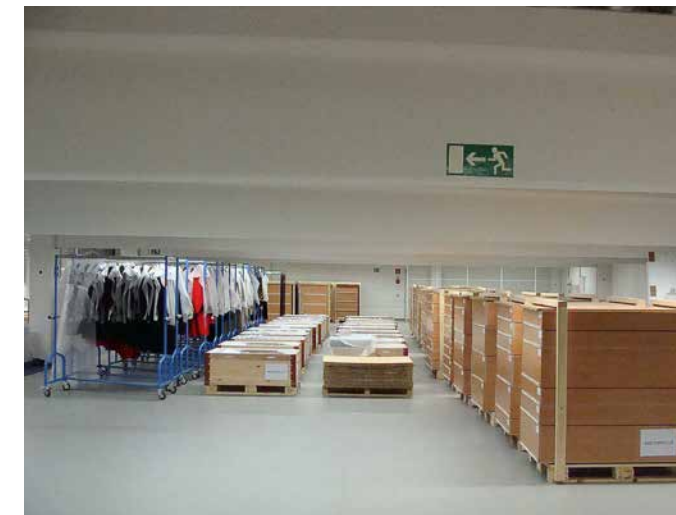
Fig. 11: Storage facility Inzersdorf, pre-packed objects of the Monturdepot.

In order to keep material costs as low as possible, most objects were moved in the drawers of the discarded cabinets. These were stacked on top one another on Euro-pallets and secured for transport with finger-jointed 5/8er wooden braces¹ by employees of the Füreder company (figs. 11, 13 and 14).

By leasing mobile clothes racks and Z-shaped base frames, hanging objects could be moved to the new location in an efficient and space-saving manner (see figs. 11 and 15). The liveries of court servants were left on their padded hangers, which were affixed to the crossbars of the mobile clothes racks with cable ties (fig. 16). Every other garment received a Cellplas²-slipcover for protection, particularly richly decorated liveries were covered with cotton fabric casings. The mobile clothes racks were additionally covered with bubble wrap for transport.

Some groups of objects (such as historic hat boxes) and pieces of exhibition equipment were relocated using stacking frames of the Austrian Railways (ÖBB), which were used individually or stacked according to need (see figs. 11, 17 and 18). They were either lined with bubble wrap (see fig. 18), or with Ethafoam at the bottom and sides (see fig. 17). In some cases the stacking frames were closed by bubble-wrap covers or pallet lids, if required.

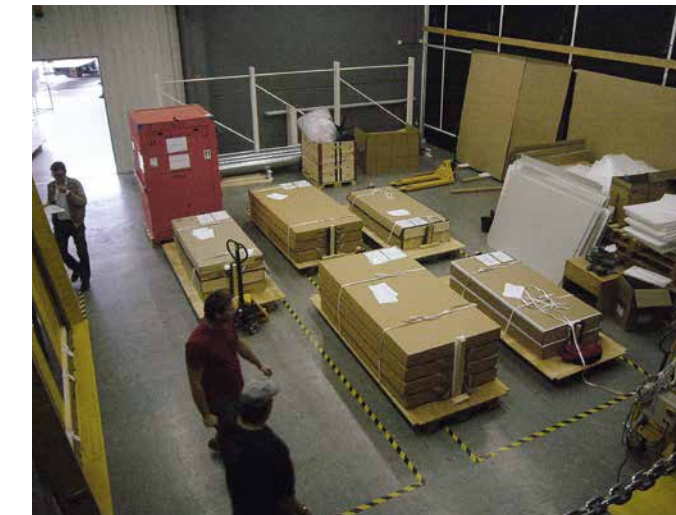
Fig. 12: Storage facility Inzersdorf, pre-placement of the packed objects for transport by the art moving company. The demarcations on the floor indicate the size of the truck.

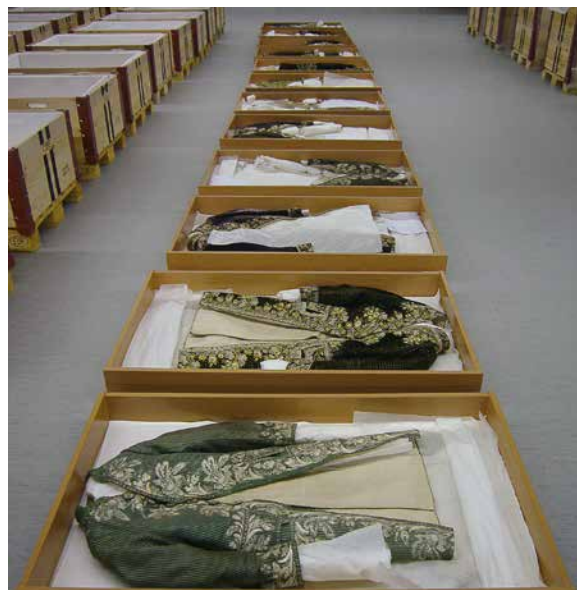
Fig. 13: Rococo tailcoats, packed in the drawers of the disused old cabinets.

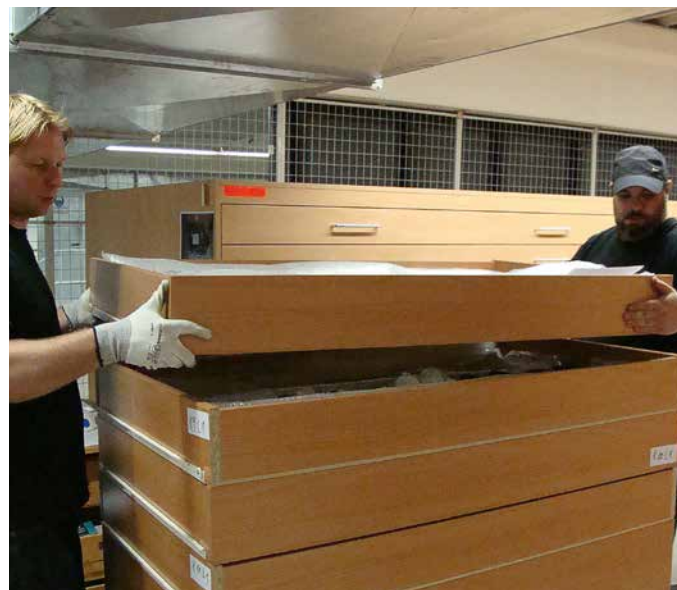
Fig. 14: Füreder company employees stacking the drawers.

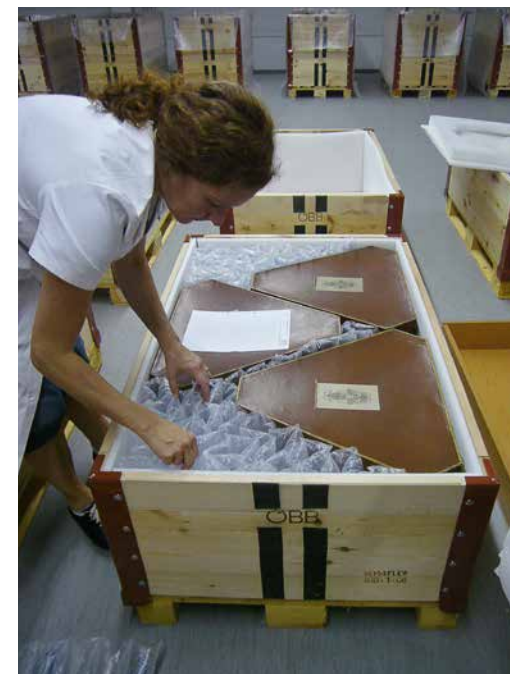
Fig. 17: ÖBB stacking frames fitted with Ethafoam, for the relocation of costume-accessories. Padding of any existing voids with LDPE-air cushions.

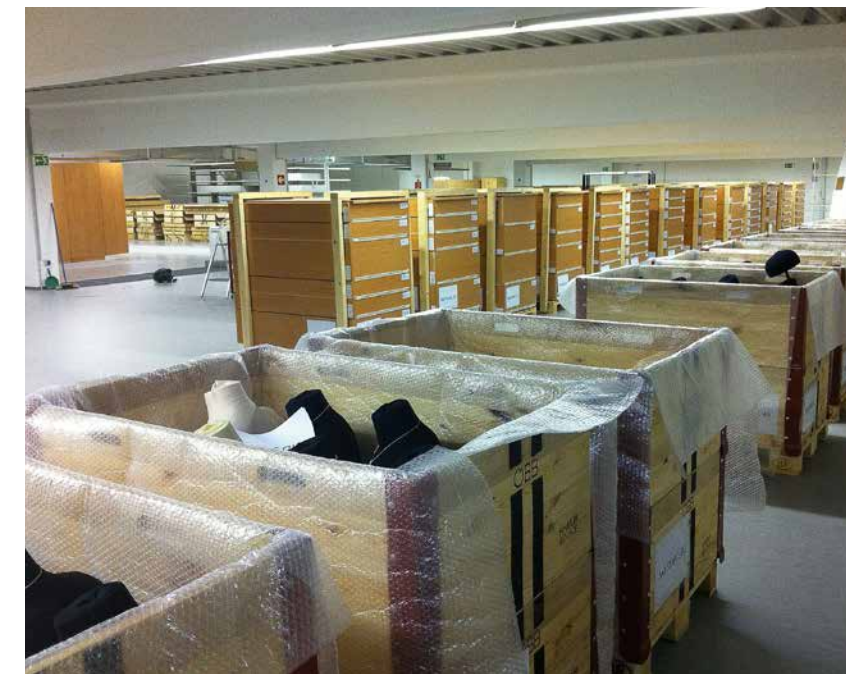
Fig. 18: ÖBB stacking frames stacked on top of one another and lined with bubble wrap, for transporting exhibition equipment such as mannequins and hat-stands.

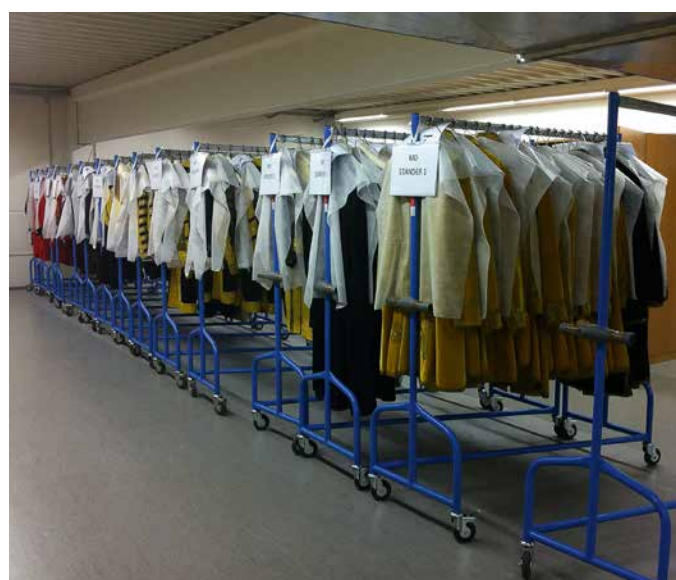
Fig. 15: Mobile clothes racks with Z-shaped base frames can be nested into one another to save space.

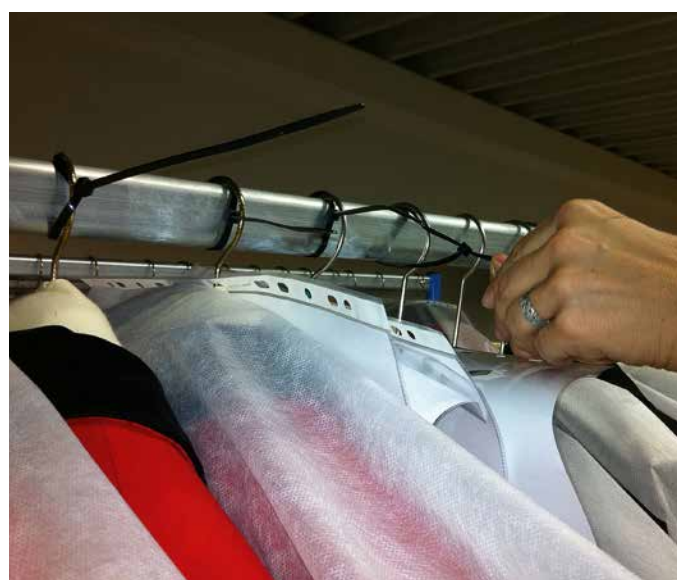
Fig. 16: Fixing individual hangers to the crossbar of the mobile clothes rack with cable ties.

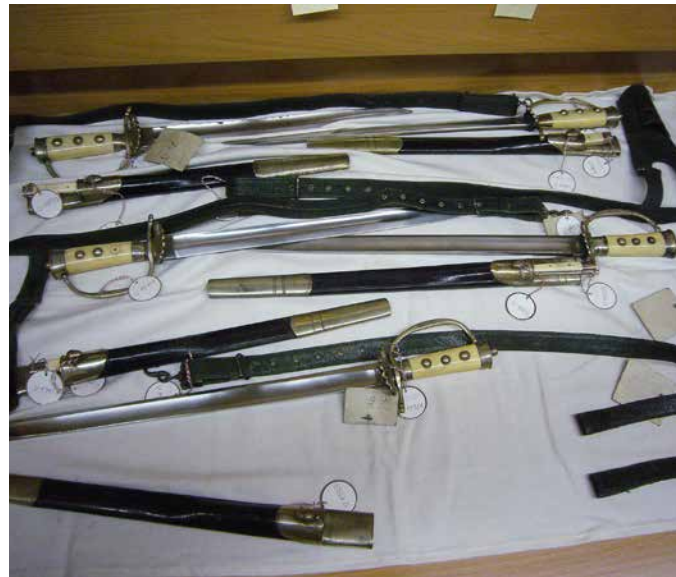
Fig. 19: Storage of hunting daggers with the accompanying sheaths and pendants in the old storage location. Danger of the objects shifting upon the drawer being pulled out.

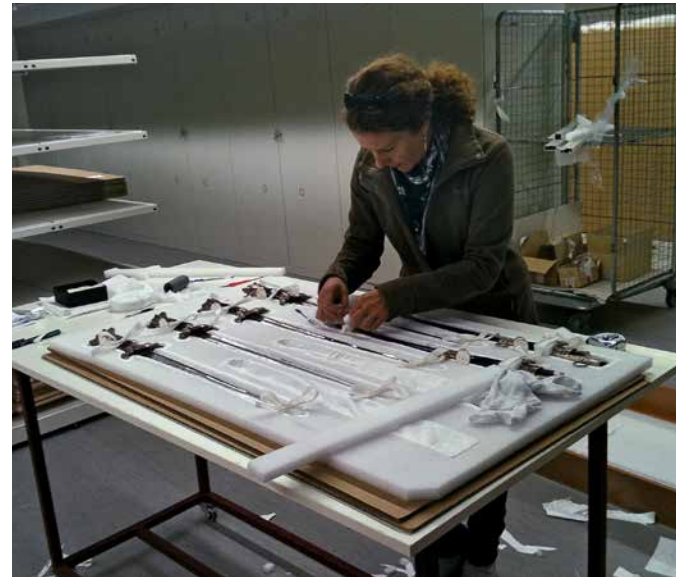
Fig. 20: Preparation of custom-fit blocks of Ethafoam, carved to the shape of the object and lined with Tyvek, for securing the objects within the drawers.

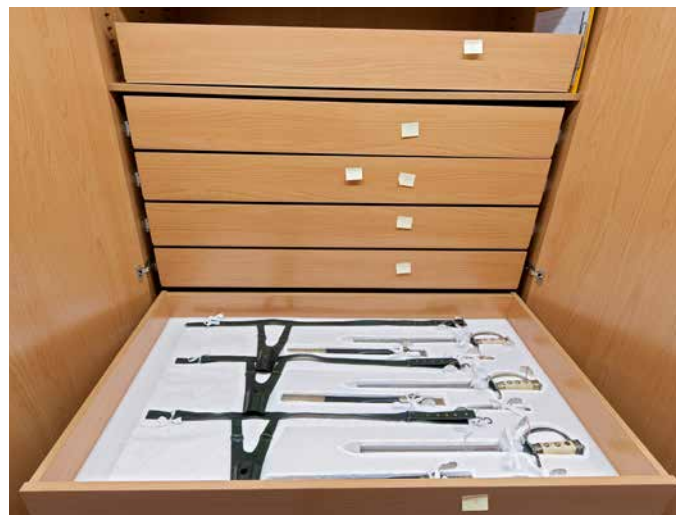
Fig. 21: Hunting daggers with the accompanying sheaths and pendants, embedded in Ethafoam for transport (old storage cabinet Inzersdorf).

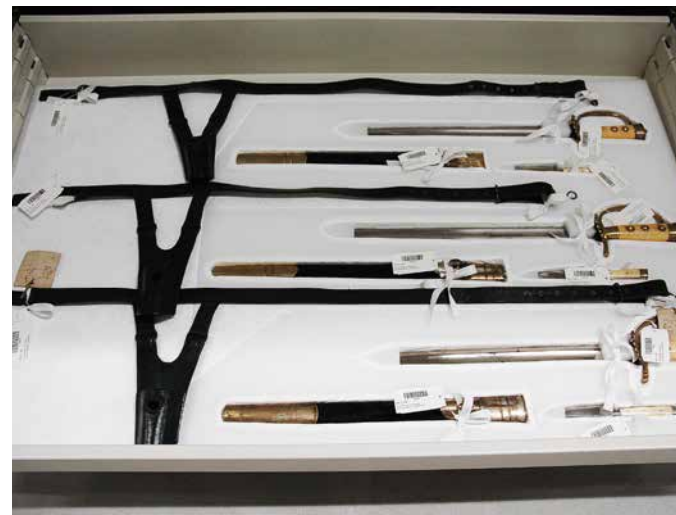
Fig. 22: Adapting the custom-made Ethafoam beds for subsequent use in the drawers of the central storage facility's new cabinets.

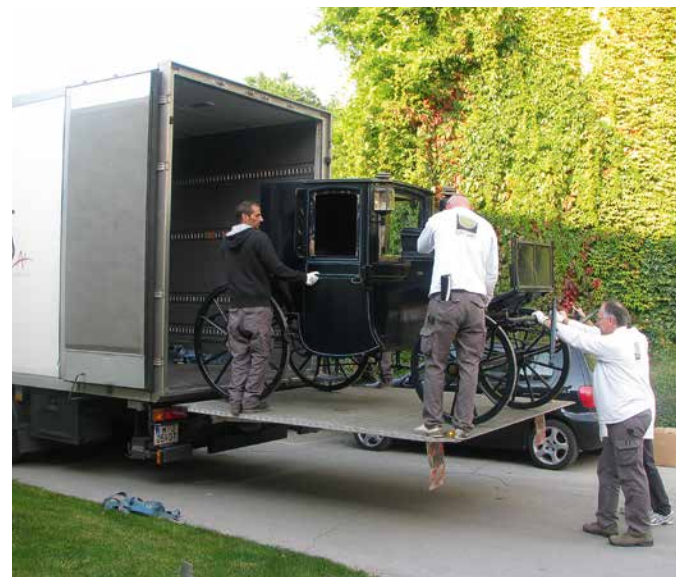
Fig. 24: Loading one of the carriages from the Wagenburg onto the art moving company's truck.

onto the truck and transported to Himberg (figs. 23 and 24). This helped to eliminate the danger of pest infestation.³ Due to their special size, their weight and their shape, objects from the Wagenburg were not wrapped for transport (see fig. 24), and could therefore only be moved in fair weather.

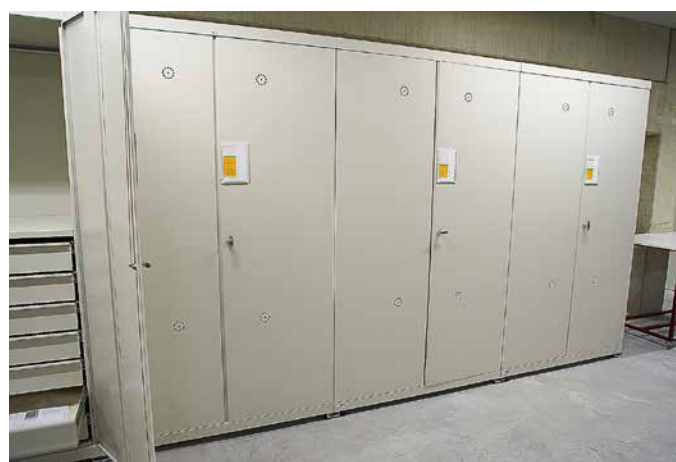
Fig. 29: Powder-coated steel cabinets by the Magista Systems/Van Keulen Interieurbouw company for storage of the Monturdepot's objects.

Powder-coated steel cabinets with variable interior furnishings such as clothes rails, shelving and drawers by the Magista Systems/Van Keulen Interieurbouw company allow for flexible storage of the costumes collection. They thereby meet the complex requirements for accommodating the manifold textiles (figs. 29 to 31).

With a width of 125 cm, a usable shelf depth of 80 cm, and a height of 220 cm, the cabinets are consistent with common standard measurements, and clothes rails, shelving levels and drawers can be hooked into a grid variably and without using tools, at intervals of 35 mm. The maximum load per linear meter is 20 kg for the drawers, for the clothes rails and shelves it is twice that amount. Vent holes were stamped into the double doors, providing for air circulation within (see fig. 29). The cabinets are labelled using magnet boards.

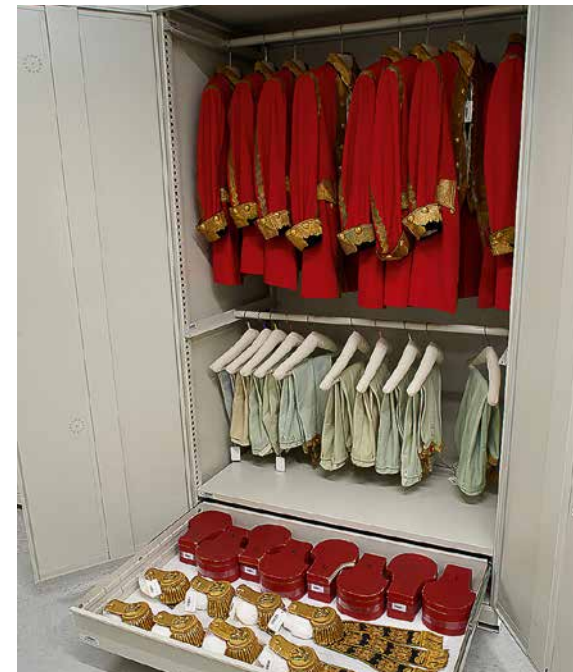
Fig. 30 a

Examples of the interior fittings of the steel cabinets, with clothes rails, shelving and drawers in different sizes.
