Technological Studies

Kunsthistorisches Museum Vienna

Special volume: Storage
Vienna, 2015

Technologische Studien Kunsthistorisches Museum.
Konservierung – Restaurierung – Forschung – Technologie,
Sonderband Depot, Band 9/10, Wien 2012/13

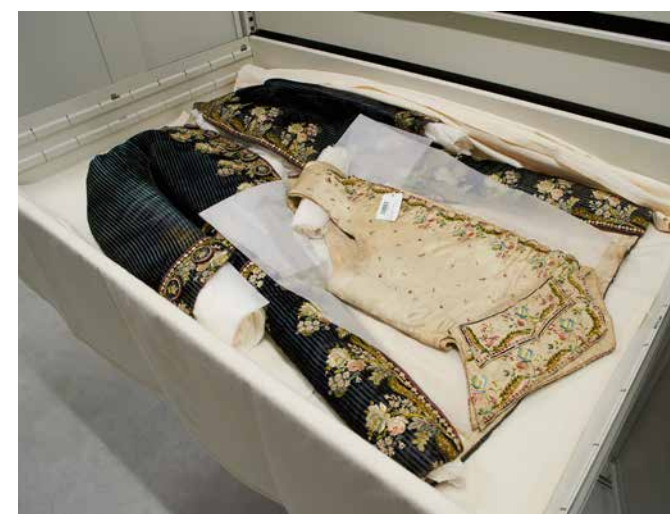
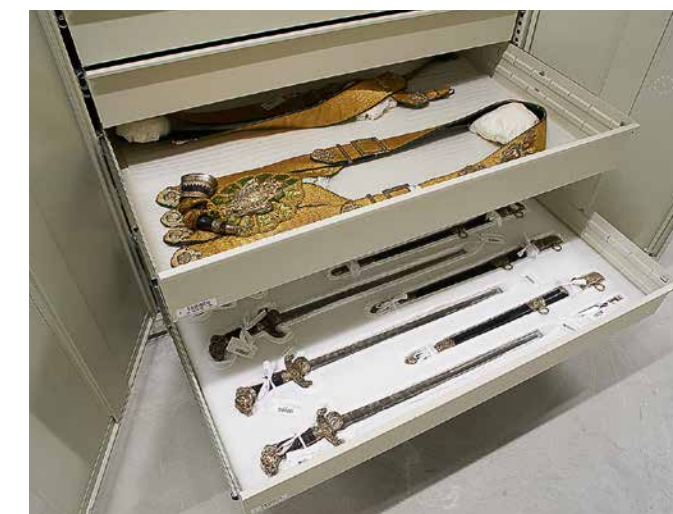
Examples of the various types of storage of costumes and accessories in drawers.

Powder-coated steel cabinets with variable interior furnishings such as clothes rails, shelving and drawers by the Magista Systems/Van Keulen Interieurbouw company allow for flexible storage of the costumes collection. They thereby meet the complex requirements for accommodating the manifold textiles (figs. 29 to 31).

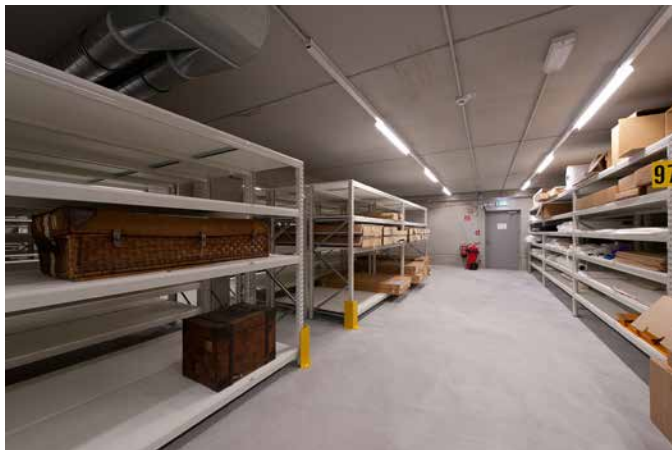
Fig. 32 a
Wide-span shelving units by the Compactus & Bruynzeel AG. On the left with deposited trunks and chests from the Monturdepot. On the right with caparisons, foil sealed, from the collection of the Wagenburg.

A space-saving alternative to free-standing trunks and chests was found in the wide-span shelving units from the Compactus & Bruynzeel Storage Systems company, which will ensure the clearly laid out storage of these objects in future (fig. 32 a). The measurements of the shelving system are 200 × 270 × 80 cm (H × W × D); it has a load-bearing capacity of 800 kg per linear meter of shelving.

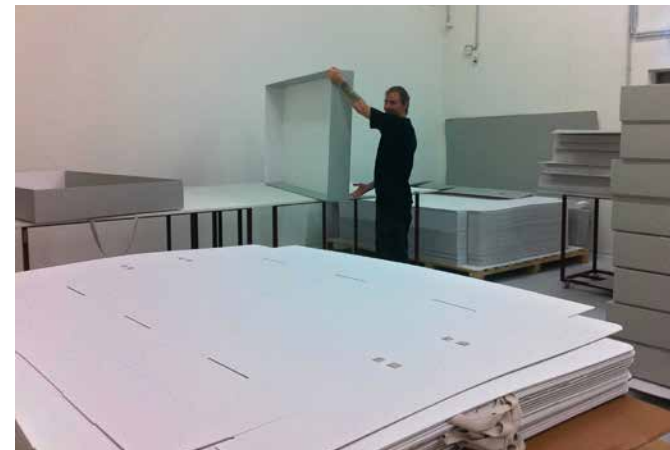
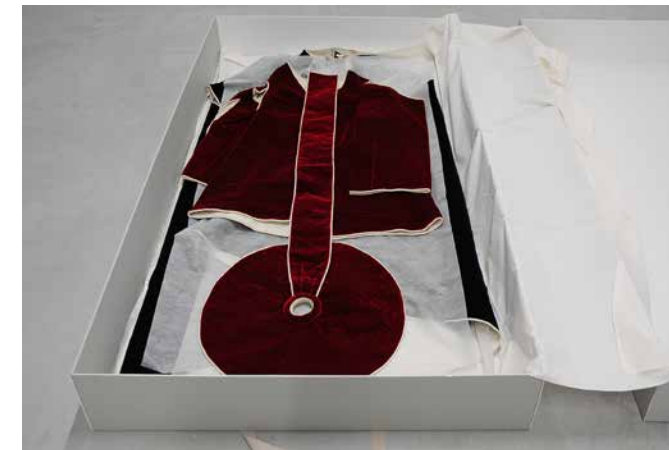
Fig. 33 a
Acid-free cardboard boxes by the Klug-Conservation company for the storage of oversized textiles. On the left, during assembly by an employee of the Japico company. On the right, with stored regalia of the English Order of the Garter.

Oversized textiles such as gowns with long trains, or the regalia of the Habsburg dynastic orders with their grand capes and vestments, are stored in flat textile storage boxes (see fig. 33 b and 34 b). These were manufactured especially for the Monturdepot by the Klug Conservation company, to the specifications of the collection's conservators, since the standard range of products available on the market (NOMI KS 16 acid-free cardboard box) did not correspond to the desired requirements in format or execution.

As is customary, the boxes are manufactured from 3 mm corrugated board, with a double wall thickness on two opposing sides. However, they are equipped with additional cotton ribbons on two sides to serve as carrying straps and thus facilitate their handling. To prevent these from shearing under strain, they are riveted to the bottom of the box twice, and covered by a further base insert. Polyester envelopes by the Monochrom company, common in the archiving of photographs, serve to label the boxes and are affixed using double-sided Secol-tape.

In order to reduce transport costs, the boxes were delivered in a flat state and only assembled in situ by an employee of the Japico company (fig. 33 a).

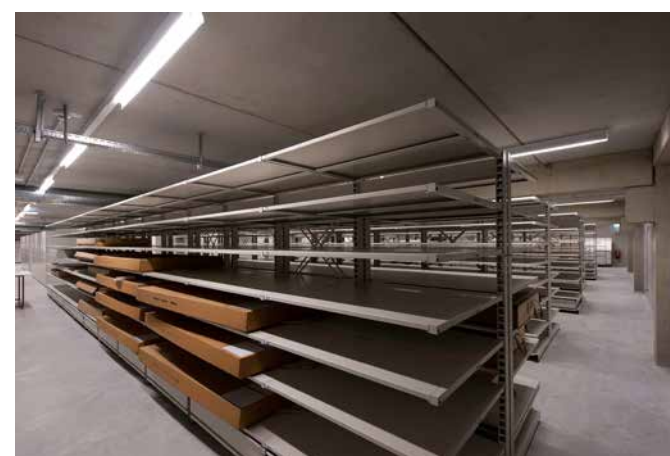
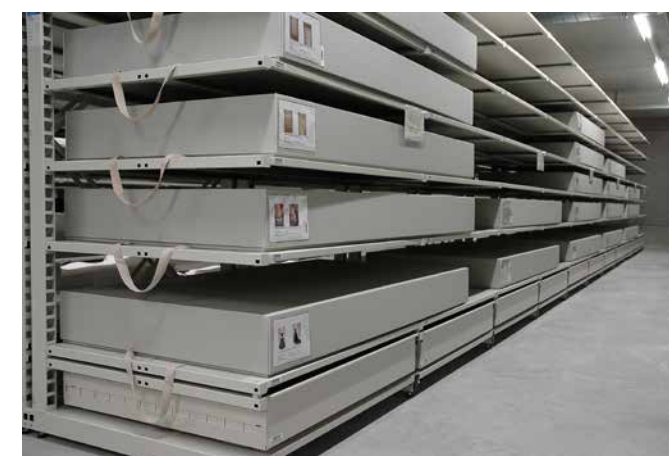
Fig. 34 a
Support-free shelving units with continuous levels by the Magista Systems/Van Keulen Interieurbouw company, with acid-free cardboard boxes by the Klug-Conservation company for the storage of oversized textiles.

The boxes are 20 cm high, 190 cm long and 100 cm wide, and thus have the largest format that can be assembled from one piece without puzzle joint connections; the width of the boxes was predetermined by the depth of the shelving system.

A support-free shelf with continuous levels was developed by the museum adviser Dr. Joachim Huber in collaboration with the Magista Systems/Van Keulen Interieurbouw company for the storage of the large-format textile boxes (fig. 34). This constitutes an innovation in the field of museum storage furnishings, as the shelf posts of the systems previously available on the market had always impaired utilisation of their full width.

The cantilever shelving system is made from steel, powder-coated on all sides. It consists of vertical shelf posts with an adjustment grid (frame size: 230 cm, adjustment grid: 5 cm), to which cantilever arms are affixed horizontally. Shelving (width: 95/120 cm, usable depth: 100 cm) can be hooked onto these flush

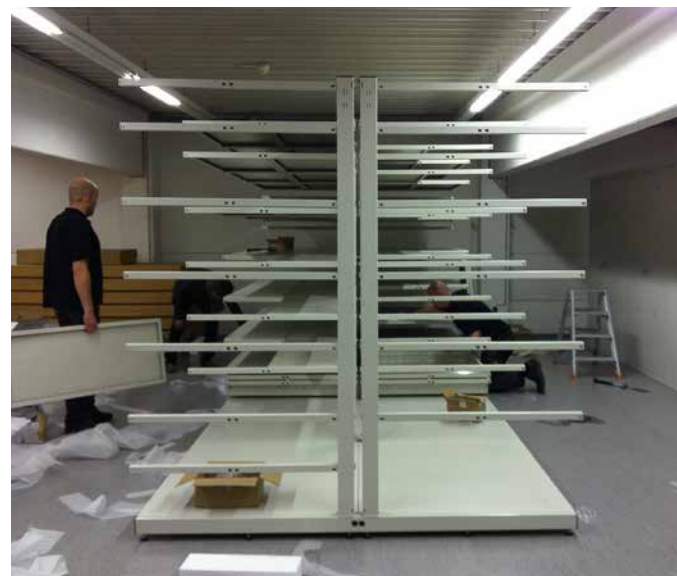
Fig. 35: Assembly of the prototype for the support-free shelving at the storage facility Inzersdorf.

According to the call for bids, the respective companies were required to produce a prototype for each part of the furnishings (fig. 35) before procurement, so that quality and functionality could be verified in advance.

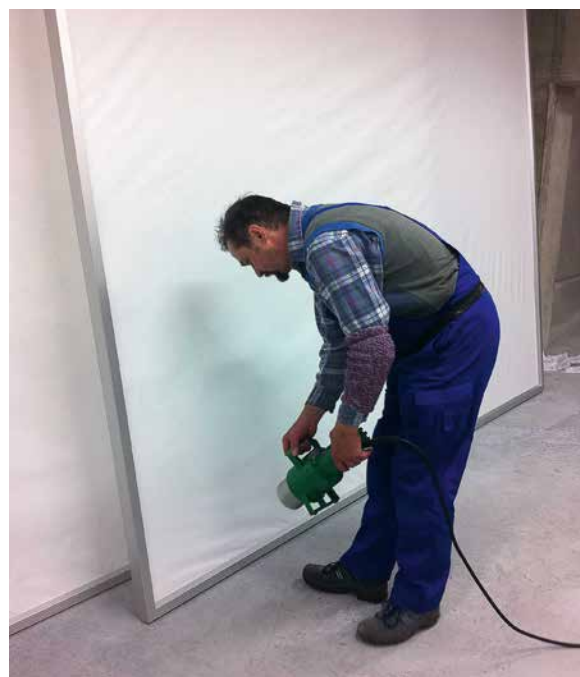
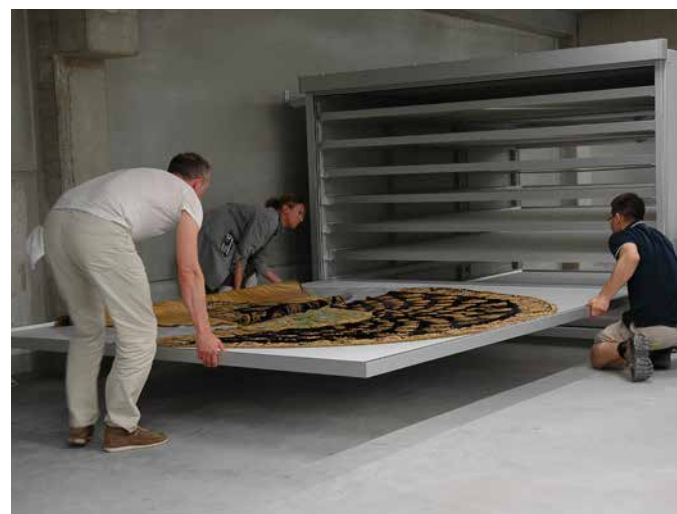
Large cabinet with shelving by the StabaArte company for the storage and display of oversized textiles. On the left, during assembly. On the right, with deposited regalia of the Order of the Holy Spirit.

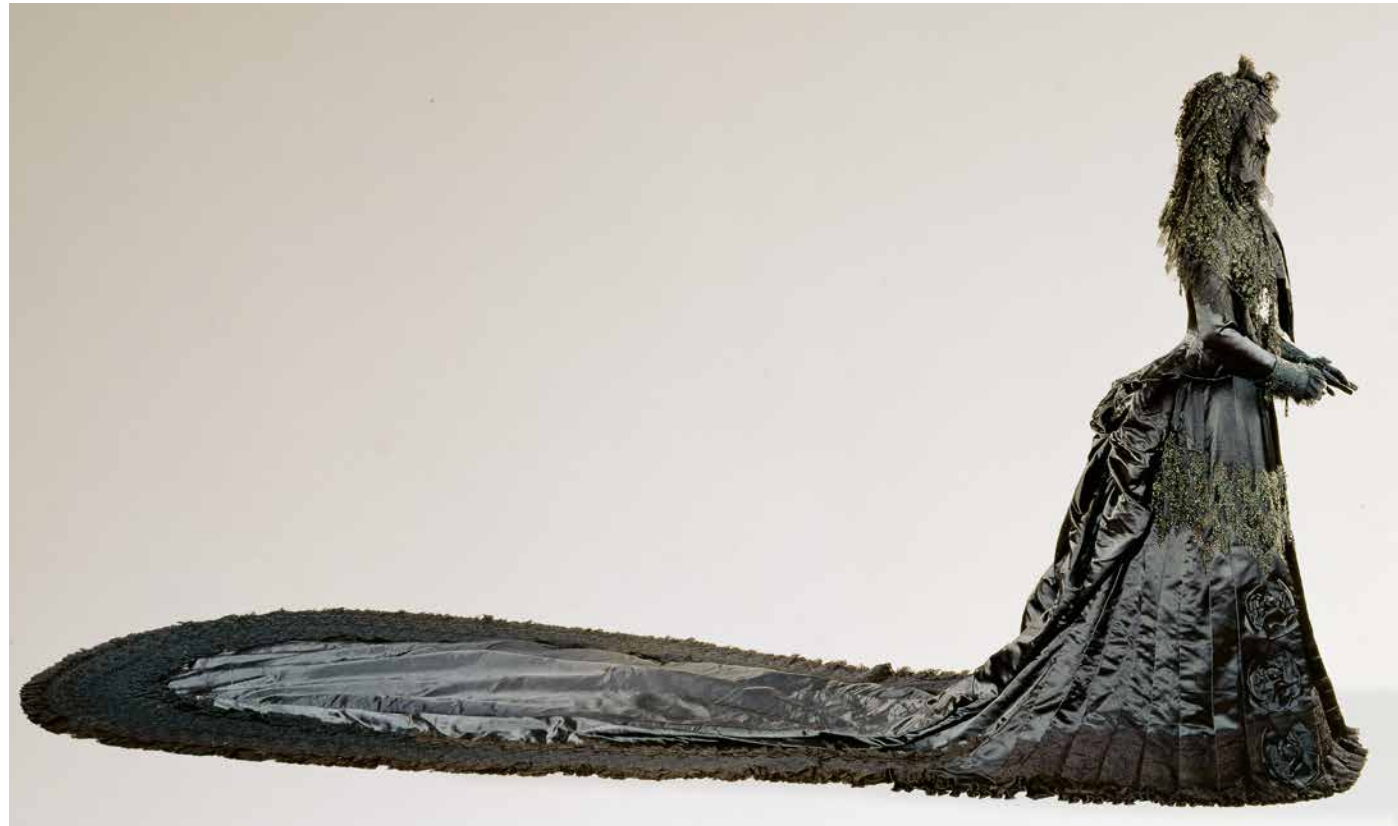
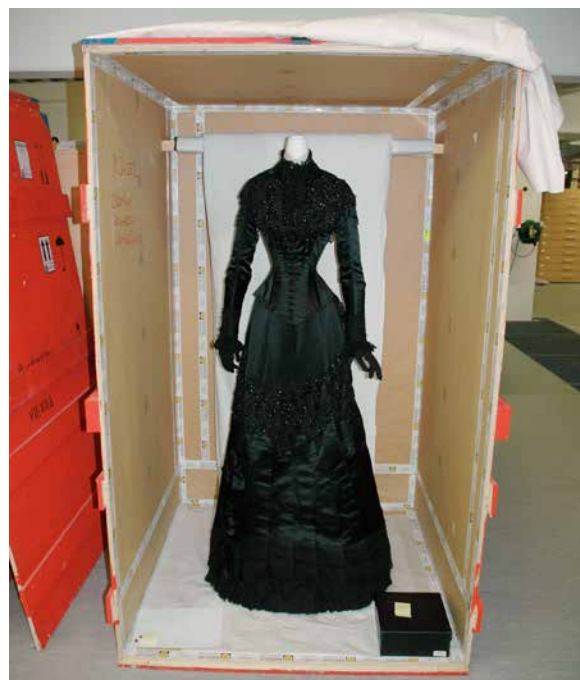
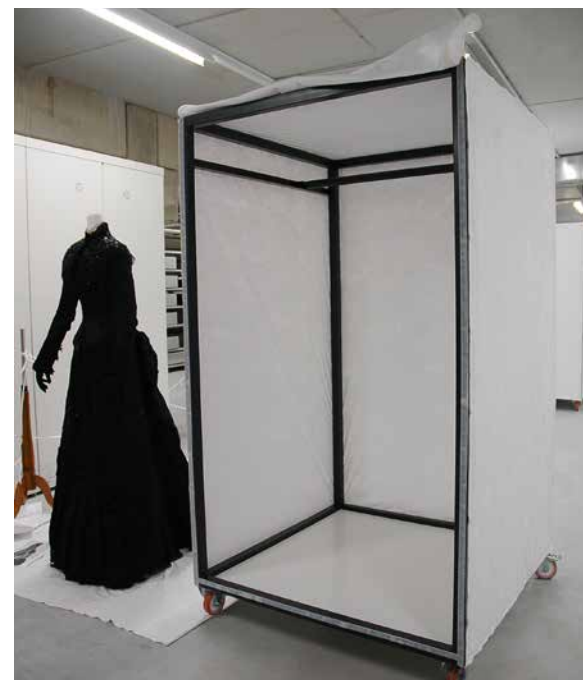
Fig. 37 a

Empress Elisabeth's large mourning robe on a custom-fit Kyoto-mannequin. Bottom left, in a crate from the art moving company. Bottom right, new accommodation in a container custom-made by the Museum company.

Mannequins will therefore be stored in custom-built, mobile "profiled pipe containers" (h 180 cm, l 110 cm, w 110 cm) (fig. 37 c), guided by the container-system developed by Martijn de Ruijter for the Tropenmuseum Amsterdam. Their bottom panels consist of PVC rigid foam board (Celuka), which is often used in the construction of display cases and is non-hazardous according to the Oddy-test. A frame of powder-coated profiled pipes is mounted onto the bottom panels, into which detachable crossbars can be hooked to accommodate the trains. The walls of the boxes are lined with Tyvek and are opened and closed using Velcro. Steering castors with locking brakes allow for easy displacement of the racks.

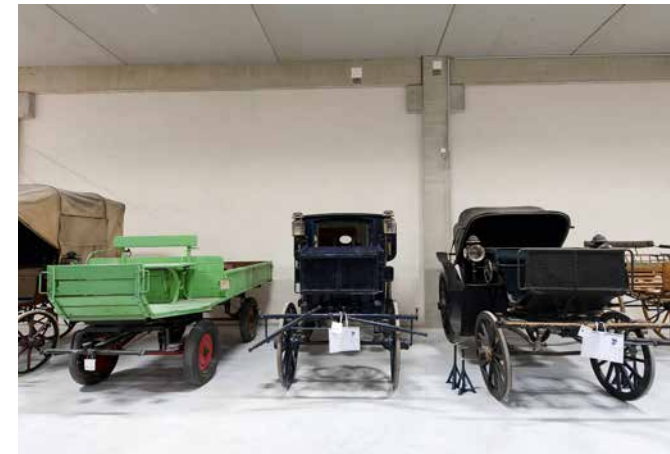
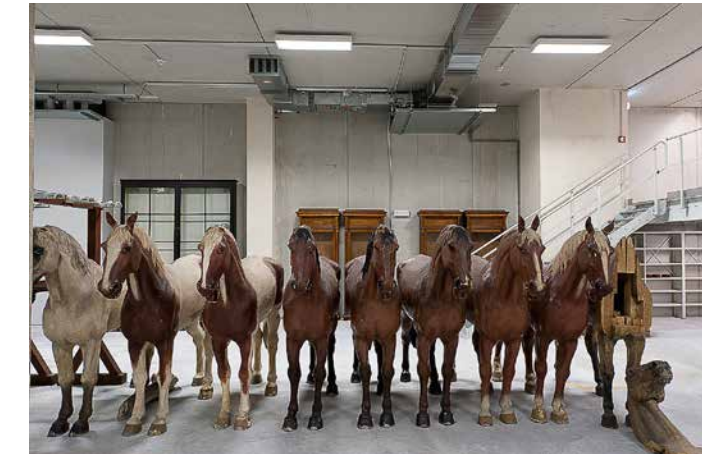
Fig. 38 a

Central storage facility Himberg, storage area of the Wagenburg with carriages (left) and model horses (right).

Not all objects can be accommodated in cabinets, shelving systems or other constructions. Their size, weight and shape sometimes necessitate a free-standing placement of the objects. The carriages, historic cabinets and exhibition equipment of the Wagenburg may be named as examples (fig. 38).

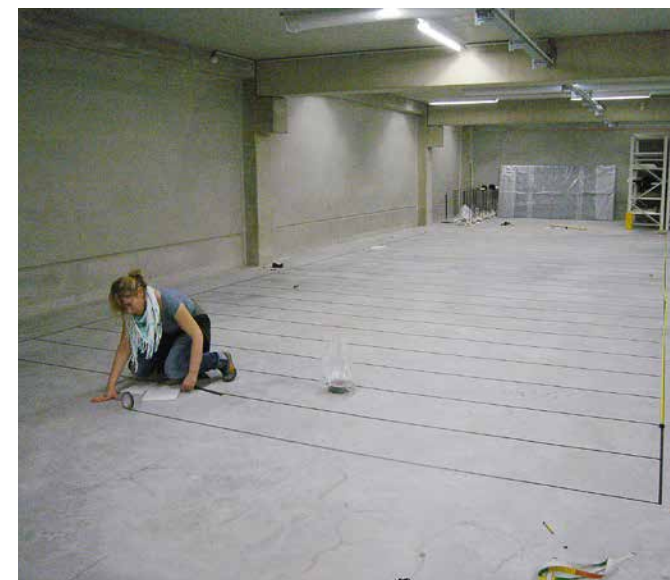
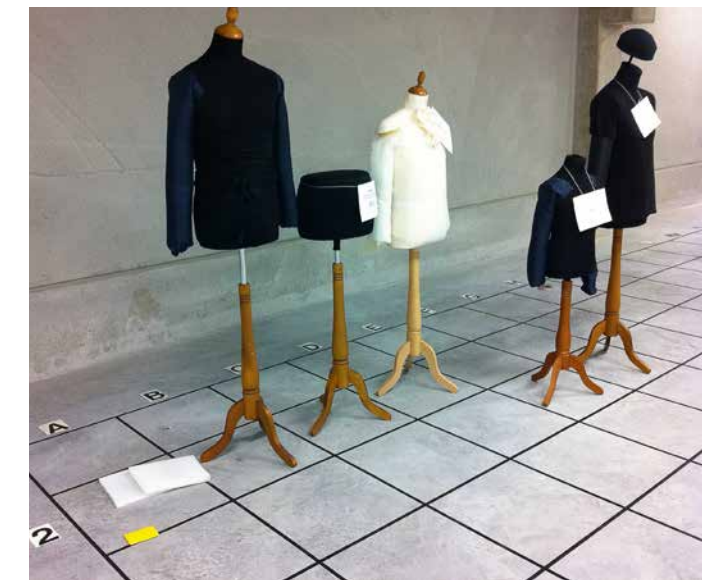
Fig. 39 a

Coordinate system for the storage of the collection of mannequins. Adhering the tape to the floor (left), and the complete grid with self-adhesive letters and numbers for determining locations (right).

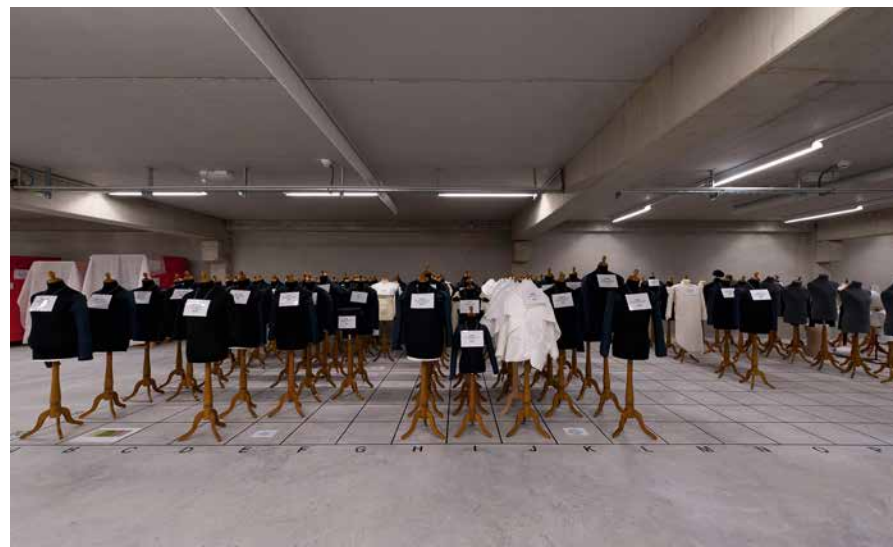
Fig. 40: Central storage facility Himberg, the completed coordinate system for storage of the collection of mannequins.

As the coordinate system conceived for the storage of the Monturdepot's mannequins in the old location had proved successful in practice, it was to be expanded and applied to the new storage facilities (fig. 40). To this end, black adhesive tape was used to form a grid on the cleaned floor, leaving fields of 50 × 50 cm size as positions for the mannequins (fig. 39). In accordance with the previous model, the columns and rows of the grid were labelled continuously with self-adhesive letters and numbers (see fig. 39 b). The assignment of positions is carried out using the corresponding coordinates (e.g. B2), which are recorded next to the respective object in the collection inventory and facilitate locating the appropriate exhibition equipment effortlessly when needed. In addition, a layout plan is available onsite, to provide the required overview in case of computer failure. To determine the locations for the carriages and sleighs in the Wagenburg's storage area, parking spaces were delineated using a grid of black fabric tape. In addition, the empty corridors between the vehicles were labelled "space for manoeuvring" in order to keep these areas free.

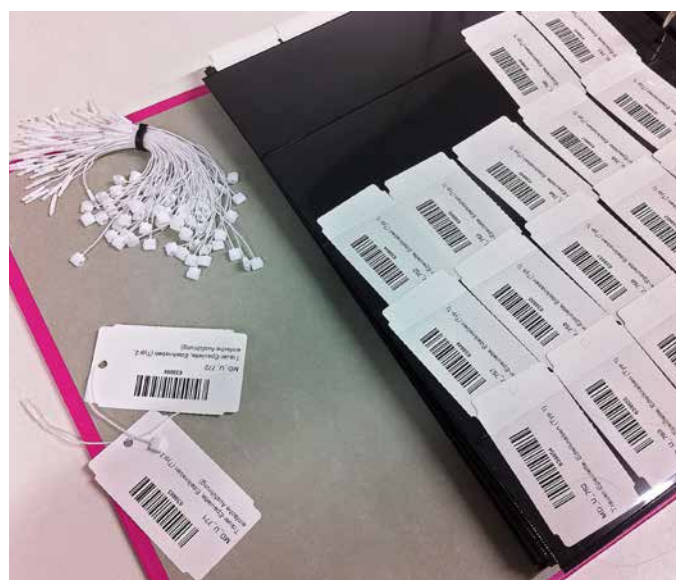
Fig. 41: Barcode labels to be affixed with polypropylene safety thread, printed in advance by the TMS-department, and sorted numerically by collection staff.

The barcodes were laser-printed onto archival hangtags made of polyethylene foil (TTR TAG PE-Foil Polyart S2), which contain the barcode, inventory number and object identification (figs. 41 to 43). These tags are carefully affixed to the objects using 12 cm polypropylene safety thread with “one time”-fastening (in white or black) (see figs. 42 and 45). For reasons of clarity, within groups of similar objects, the tags are always affixed to the same spot (for uniforms e.g. to the uppermost buttonhole). For objects to which no tags can be attached (such as original hat boxes), the object information is adhered to a transparent polyethylene strip, which is placed around the object as a banderole, without interfering with the original material (fig. 44).

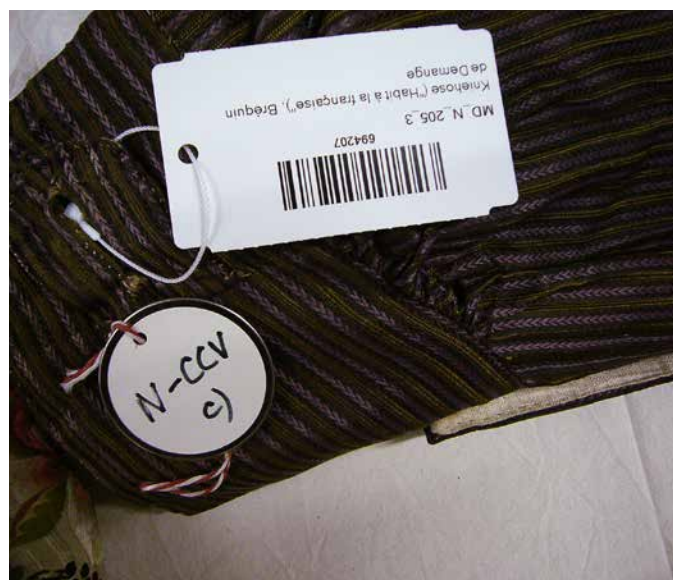
Fig. 42: Detail of a pair of breeches from the Monturdepot, with its barcode label affixed to the buttonhole. Next to it, the old, manually written inventory label.

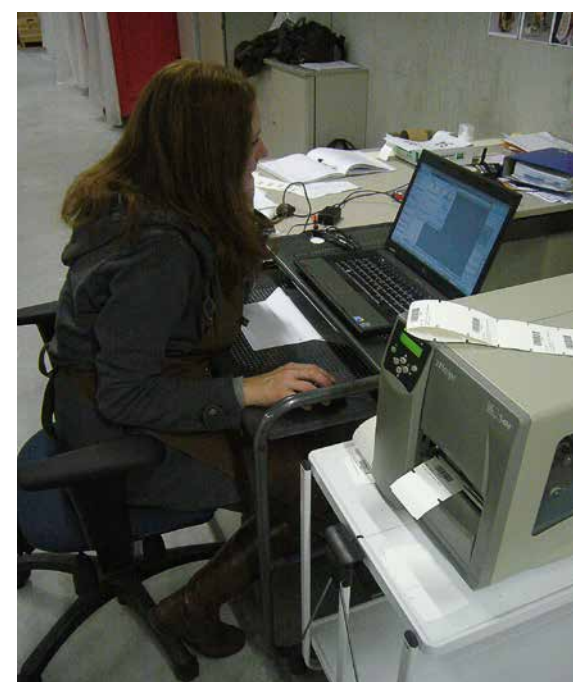
Fig. 43: Employee of the Wagenburg/Monturdepot collection printing out barcode labels at the central storage facility.

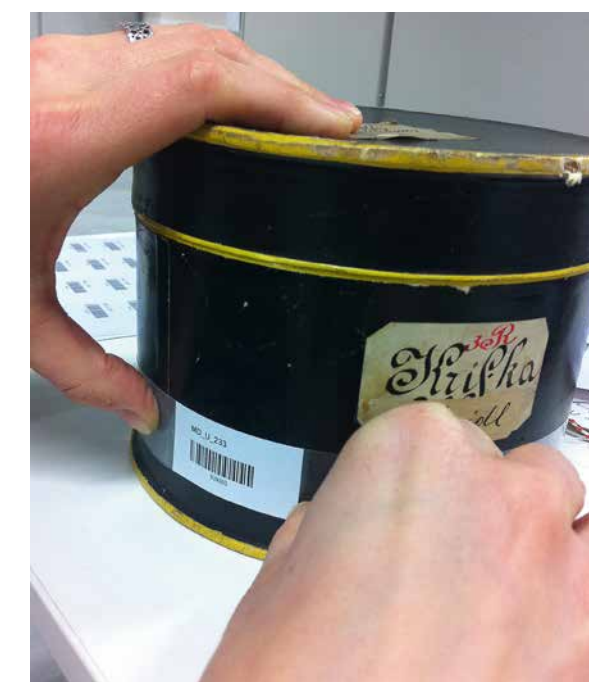
Fig. 44: Tagging of an original wig-box from the Monturdepot with a banderole made of a strip of polyethylene with a barcode label adhered to it.

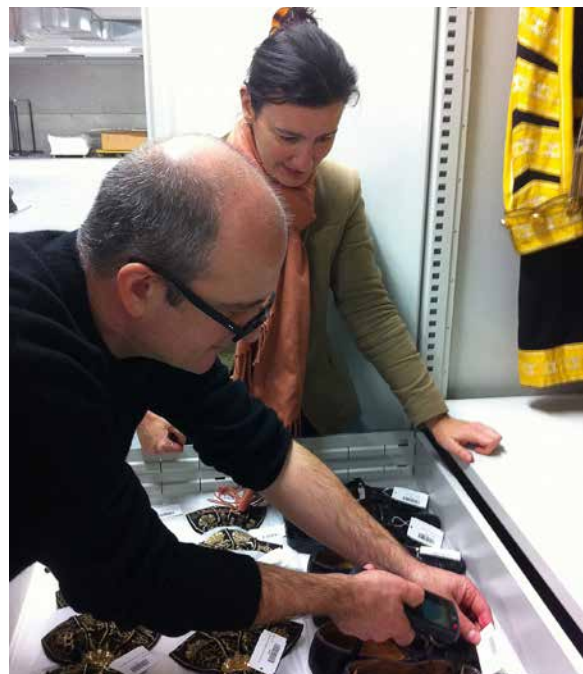
Fig. 45: Reading of object data using a barcode scanner.

An innovation which significantly enhanced the efficiency of storage was the introduction of barcodes: by means of electronically readable barcodes, any change in an object’s location can be automatically registered using a reading device (Motorola MC 1000 Scanner) (see fig. 45) and electronically processed. In addition to barcodes for the objects, there are barcode labels on shelves, drawers or shelving (so-called “location-IDs”). Due to these barcodes, any change in location, including specifications of the date and the person in charge, will be electronically recorded.⁵

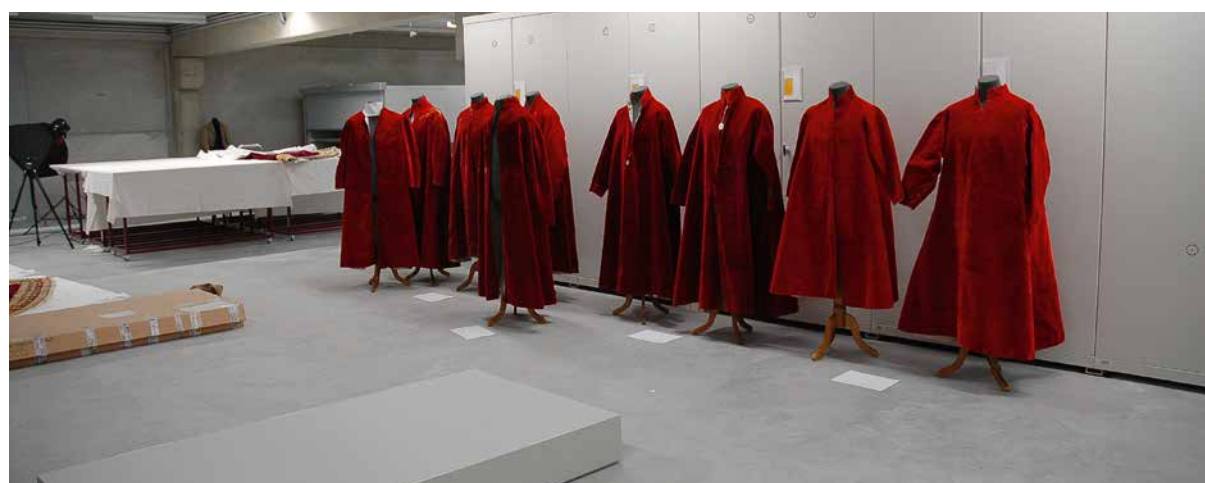
Fig. 47: Vestments of the Order of the Golden Fleece, lined up at the central storage facility for scientific examination. In front of them, the flat textile storage boxes custom-made for this collection.

The robes of the Habsburg dynastic orders previously housed in the Hofburg however can only be moved to their final location bit by bit: for decades they were stored under overcrowded conditions in inadequate containers and are now being transferred to new, custom-made textile boxes (fig. 47) and cabinets.

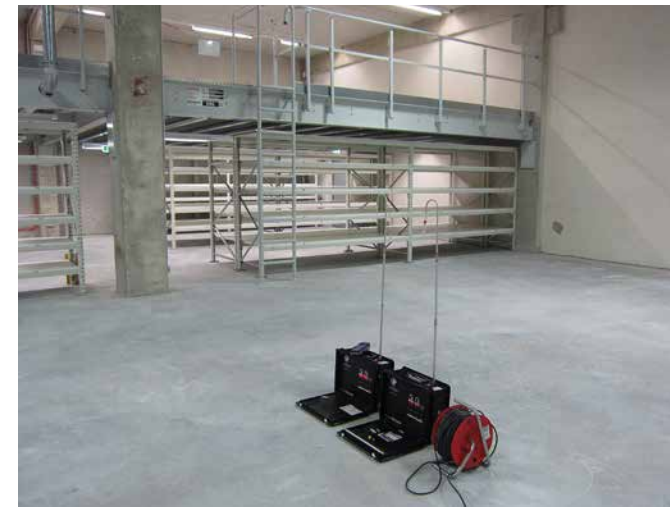
Fig. 1: First air pollutant measurement carried out by IBO Innenraumanalytik OG in August 2011; view of the storage area on F1, Imperial Carriage Museum/Court Wardrobe with mezzanine (intermediary steel platform) during indoor air sampling.

The procedure originally planned for the initial pollutant assessment in the still empty storage facility and the repetition of air sampling after it had been equipped with storage furnishings could not be carried out exactly in this way because completion of the spaces overlapped with their furnishing. It was still possible, however, to test the spaces with a mezzanine (intermediary steel platform) and furnishings already in place before bringing in the first objects. This served to establish comparison values for later measurements (*fig. 1*) and to evaluate the Oddy-tests carried out beforehand on all materials used for coating the storage

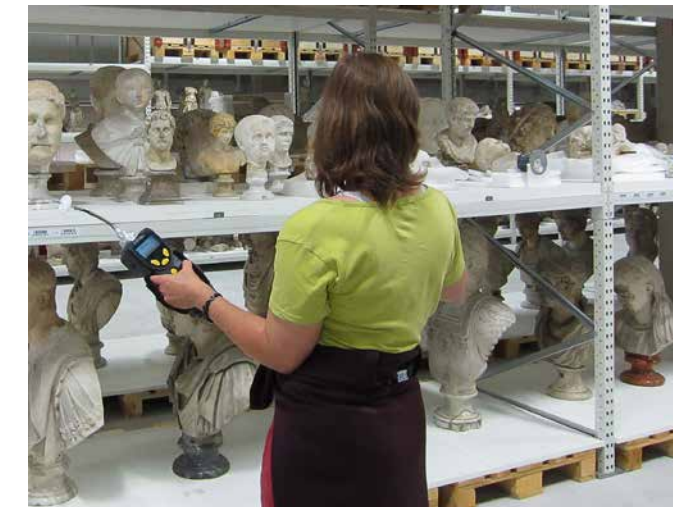
Fig. 2: Regular monitoring of VOCs with the handheld VOC measurement device ppbRAE 3000, here in the storage area for the Collection of Greek and Roman Antiquities.

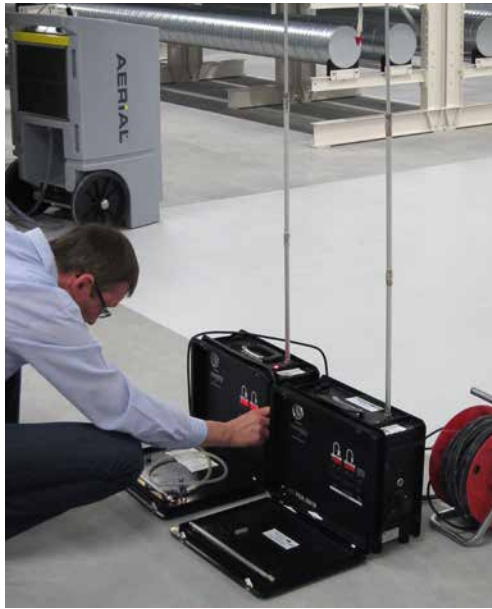
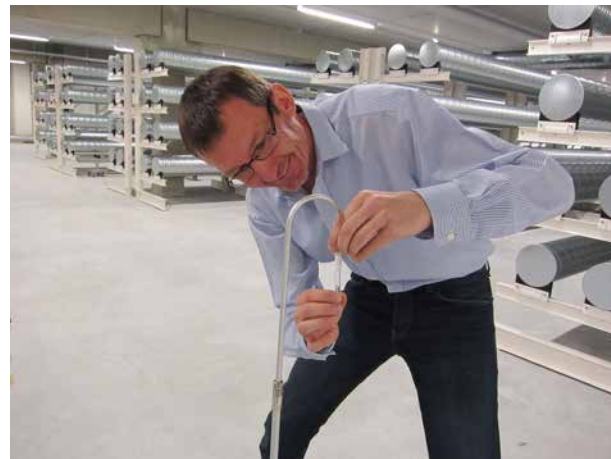
Fig. 4 a

A colleague from IBO Innenraumanalytik OG testing the air on F3, Kunstammer-Tapestries for aldehydes in August 2011.

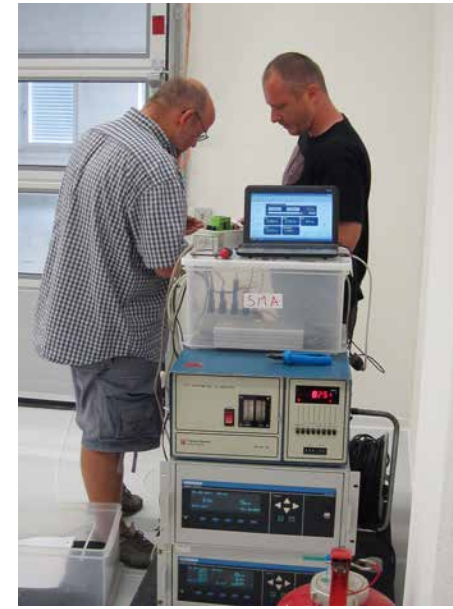
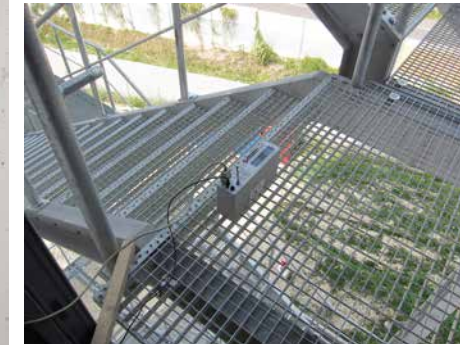
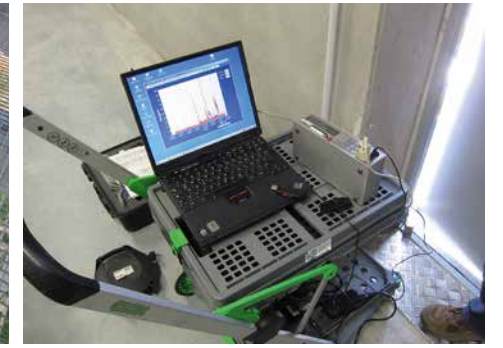
Fig. 5 a

Testing the concentration of typical pollutants and particulates found in outside air in August 2011. Fig. 5 a: Preparation for testing for NO_x and SO₂ by employees of a company contracted by IBO Innenraumanalytik OG. Fig. 5 b and c: Measuring particulate matter in outside air – as a comparison with that found in indoor air – in F3, Kunstammer-Tapestries.

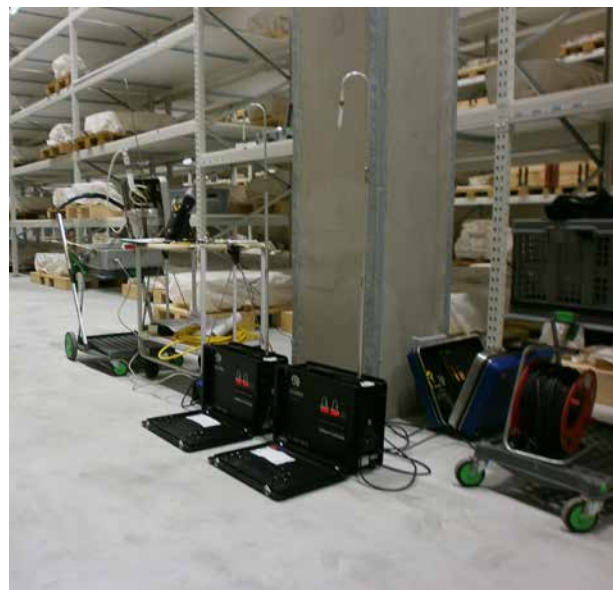
Fig. 6: Second air pollutant measurement by IBO Innenraumanalytik OG in September 2012; view of GF, Collection of Greek and Roman Antiquities during indoor air sampling. The shelves are already filled with objects on Euro-pallets.

During the repetition of the air sampling in September 2012, the most contaminated storage area – that containing heavy stone objects from the Collection of Greek and Roman Antiquities placed on wooden pallets – was chosen, along with one of the earlier investigated areas, in order to compare the qualitative and quantitative identification of air pollutants (figs. 6 and 7). As expected, primarily terpene derivatives from the wood used in the pallets and solvent

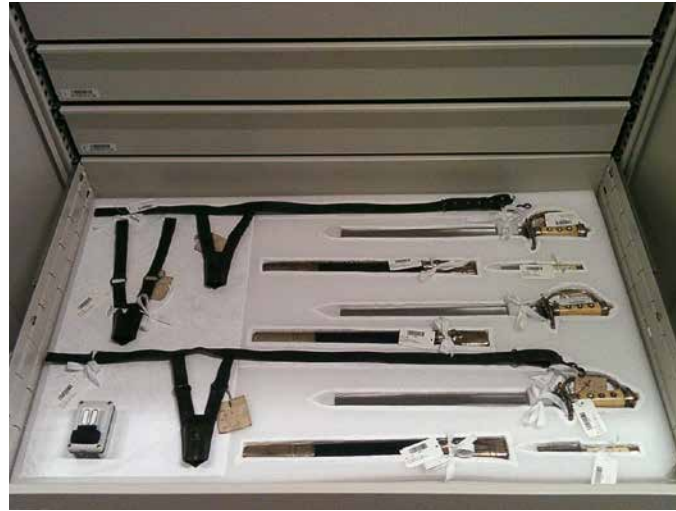
Fig. 9 a: Use of the AIRCORR I logger with lead sensor (below, left) in a drawer already filled with artefacts in F3, Imperial Carriage Museum/ Court Wardrobe.

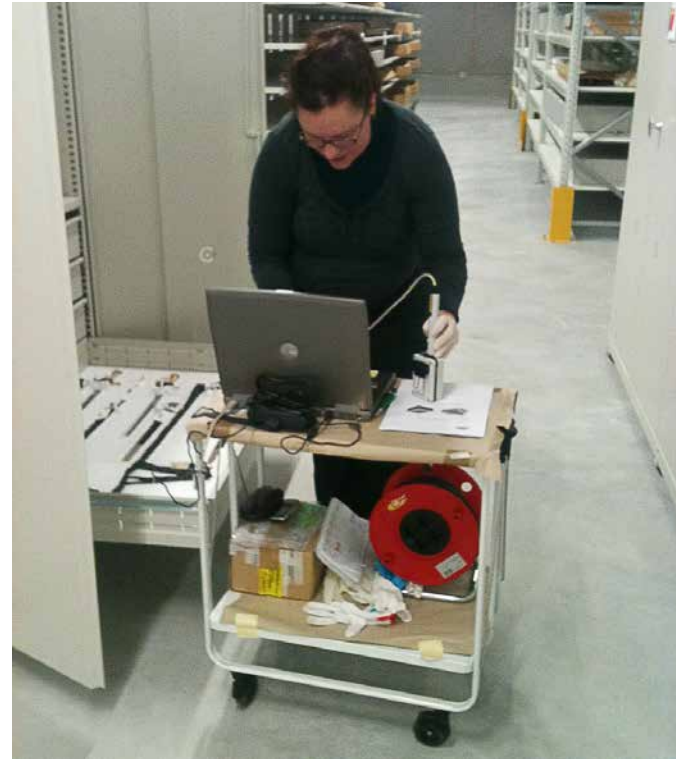
Fig. 9 b: Collecting the corrosion data from the lead sensor, which was in place as shown in *fig. 9 a* for 20 days.

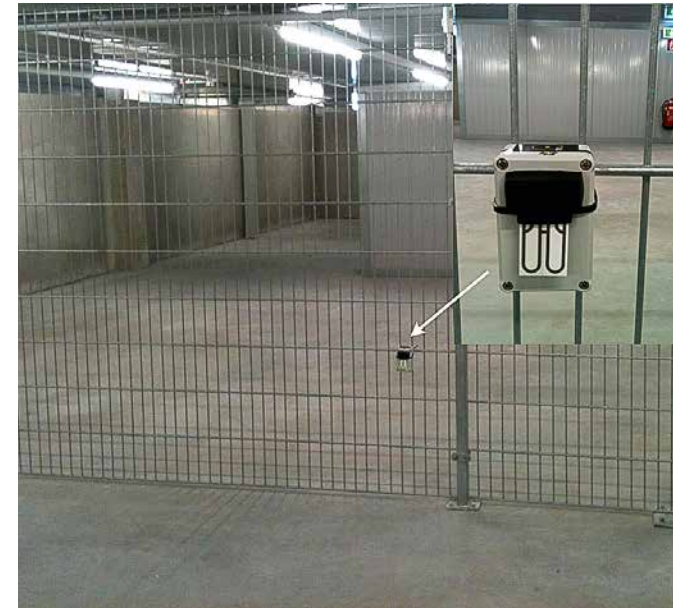
Fig. 11 a: Use of the AIRCORR I logger with a bronze sensor in the still empty F2, Coin Collection, climate box.

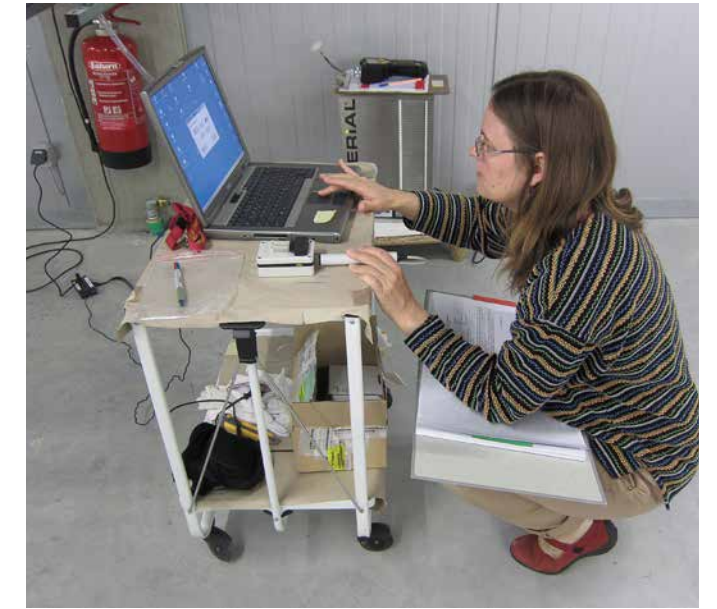
Fig. 11 b: Collecting the corrosion data from the bronze sensor, which was in place as shown in *fig. 11 a* for 21 days.

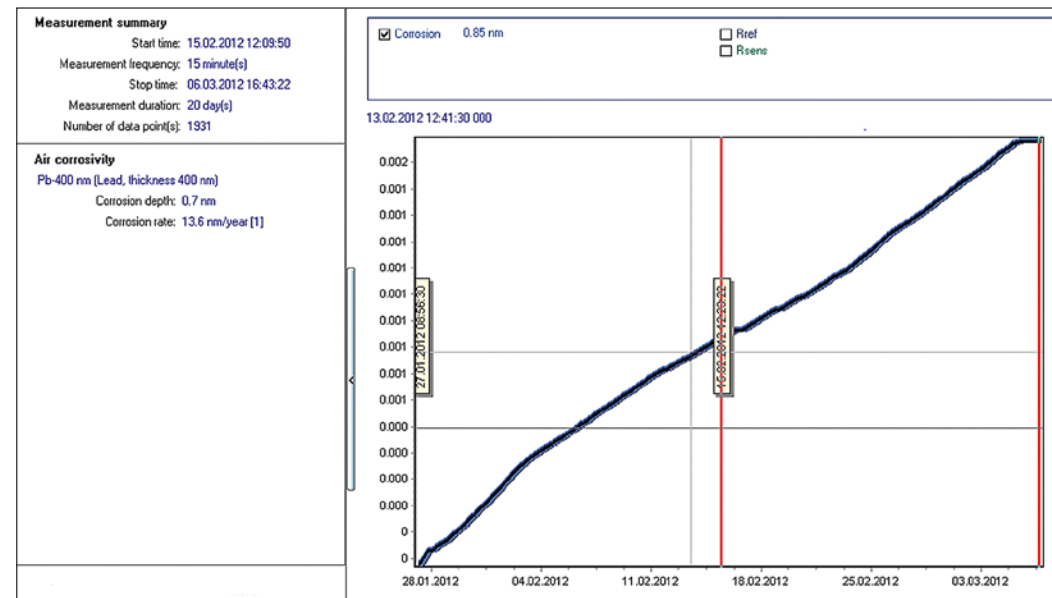
Fig. 10: Results of the evaluation of the lead sensor placed in F3, Imperial Carriage Museum/Court Wardrobe, gained by using the associated software. Like with all sensors in the MUSECORR system, the lead sensor can also be used more than once in different locations for testing the corrosive potential of the surrounding atmosphere. In the evaluation shown here, the measurement period in F3, Imperial Carriage Museum/Court Wardrobe is delimited by the two red lines (from February 15th, 2012 to March 6th, 2012). The evaluation of this section of the corrosion curve shows a corrosion depth of 0.7 nm and a corrosion rate of 13.6 nm per year. According to the project leaders at MUSECORR, this corresponds to a potentially non-corrosive environment for objects.

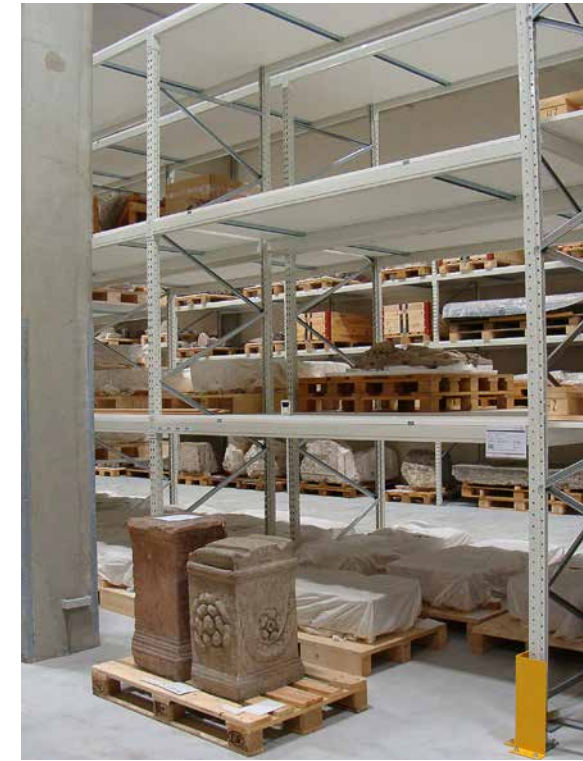
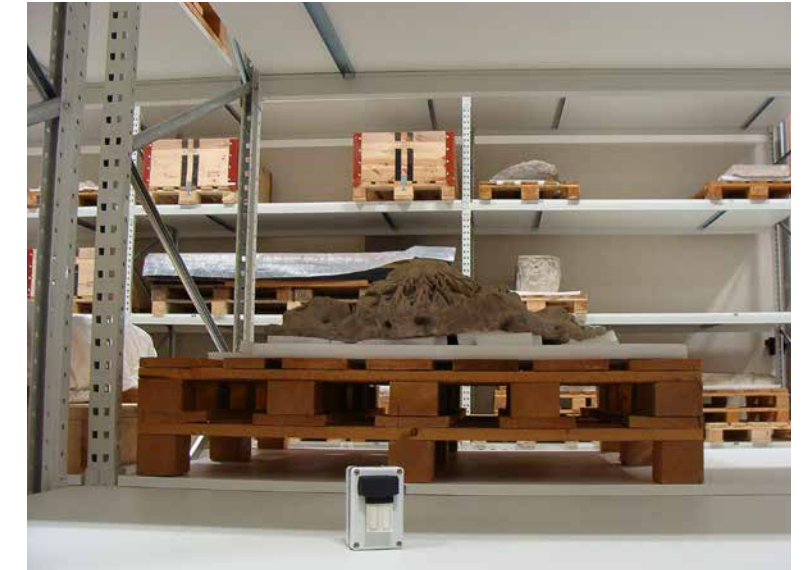
Fig. 14 a

Use of the AIRCORR I logger with a silver sensor in GF, Collection of Greek and Roman Antiquities, with objects already moved in.

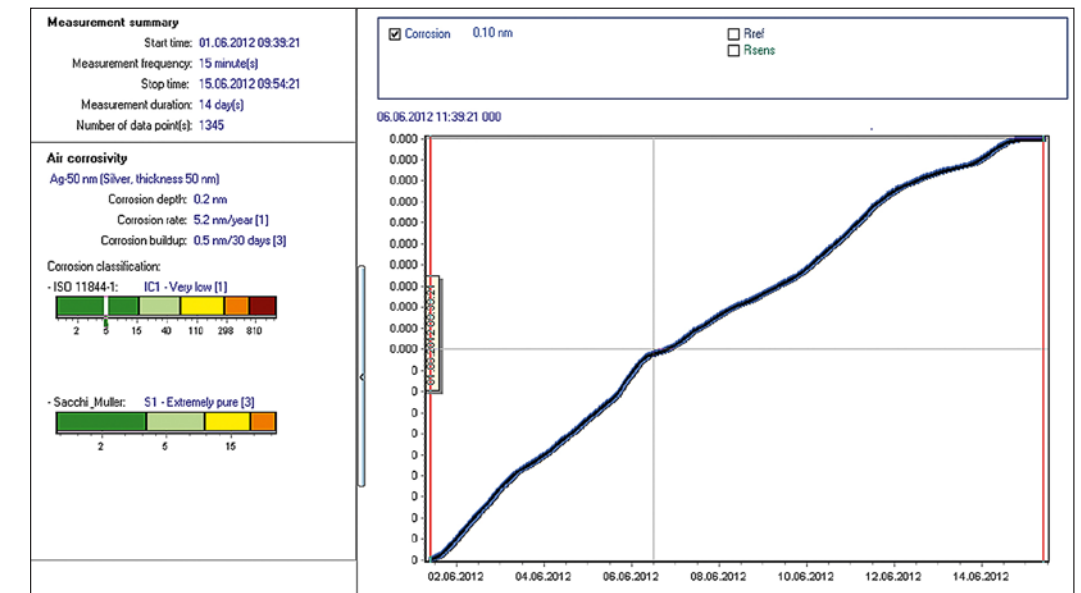
Fig. 15: Results of the evaluation of the silver sensor in GF, Collection of Greek and Roman Antiquities, also with a corrosion classification indicating an unpolluted environment. The lead and bronze sensors also produced good results in this area, i.e., little potential for corrosion in the atmosphere, although contamination by VOCs inside this storage area was the highest.
