Catena 50 (2003) 135–150

# Quantifying historical gully erosion in northern Bavaria

Markus Dotterweich\*, Anne Schmitt, Gabriele Schmidtchen,  
Hans-Rudolf Bork

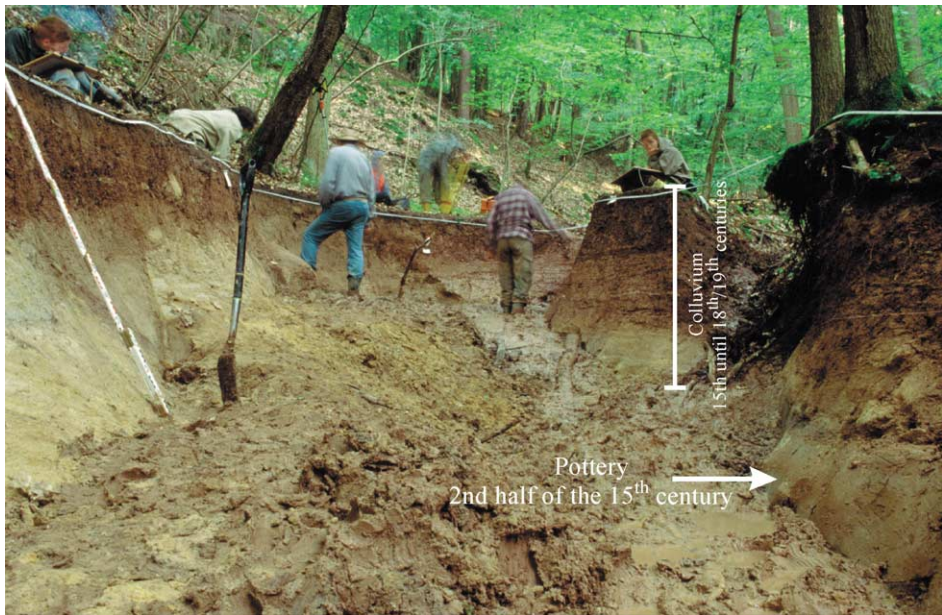
Exposure no. 10 (Fig. 4) shows the recent amphitheatre-shaped area of the gully head with sediments of more than 20 different layers of gravel, sand, loam and silt. The sediments from the lower part of the sandy–silty Triassic sandstone can be found at the northward-facing slope. The sediments at the bottom of the exposure (approximately 1 m

Fig. 4. Exposure no. 10.

above the basis of the origin sandstone) included some pieces of pottery which date back to the latter half of the 15th century (archaeological dating: Dr. J. Haberstroh, Bavarian State Department of Historical Monuments, May 27, 1999) and many hundred pieces of charcoal. The first meter of sediment in the exposure is red silt originating from the lettic southward-facing slopes.

*Phase 5:* After the significant event of Phase 4, some small landslides occurred at the edge of the gully. The gully was then filled with sediments from the slopes. Exposure no. 10 (Fig. 4, front of the picture) shows these sediments.

*Phase 8:* During a large rainfall event, the recent gully, featuring an average depth of 1.6 m, cut through the medieval sediments along the track in the Wolfsgraben. Fig. 3 represents the “recent gully” and Exposure no. 10 of Fig. 4 shows the active gully head.
