# Channel instability in a forested catchment: a case study from Jones Creek, East Gippsland, Australia

Tim J. Cohen<sup>\*</sup>, Gary J. Brierley<sup>1</sup>

*School of Earth Sciences, Macquarie University, North Ryde, NSW 2109, Australia*

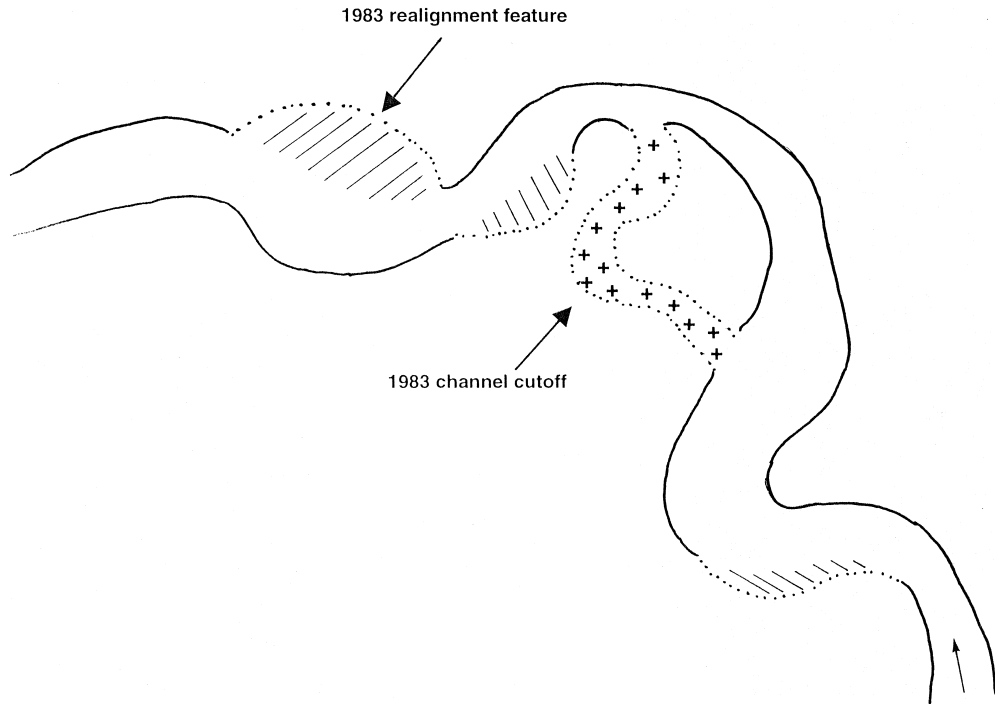
Fig. 3. Schematic example of a lateral realignment feature in contrast to a section of the 1983 channel that has been separated from the channel. Realignment features reflect lateral adjustment of the channel planform and shift in the focus of bend migration.

alignment features. Realignment features reflect lateral channel adjustment, in contrast to channel cutoffs which represent bends or sections of the channel that have been separated from the contemporary channel (Fig. 3).

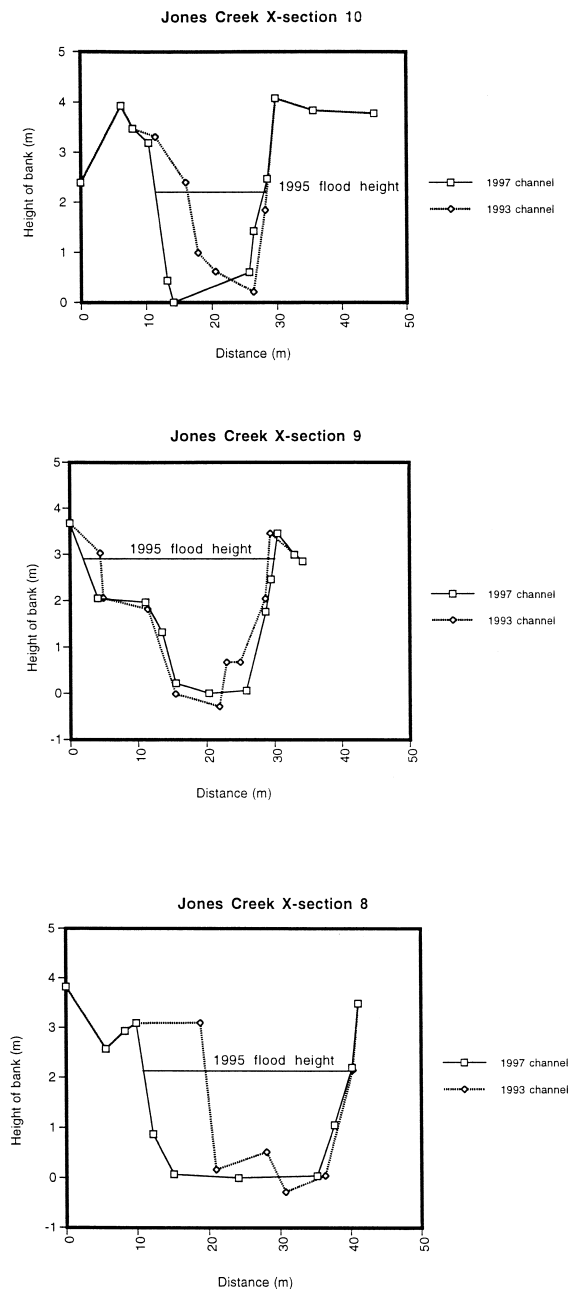
Fig. 6. Cross sectional changes in the middle section of Jones Creek between 1993 and 1997 highlighting localised increases in cross sectional area and lateral adjustment of channel geometry.

Aerial photographs from 1992–1994 indicate little change in channel planform of Jones Creek. The last three months of 1995 were characterised by high maximum monthly rainfall producing a bankfull event on Jones Creek on the 5th and 6th of December with an estimated discharge of around  $130 \text{ m}^3 \text{ s}^{-1}$ . The 1995 flood induced little change in planform in the study reach. A flood in June 1998, which was approximately three quarters bankfull, resulted in a cutoff in the upper part of the study area. The period from 1992 to the present has been characterised by continued channel expansion, bar deposition and lateral adjustment and is identified as the third phase of channel change in Jones Creek. Bankfull widths and cross sectional area increased slightly with small fluctuations in mean depth (see Table 1). Straightening is still operative with 1–2 cutoffs in the process of occurring. The contemporary behaviour of Jones Creek is characterised by localised increases in cross sectional area, with shifts in the erosional foci being the dominant process as exemplified by Fig. 6.

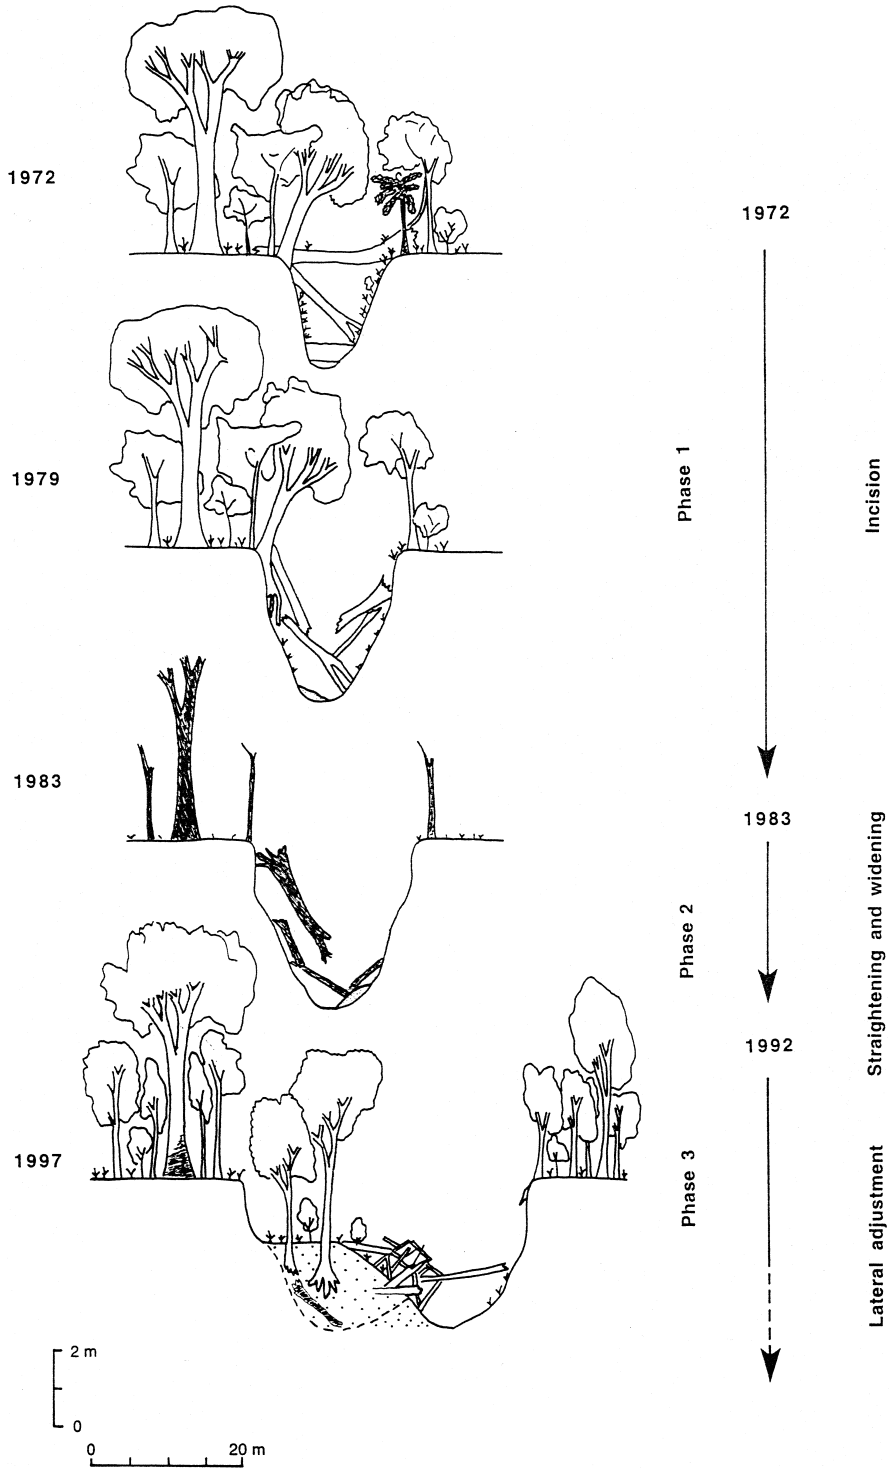
Fig. 8. Schematic diagram of the 3 phases of channel change in Jones Creek from 1972 to 1997.

The three periods of channel change identified along Jones Creek since 1972 are shown schematically in Fig. 8. It must be noted that the processes

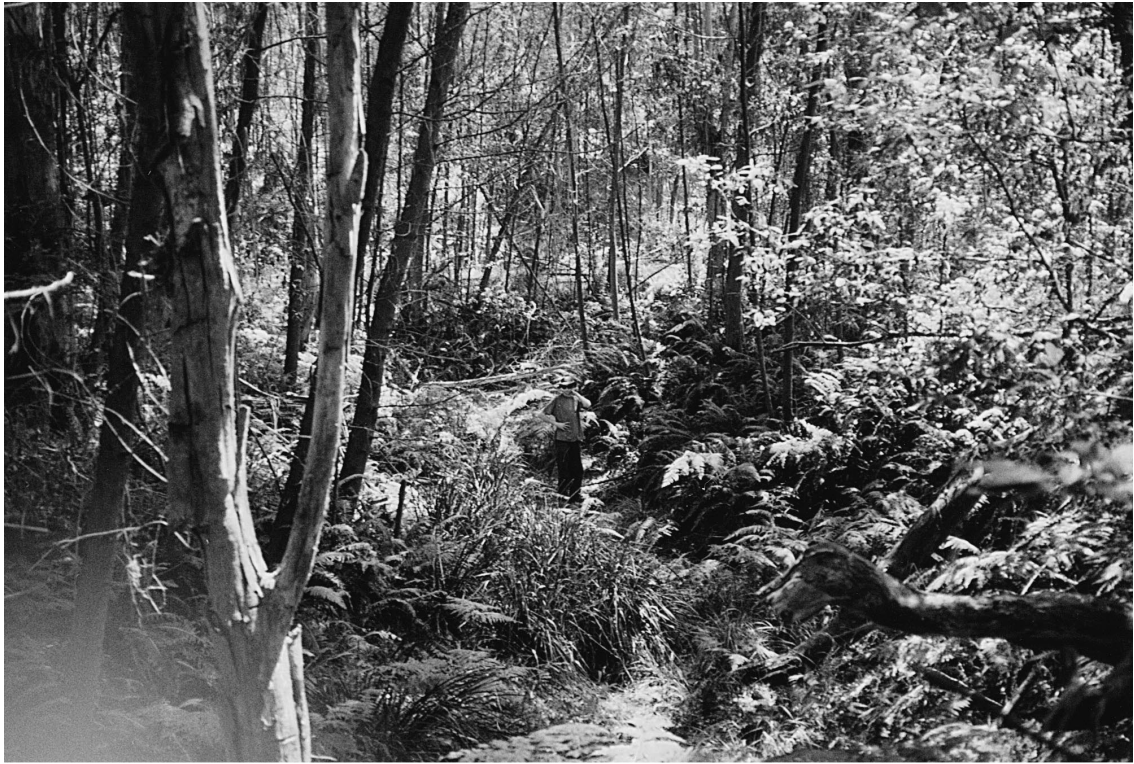
Fig. 9. Downstream view of a 1972 channel in Jones Creek, prior to destabilisation. Note the narrow symmetrical channel.

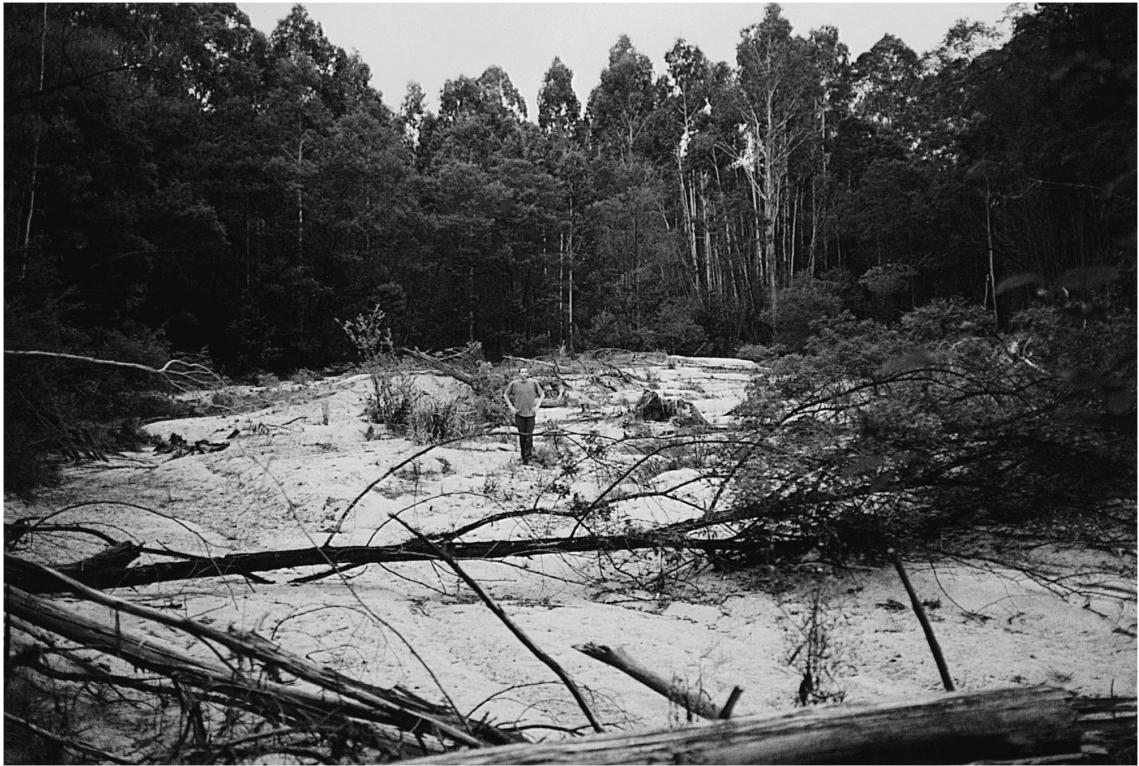
Fig. 10. Upstream view of the contemporary channel in Jones Creek highlighting the widened nature of the current channel.

Phase 3 (1992 to present) has been a period of ongoing channel expansion and straightening, with a reduction in sinuosity to 1.5 (Fig. 10). Estimated specific stream powers are approximately four times higher than in 1972. There has been continued aggra-
