CHAPTER 4

Atmospheric corrosion and conservation of copper and bronze

D. Knotkova & K. Kreislova
SVUOM Ltd., Prague, Czech Republic.

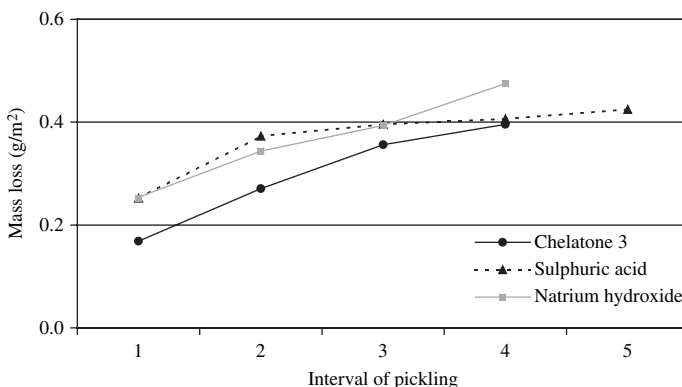
Figure 1: Corrosion loss of copper during pickling.

In the case of the samples covered with a thick layer of corrosion products, the course of pickling is similar: only the absolute values of material loss are higher. Chelatone 3 solution acts more strongly in the first interval, but after the second interval the intensity of dissolving corrosion products is similar to that of the sulfuric acid solution. The total material loss after pickling in Chelatone 3 solution is lower than in the case of pickling in the sulfuric acid solution, while the degree of cleaning the surface is the same (Table 11).

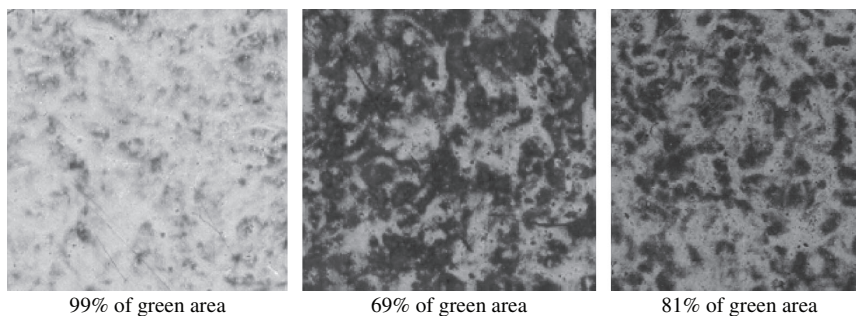
Figure 2: Changes of the layer of artificial green patina Nordic Green.

Sheets of artificial patina Nordic Green have been exposed for a long term at the atmospheric test sites of SVUOM and the changes of patina layer are being observed. A gradual wash-out occurred during the exposure but after approximately four years the green surface began to spread again. There is a gradual formation of natural patina, which grows through the layer of artificial patina. Computer picture

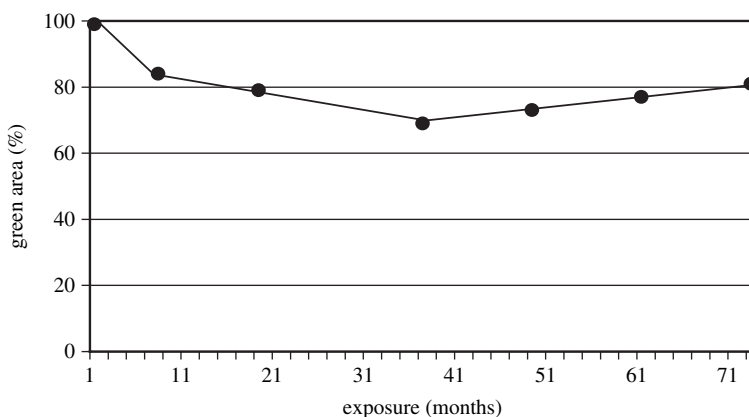
Figure 3: Changes of the layer artificial green patina Nordic Green during long-term exposure at a field test site Prague.

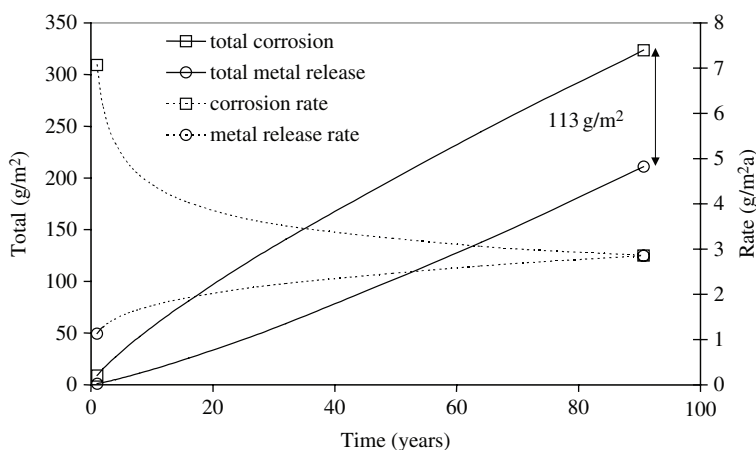
Figure 4: Calculated copper corrosion and metal release amounts and rates.

bronze sculptures. Results of average corrosion rates and metal release rates are shown in Table 16 after 1, 2, 4 and 8 years of exposure. Metal release rate is always lower than corrosion rate and the proportion increases with time due to decreasing corrosion rates and increasing metal release rates.

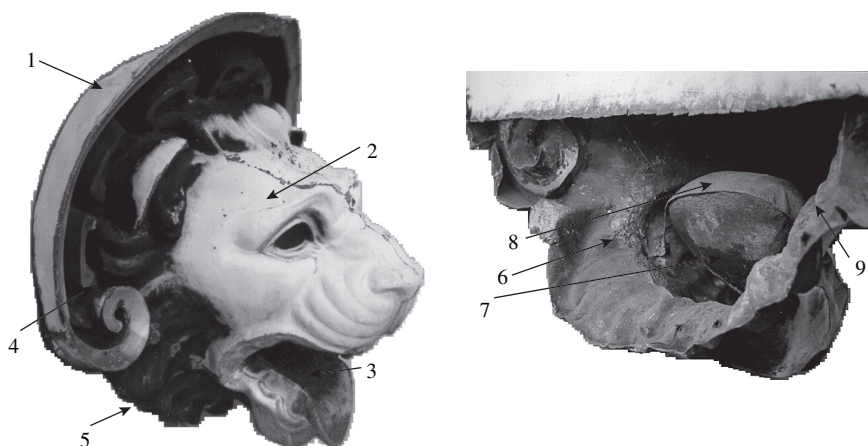
- isolated cracks in area of forming and joints
- release of joints, non-functional joining by steel nails
- bimetallic corrosion
- occurrence of black spots in the area of soldered joints
- occurrence of crusts
- degradation of gilded surface

X-ray analysis of surface layer

Area of removal of samples	Appearance of layer	Composition
1 Upper hem	Bright green, turquoise	Brochantite
2 Upper edge of eye	Bright turquoise	Brochantite, antlerite
3 Mouth	Grey and green	Antlerite, quartz, gypsum
4 Profiled part of hem	Dark gray	Cuprite, antlerite
5 Lower dark hem	Red and brown	Cuprite, antlerite
6 Lower part of inside surface with dust and crusts	Bright turquoise with gray parts to dark gray and green	Antlerite, chalcantite, gypsum, (NH ₄) ₂ Cu(SO ₄) ₂ · 6H ₂ O
7 Lower part of inside surface	Turquoise, gray parts	Chalcantite, antlerite, brochantite, gypsum
8 Upper part of inside surface	Grey-and-green to dark green, dark gray	Antlerite, quartz
9 Inside surface of hem	Brown, gray and green	Cuprite, quartz, antlerite

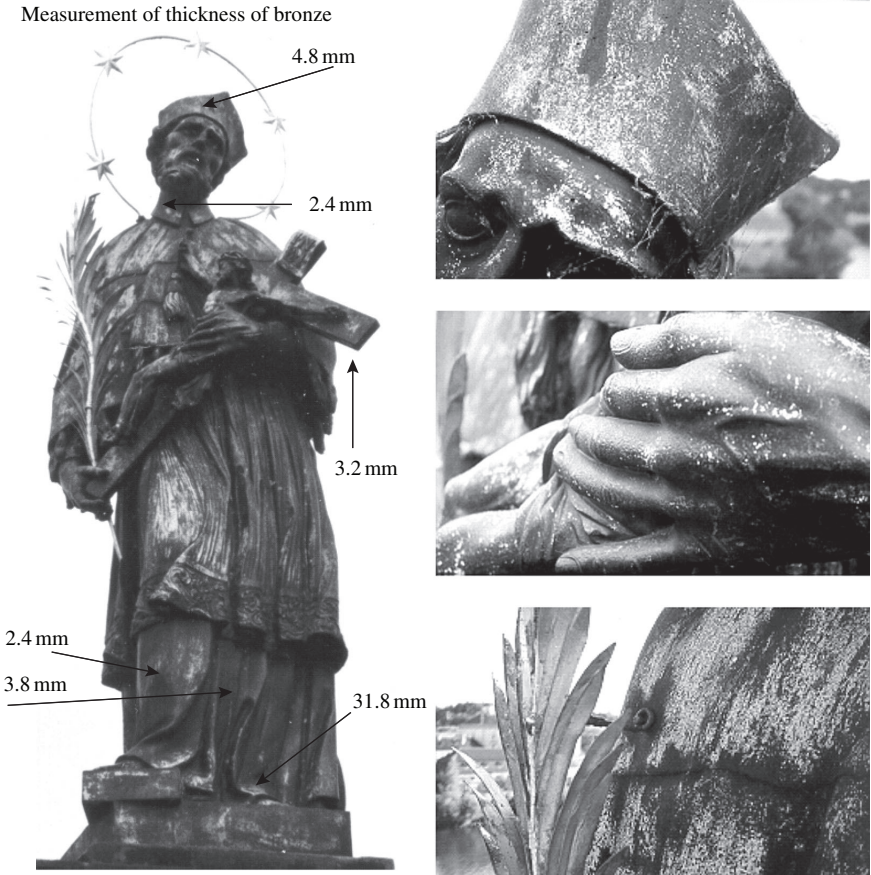
- small holes on the most open areas (forehead, cap)
- dark surface with dust deposits in shelter position
- corrosion on the borders of grain of alloy
- application of lead as filling material for holes and openings

X-ray analysis of surface layer

Area of removal of samples	Appearance of layer	Composition
Upper surface of cap	Green-and gray	Brochantite, cuprite
Lower part of coat, shelter	Black	$(\text{NH}_4)_2\text{Cu}(\text{SO}_4)_2 \cdot 6\text{H}_2\text{O}$, graffite
Open surface of body	Green	Brochantite, quartz, cuprite, anglesite (PbSO_4)

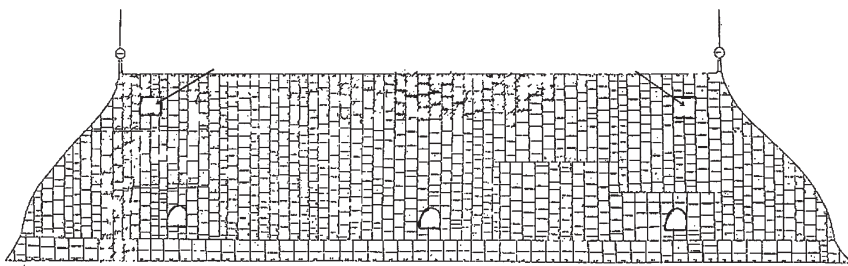
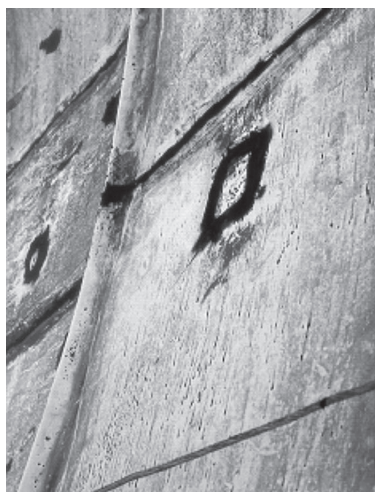
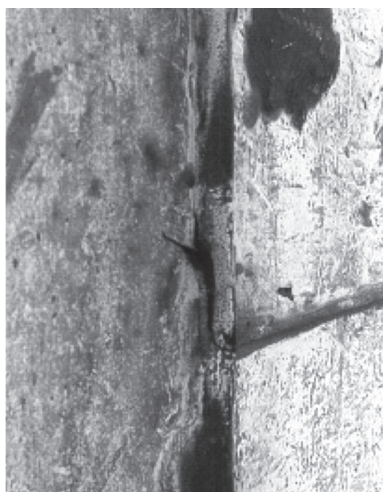
East side of roof

- cracks and perforations on the sheets with minimum thickness
- occurrence of black spots on sheets

X-ray analysis of surface layer

Area of removal of samples	Appearance of layer	Composition
1 Cover of window	Middle green	Brochantite
2 Sheets on east side	Yellow and green	Brochantite, quartz, gypsum
3 Area with black spots	Black	Cuprite

Microprobe analysis of spots: high amount of Fe

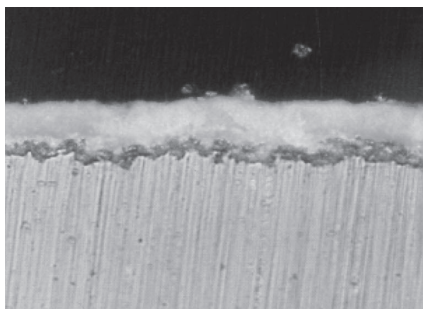
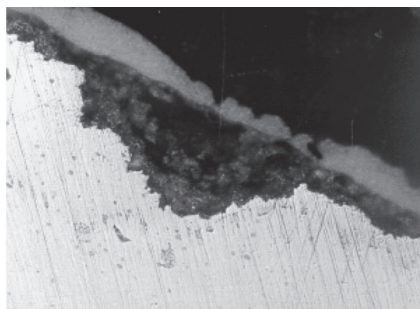
200×

Metallography cross: layered patina – lower layer cuprite; upper layer brochantite, antlerite pits

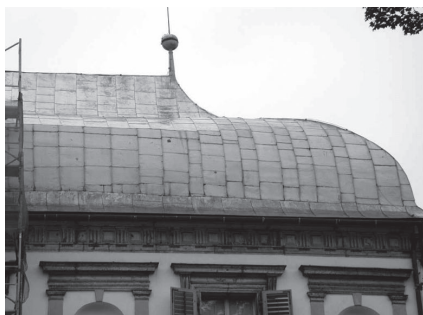
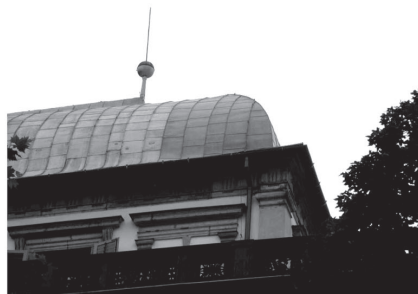
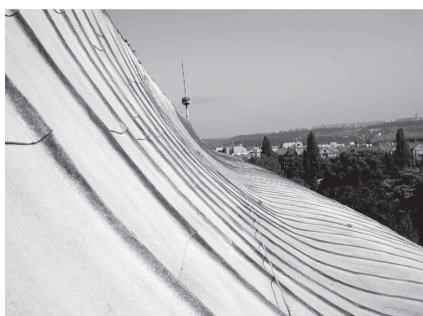
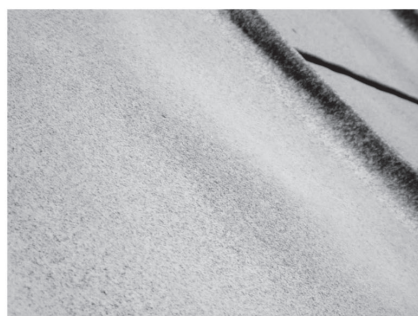
Reconstruction:

- realized in 2000–03
- replacing of damaged sheets by new copper sheets
- application of artificial green patina on replaced sheets
