This article aims to reconstruct the geomorphologic and landscape effects of the most catastrophic flood from a man-made dam failure within the territory of today's Czech Republic, namely, the Bílá Desná dam failure, which occurred on 18 September 1916, only one year after the completion of its construction. At the same time, the specific aim of this paper

2. Study area and characteristics of the former Bílá Desná dam

2.1. Characteristics of the former Bílá Desná dam

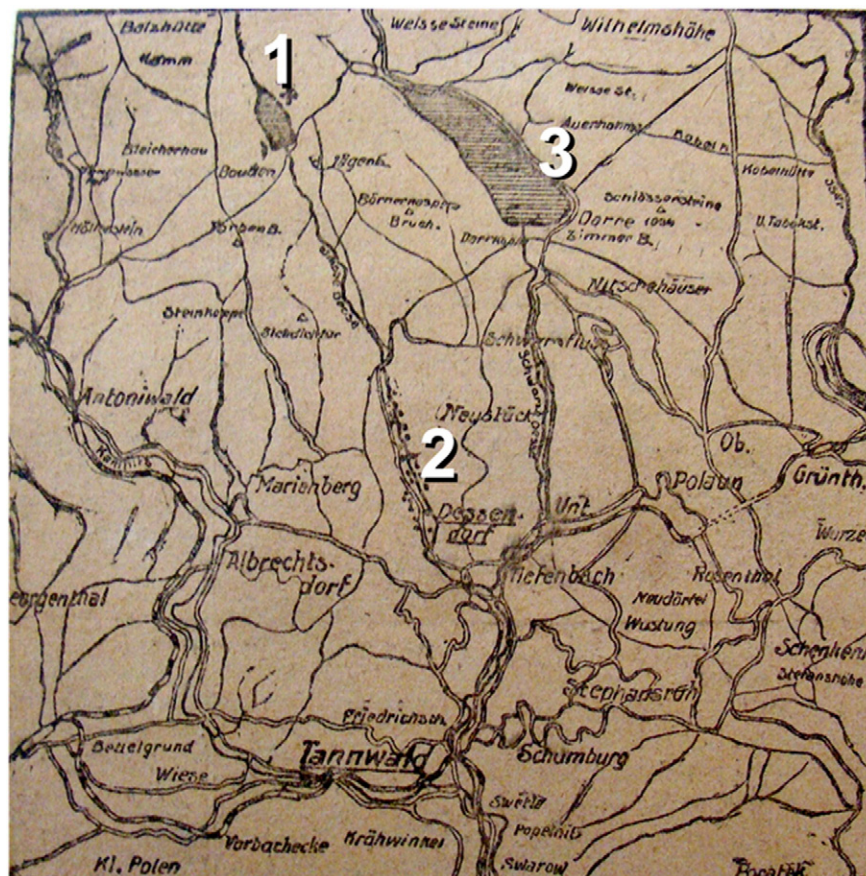
Fig. 2. Unique archival map showing the position of the Bílá Desná dam (1) in the short interval between its completion and failure. The village of Desná (Dessendorf) is represented by (2), and the Souš dam is represented by (3). The Bílá Desná reservoir was connected to the Souš reservoir by an underground tunnel. Source: Archive in the Jablonec nad Nisou.

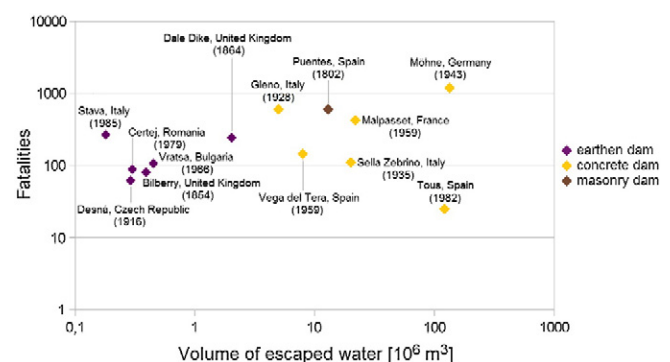
In comparison with recorded floods following dam failures in Europe, the Bílá Desná dam failure claimed a high number of fatalities relative to the volume of escaped water (Fig. 10). The discharged volume of 290,000 m³ and 62 fatalities provide an extremely catastrophic ratio of 4677 m³/victim. From this point of view, the Bílá Desná dam failure is considered one of the worst dam failures ever recorded worldwide. In the regional context of the Czech Republic, no recorded hydrometeorological flood (e.g., the great floods in 1997 and in 2002) claimed such fatalities. According to the number of fatalities, this event is currently ranked among the most catastrophic earthen dam failures in Europe. When we consider the time of the dam failure, this event was ranked as one of the most catastrophic dam failures until 1916 and, therefore, significantly affected the engineering of earthen dams in the entire Central Europe region (Žák, 1996).

Fig. 10. Comparison of the most catastrophic European dam failures. (Data: Harrison, 1974; Costa, 1985; Alcrudo and Mulet, 2004; Peng and Zhang, 2012).
