# The drainage of the Lake Ha!Ha! reservoir and downstream geomorphic impacts along Ha!Ha! River, Saguenay area, Quebec, Canada

G.R. Brooks<sup>\*</sup>, D.E. Lawrence<sup>1</sup>

*Geological Survey of Canada, 601 Booth Street, Ottawa, ON, Canada K1A 0E8*

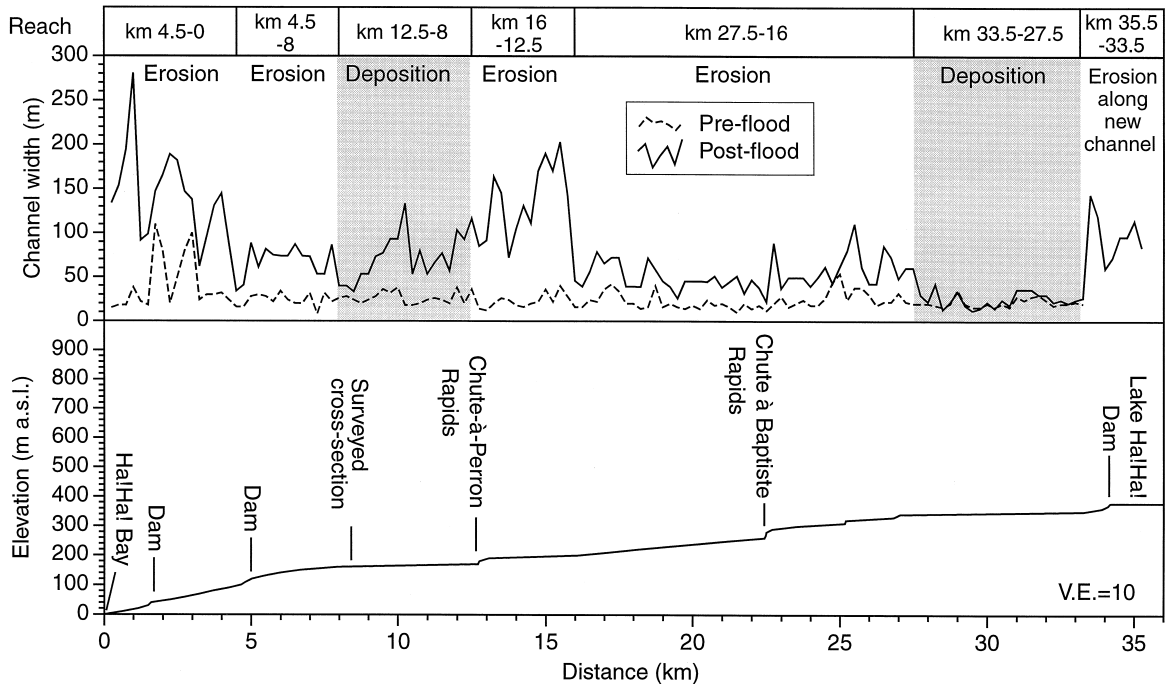
Fig. 10. Graphs depicting the pre-flood and post-flood downstream changes in channel width along Ha!Ha! River and the pre-flood longitudinal gradient of the valley. The erosion and deposition designations (the latter zones are also shaded) across the top of the channel width graph refer to the dominant geomorphic process along the valley bottom within a given reach.

from 60 to 144 m wide, with a mean width of 98 m (Fig. 10). Reflecting the high-magnitude of the outflow from Lake Ha!Ha!, the post-flood mean width is approximately 4.5 times greater than the pre-flood channel of the river downstream between km 33.5 and 27.5. Incision along the new channel decreases downstream from a maximum of about 14 m in the area of the eroded dyke to a negligible change at the junction of new and pre-flood channels (INRS-Eau, 1997).

the channel; the pre-flood meandering planform of the river essentially was preserved. The pre-flood and post-flood widths ranged from 16 to 36 m (mean 22 m) and 12 to 42 m (mean 26 m; Fig. 10), respectively, with some of this difference probably partially reflecting minor error in measurement, on the map, or minor aggradation of the channel.

at km 13 to several metres at km 16 (INRS-Eau, 1997). The post-flood channel is considerably wider (72 to 190 m, mean 136 m) than the pre-flood channel (12 to 40 m, mean 24 m) along the entire reach (Fig. 10). A section of the pre-flood channel at

Between km 12.5 to 8.5, the width of the post-flood (33 to 133 m, mean 77 m) is considerably wider than the pre-flood channel (18 to 36 m, mean 26 m, Fig. 10). This reflects the development of a new channel on the aggraded valley bottom rather than the erosion of the pre-existing margins of the channel. At km 10.5 to 10, a large sheet of sand, up to several metres thick, was deposited in a broad, low-lying area of the valley bottom and buried the pre-flood channel and a large area along the right side of the valley bottom (including the foundations of several homes; Fig. 14). From km 8.5 to 8, the subaerial margins of the channel essentially are preserved, but the post-flood width is greater than the pre-flood (33 to 40 m vs. 24 to 28 m, respectively; Fig. 10). This apparent widening probably reflects minor aggradation of the river bed. Beginning at km 8 and extending downstream, the river bed is eroded into the pre-flood bottom of the channel.

Significant widening of the channel (Fig. 10) along much of Ha!Ha! River (specifically, from km 35.5 to 33.5, 27.5 to 12.5 and 8 to 0) is evidence that the flow energy of the flood exceeded the erosive threshold of the pre-flood perimeter of the channel and associated valley bottom (floodplain, terraces). In the recent flood literature (following Baker and
