Bank erosion history of a mountain stream determined by means of anatomical changes in exposed tree roots over the last 100 years (Bílá Opava River — Czech Republic)

Abstract

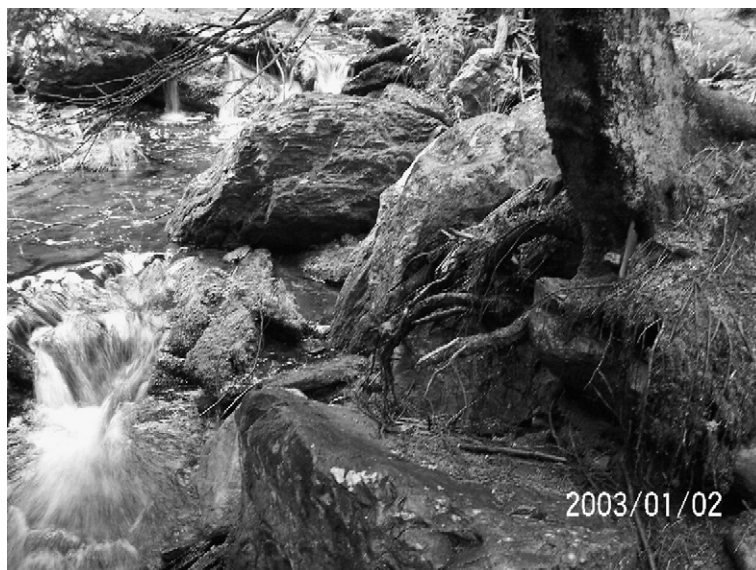
Fig. 2. Photograph showing exposed spruce roots in the Bílá Opava riverbed.

The roots of spruce growing on the valley bottom of the Bílá Opava River are exposed due to erosion (Fig. 2). Exposure dating made it possible to determine the time when intensive erosion occurred at the sites under examination. In March 2004, before collecting samples in the study area, the authors exposed dozens of spruce roots in order to monitor changes in anatomical features occurring after exposure. The experimental trees grew in the Silesian Highlands in southern Poland in limestone soil. One year after exposure, every tree produced clearly marked tree rings divided into early and late wood with small, numerous cells. This means that spruce are capable of producing annual rings with anatomical changes after exposure.
