Kokořín

Anežka Pikulová (498101)

Hrad bergfritového typu.

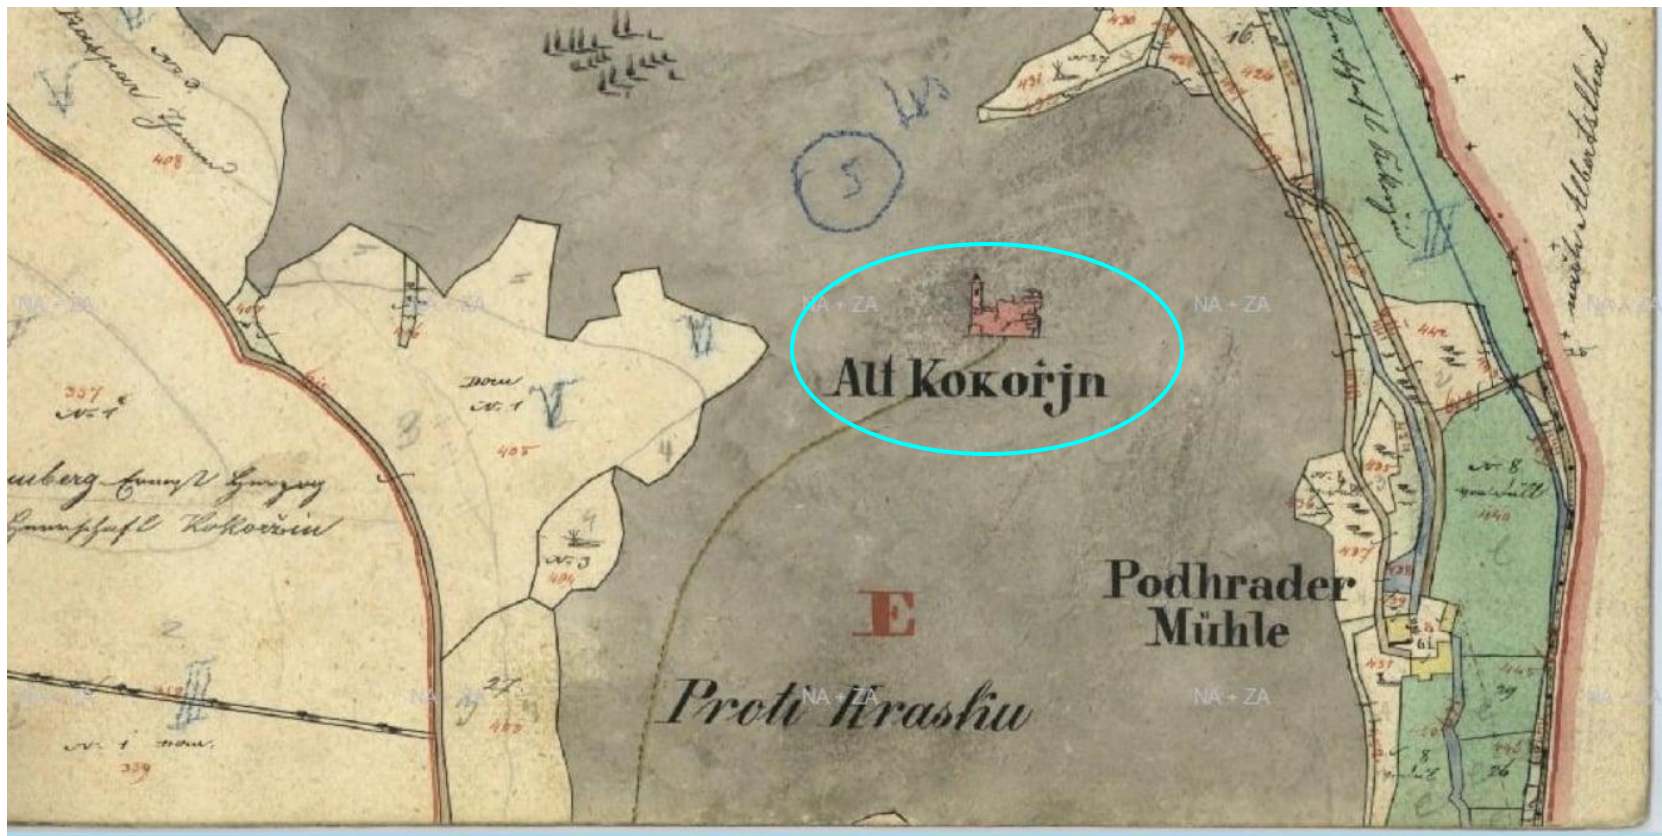
Indikační skica (3271-1) z roku 1842 katastru Kokořín - Kokorzin. Hrad Kokořín vyznačen v modré elipse.

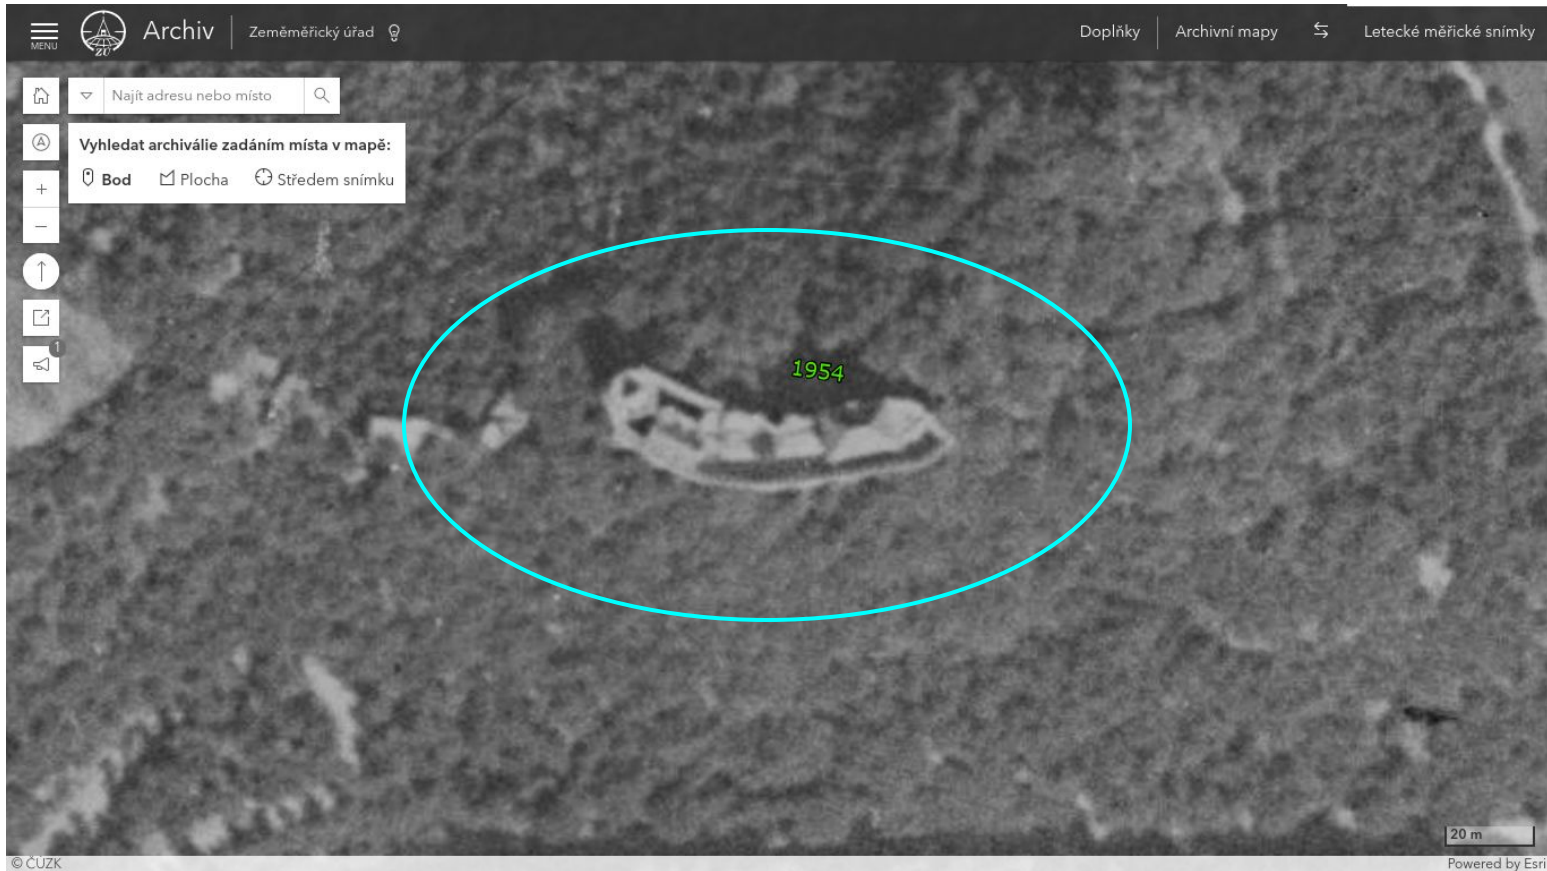
Archivní ortofoto z roku 1954. Poloha hradu vyznačena v modré elipse.
